Mona Vale Fernery
PRK 0555 BLDG 007 EQ2
Detailed Engineering Evaluation
Quantitative Report
Version FINAL

63 Fendalton Road, Fendalton

Christchurch City Council

Date
19 March 2013

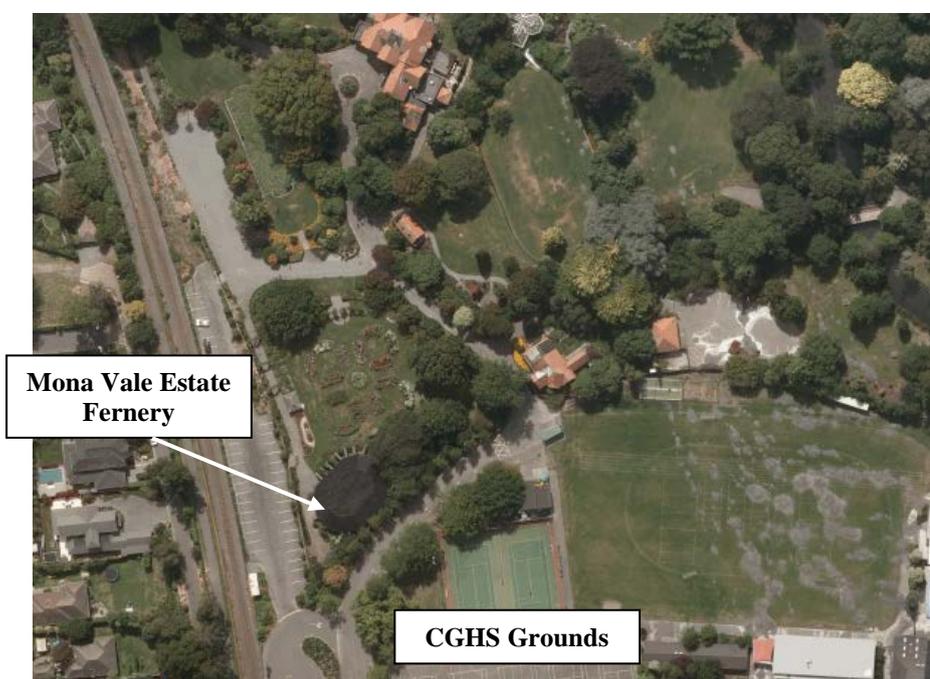
Figure 3 Post February 2011 Earthquake Aerial Photography³

Aerial photography taken following the 22 February 2011 earthquake shows signs of moderate liquefaction outside the building footprint, and significant liquefaction in the Christchurch Girls' High School grounds adjacent to the site, as shown in Figure 3.

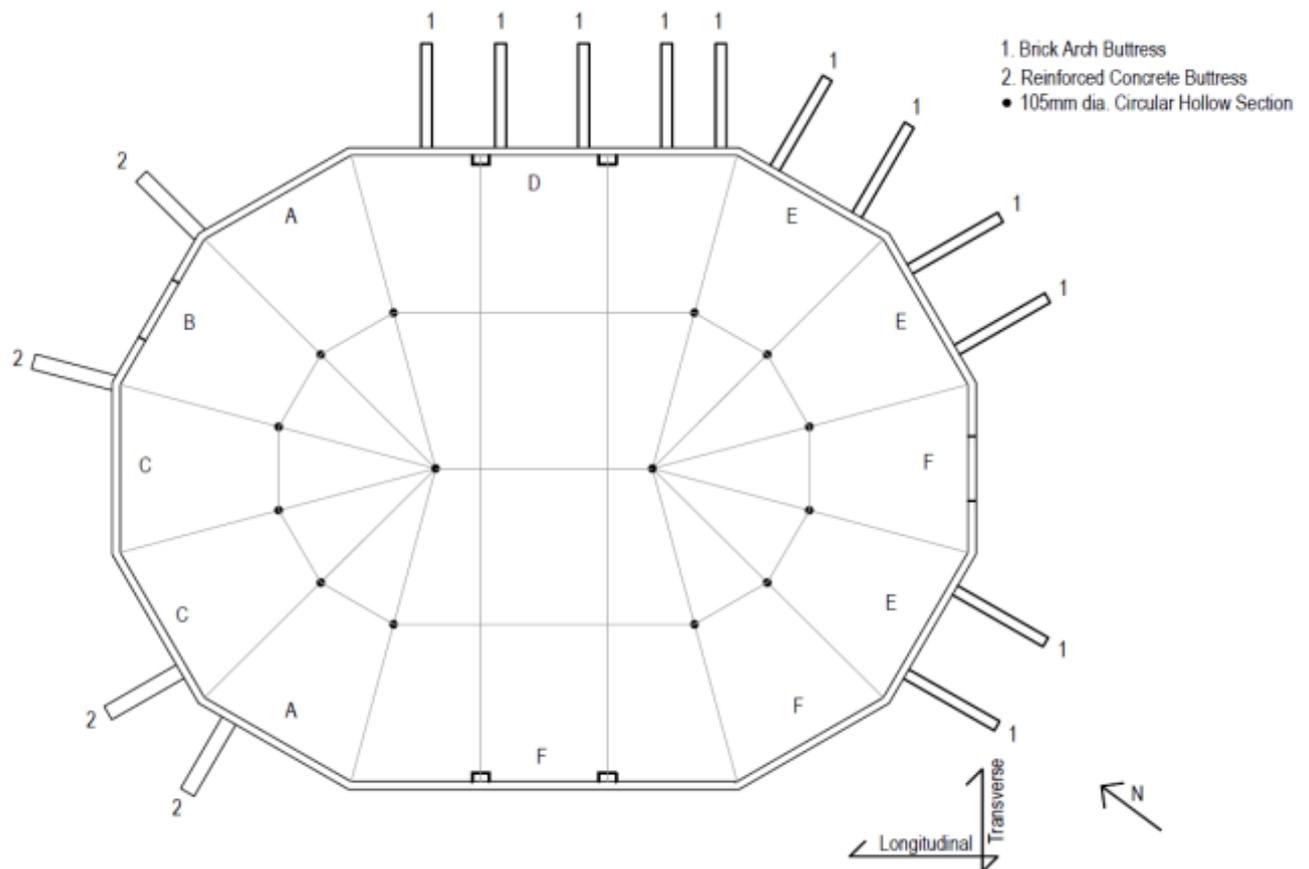
Figure 4 Plan showing wall panels as considered.

All panels (A/B/C) on the north-western end of the structure is expected to span vertically from the ground to the reinforced concrete ring beam. The reinforced concrete ring beam is expected to span horizontally for the width of the single panel (A/B) except where it spans for the width of two panels (C) given the larger spacing of the reinforced concrete buttresses. The capacity of the reinforced concrete buttresses' were checked for the combined demand from the unreinforced brick masonry panels and the timber pergola roof structure.

In the transverse direction, the UBAB (unreinforced brick arch buttresses) provide restraint to the timber pergola roof structure and the adjacent unreinforced brick wall panel (D). The locations of the UBAB do not require the reinforced concrete ring beam to distribute loads from the wall, given their central locations. In other locations, the UBABs will provide restraint to the adjacent panel (E) only. Where there is no buttressing to wall panels (F), they are expected to behave as free standing walls. Similarly, in the out-of-plane direction the UBAB, as found at panels D/E, are to behave as free standing walls.

Elements of the structure were found to have varying performance in regard of %NBS, with the controlling value being found to be 1%NBS for Wall Panel D. The low %NBS score is due to the high demand on this element from the roof structure and panel, and the poor performance of unreinforced masonry in a seismic event. Buttressing at Wall Panel D was found to be the only lateral restraint for the roof structure in the transverse direction.

Currently the building is found to be Earthquake Prone, as such it would be advised to proceed with strengthening concepts.

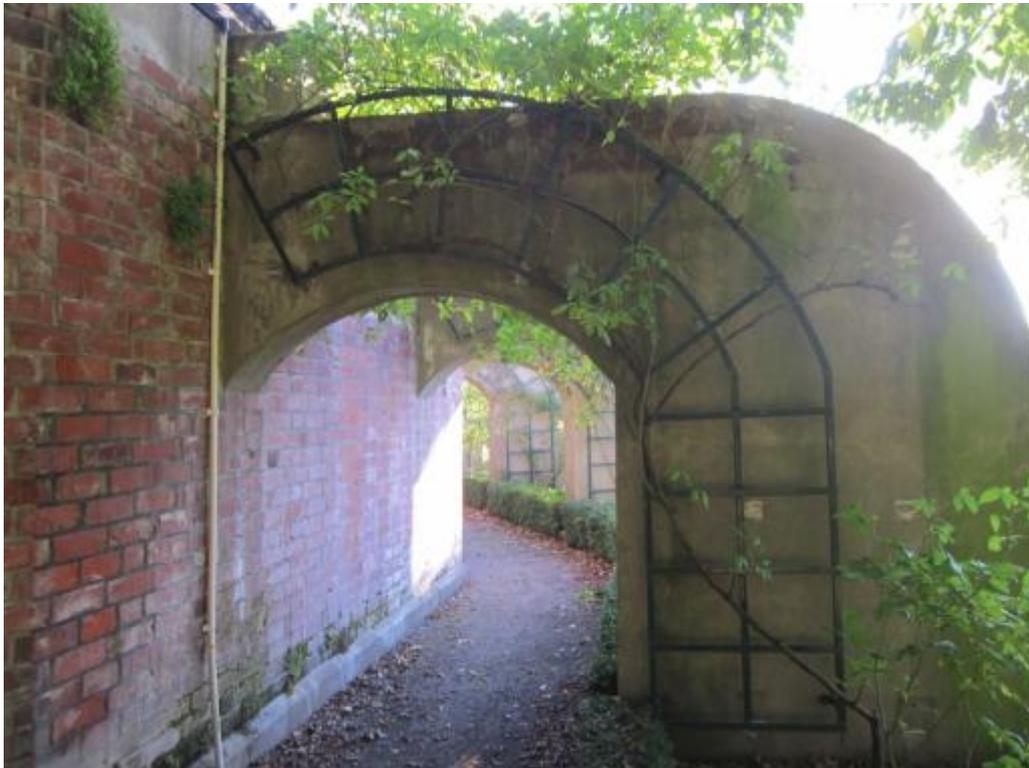
Currently the unreinforced brick arch buttresses on the main western elevation are failing with a %NBS of 1%. Design concepts should be undertaken to strengthen the structure.

Photo 6. Unreinforced Brick Arch Buttress.

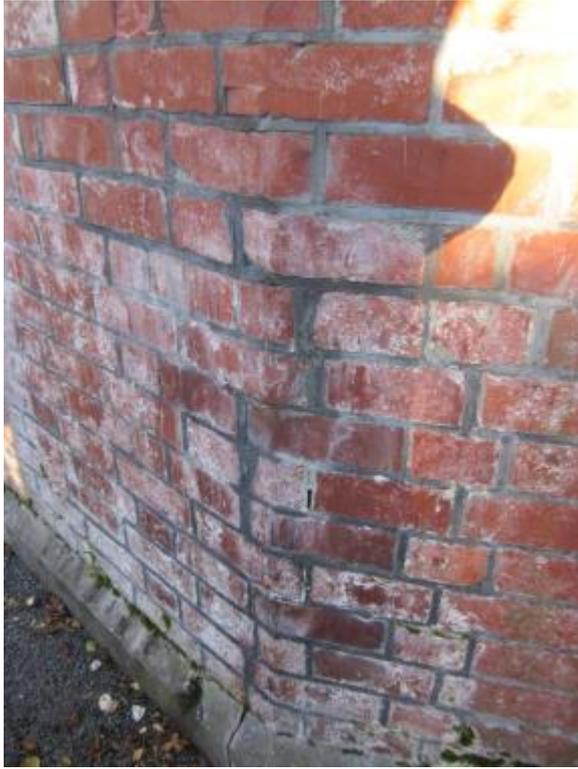
There were no settlement issues identified during the inspection of the structure. There was minor cracking noted in the unreinforced brick masonry joints. The mortar has been repointed in numerous locations. While the cracking may be a result of recent seismic activity, it may also be attributed to the age and type of structure.

Photo 9. Repointed Unreinforced Brick Masonry Joints.

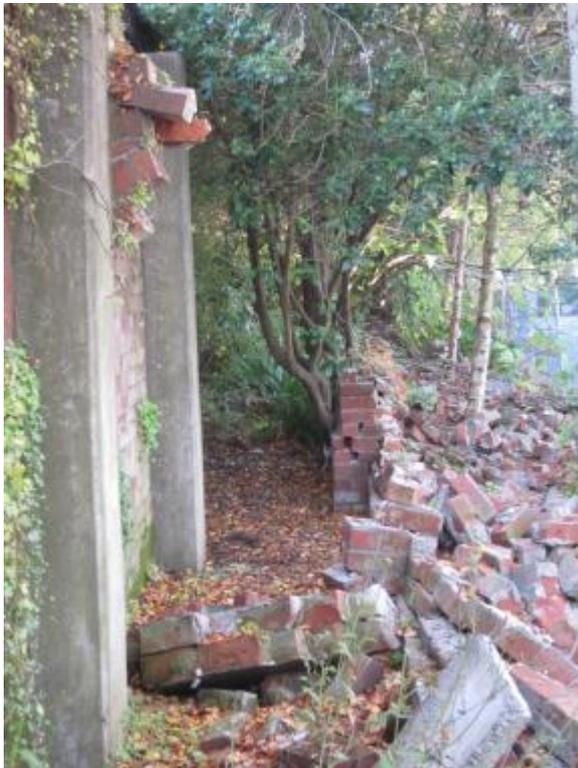
The adjacent unreinforced brick masonry boundary wall, which was connected to the structure by a brick arch, was found in rubble. The exact cause is unclear, however the recent seismic activity would be considered a factor.

Photo 10. Collapsed Boundary Unreinforced Brick Masonry Wall adjacent to structure.

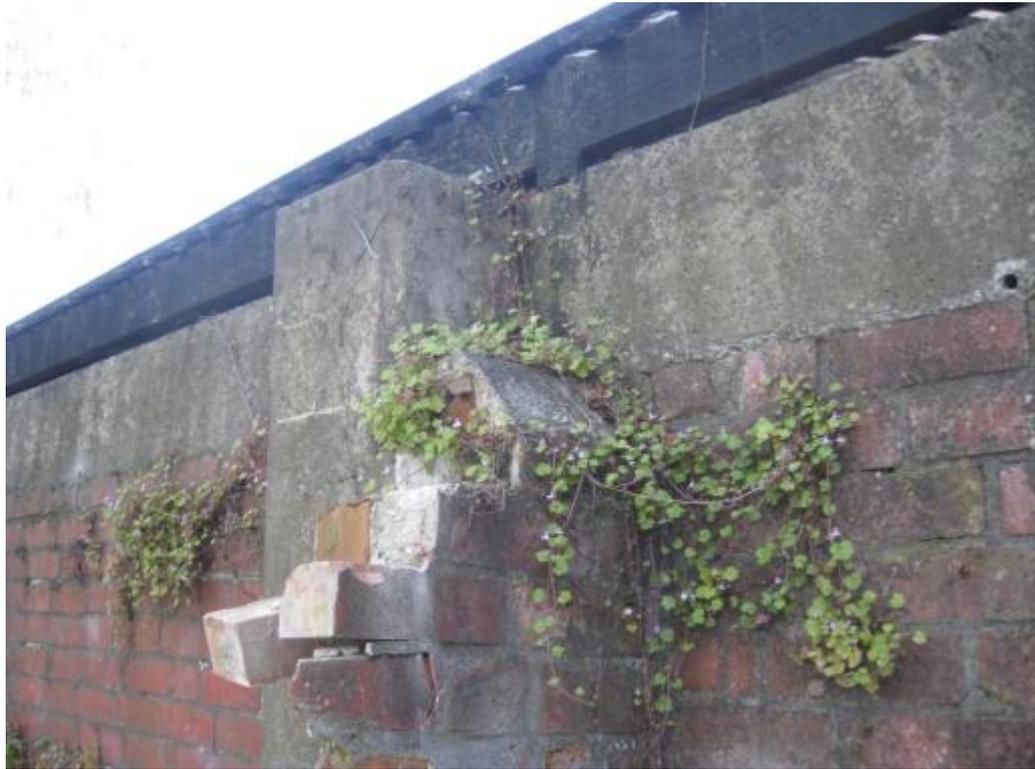
Photo 11. Brick arch previously connecting the boundary wall to structure.
