Christchurch City Council

Mona Vale Toilets
PRK 0555 BLDG 003

Detailed Engineering Evaluation
Quantitative Assessment Report

Date: February 2014
Reference: 6-QUCC1.15
Status: Final V2

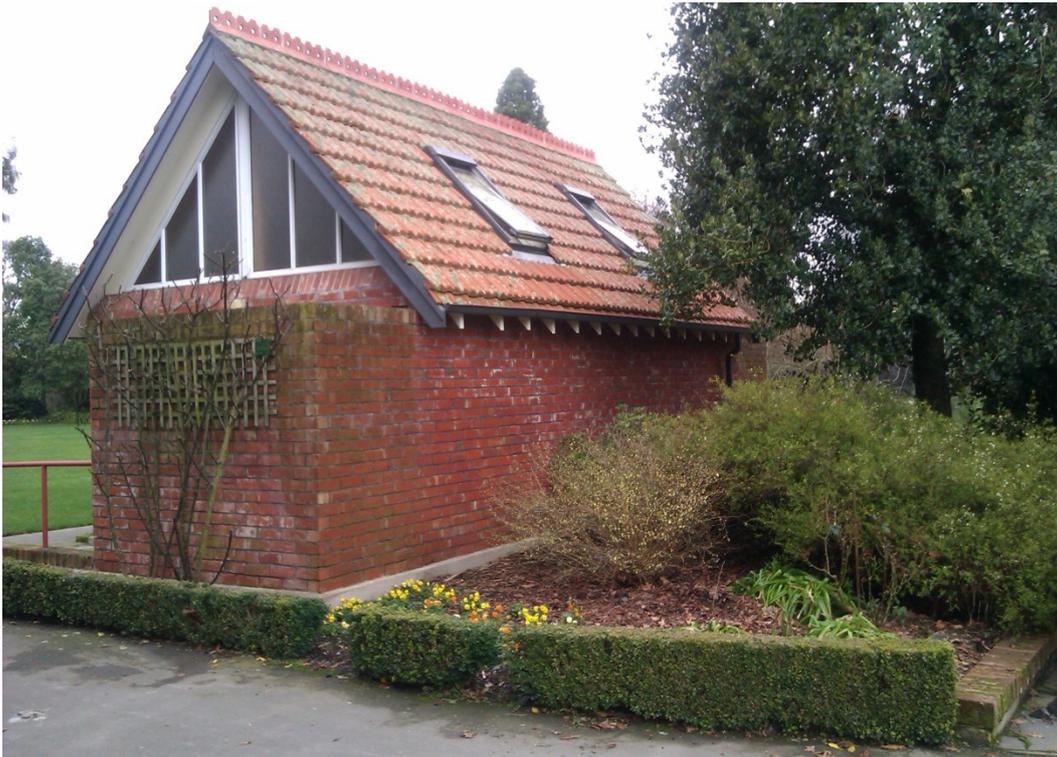
Photo 1: External View from Rear

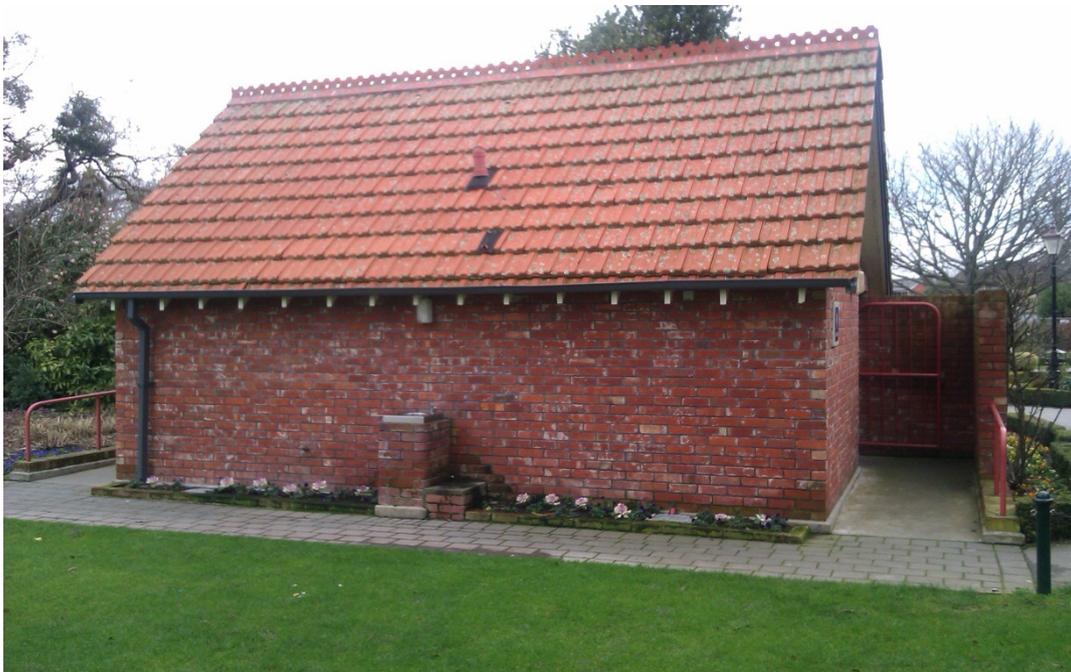
Photo 2: External View from Front

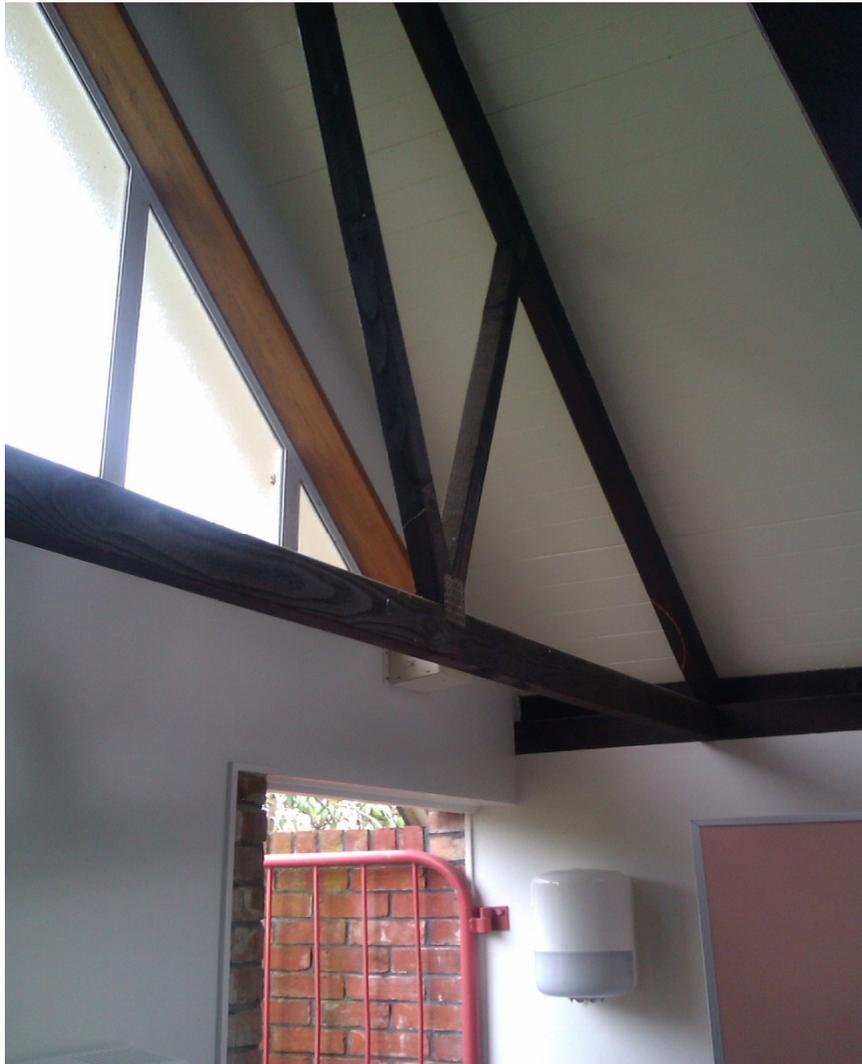
Photo 3: Internal View

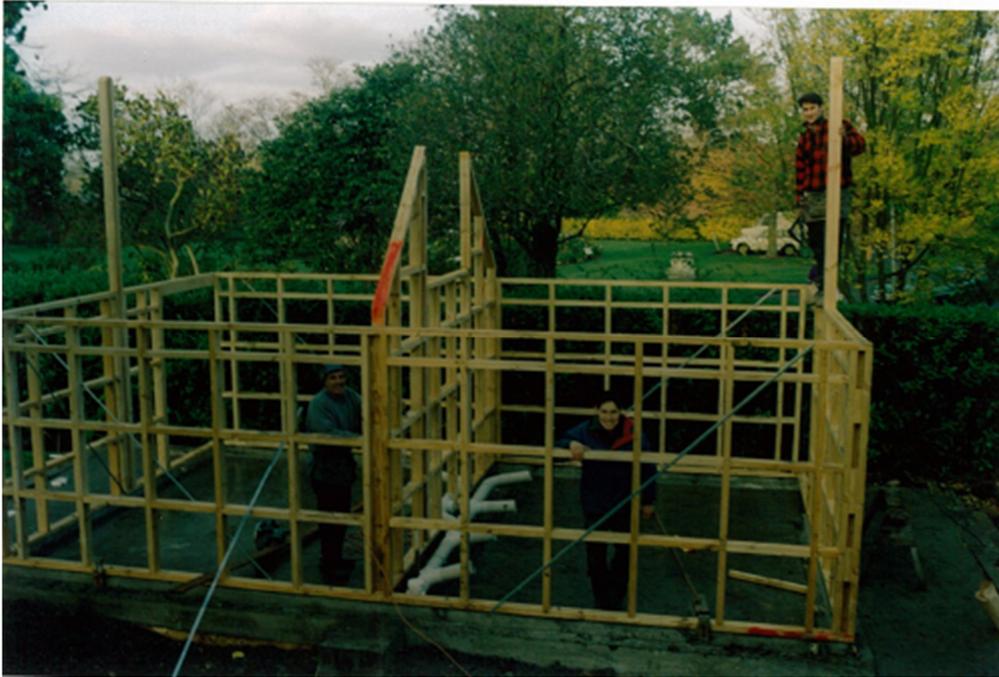
Photo 4: Construction Progress, 1992

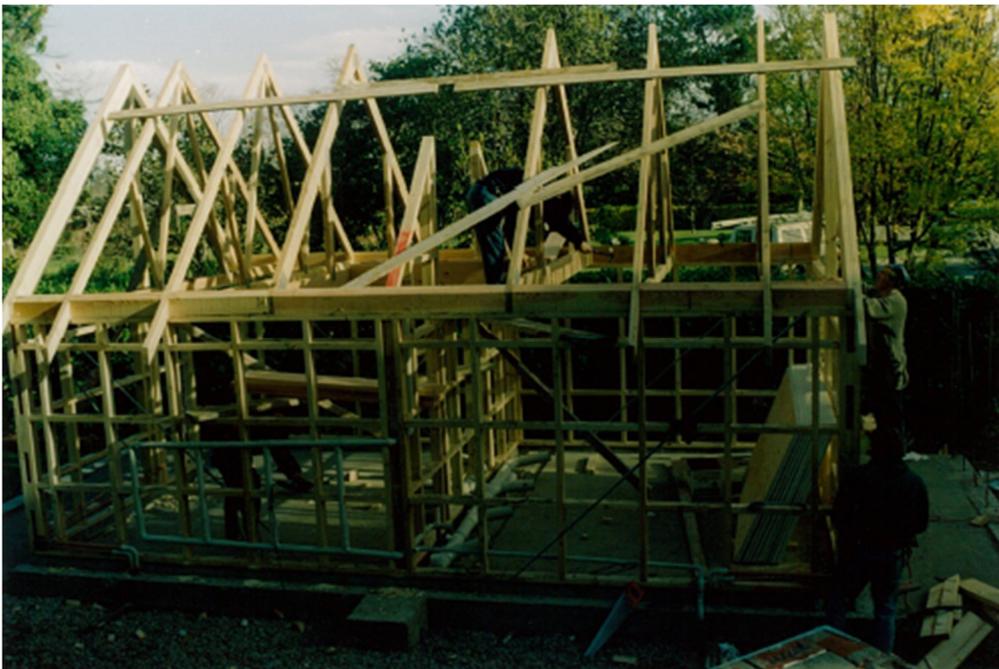
Photo 5: Construction Progress, 1992
