Moncks Spur Reserve Pump Station
#3

Qualitative Engineering Evaluation

Reference: 231557

Date: 5 July 2013

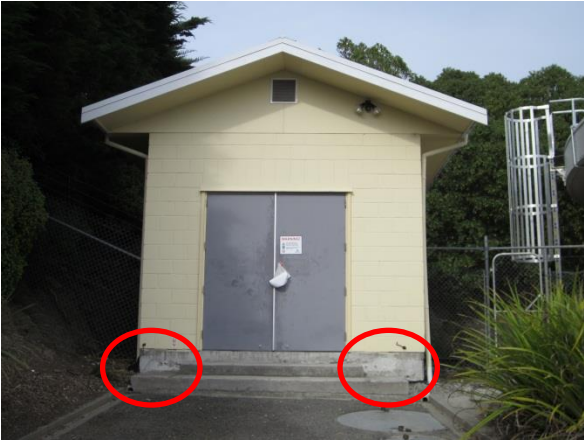
<p>Building western elevation.</p> <p>Slight spalling on foundation.</p>

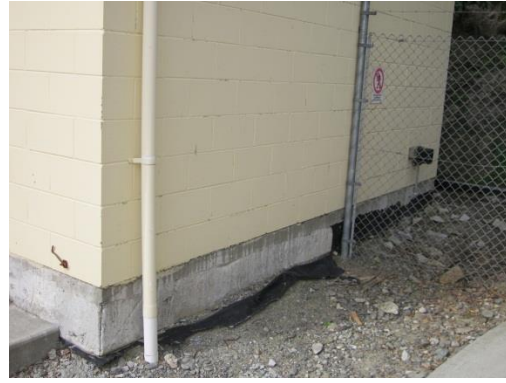
Southern elevation the Moncks Spur Reserve Pump Station #3.

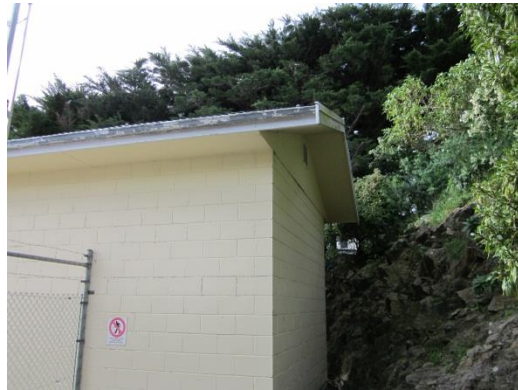
South-eastern elevation the Moncks Spur Reserve Pump Station #3.

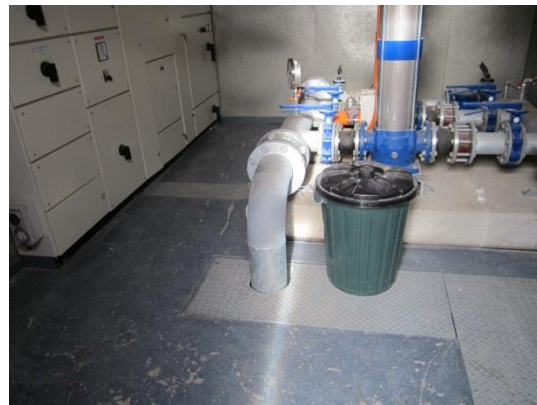
Internal view of the pump station.
