Murchison Park Toilet  
Qualitative Engineering Evaluation

**Reference:** 229179  
**Prepared for:**  
Christchurch City Council

Functional Location ID: PRK 0444 BLDG 001 EQ2

**Date:** 22 November 2012

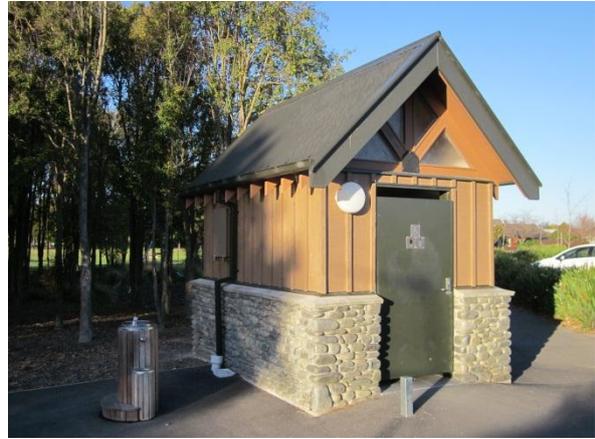
Northeast corner of the building.

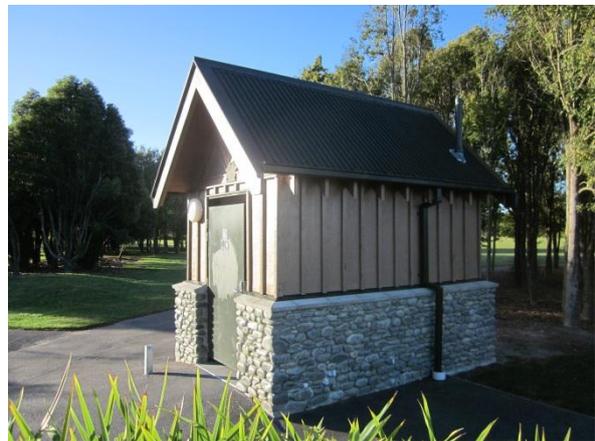
Northwest corner of the building.

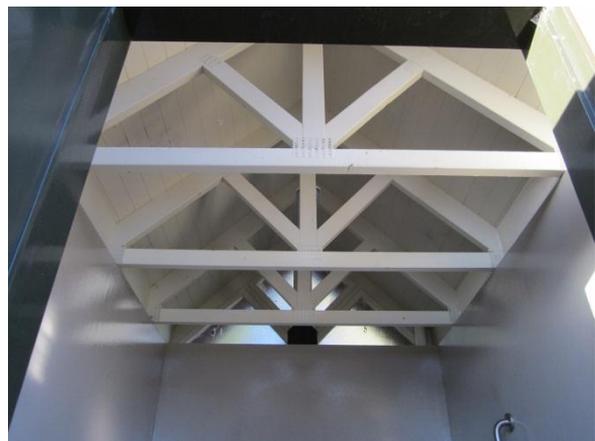
Timber truss detail.

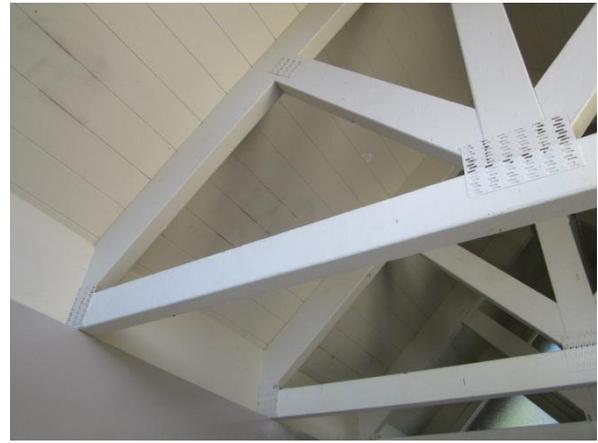
View of timber sarking.

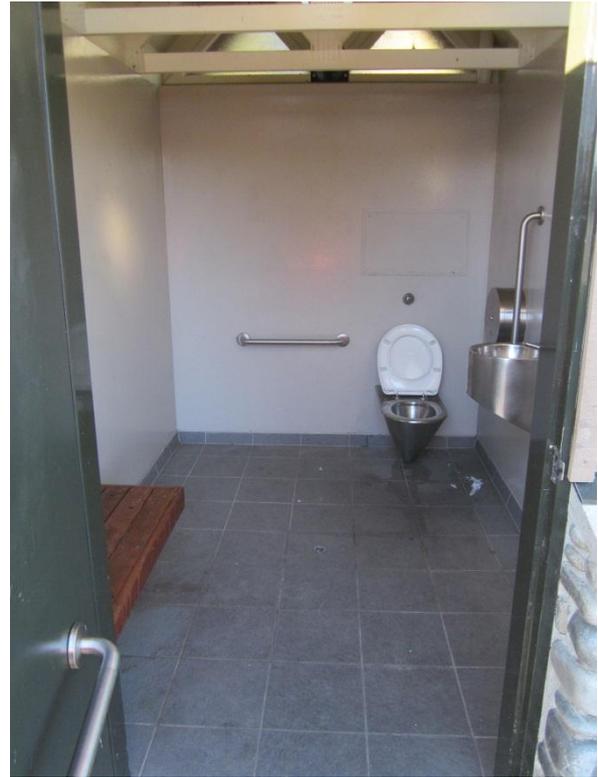
Interval view of the toilet area.
