**Nelson Street /  
Picton Ave  
Housing Complex  
PRO 0530**

**Detailed Engineering Evaluation  
Quantitative Assessment Report**

**7 Nelson Street / 77 Picton Avenue,  
Riccarton, Christchurch, 8011**

Date: February 2014  
Reference: 6-QC390.00  
Status: Final

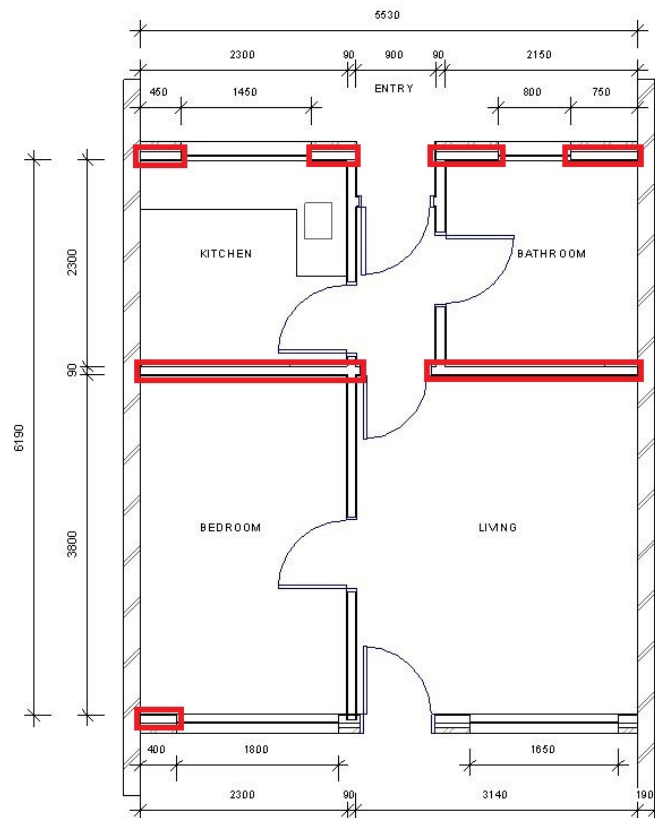
The residential units have a capacity of 63% NBS as limited by the in-plane shear capacity of the timber-framed shear walls in the longitudinal direction. They are deemed to be a ‘moderate risk’ in a design seismic event according to NZSEE guidelines.

Figure 7: Walls used for bracing in the longitudinal direction single unit.

- It is recommended that a strengthening works scheme be developed to increase the seismic capacity of the blocks to at least 67% NBS.
- Veneer at height (gable ends) have the veneer ties checked.
- Cosmetic repairs be undertaken as required.

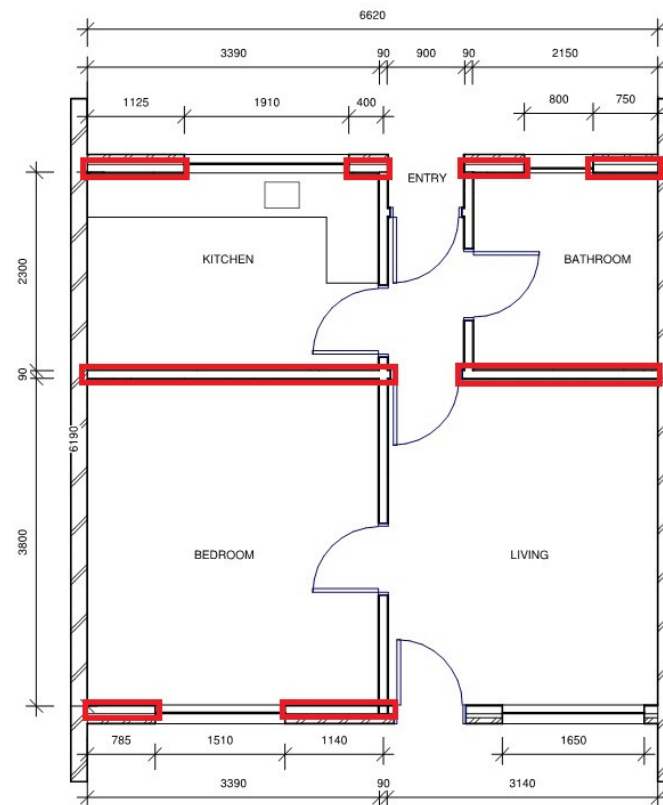
Figure 9: Walls used for bracing in the longitudinal direction double unit.

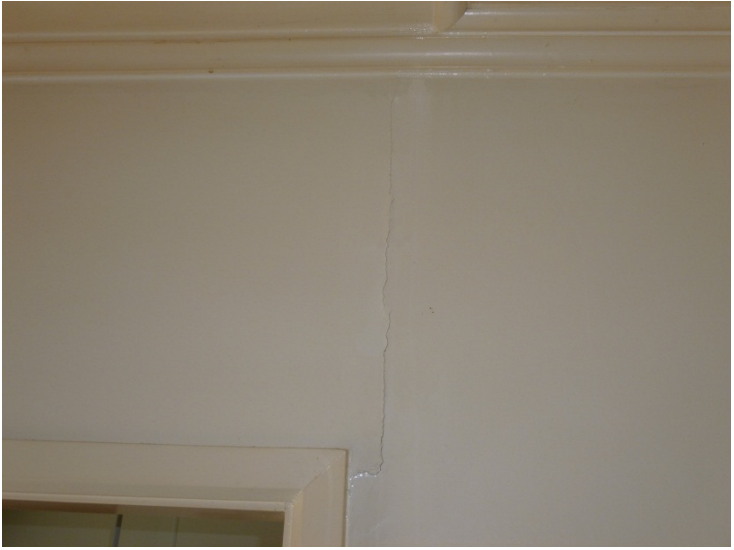
Minor cracking to some internal linings was observed, primarily around the doors and windows of Units 4, 5 and 9 (off Picton Ave). There was also minor damage observed to interior wall linings in Unit 9 (Photo 11).

10.	Typical cracking to interior linings (Units 4, 5 and 9 off Picton Ave)

- It is recommended that a strengthening works scheme be developed to increase the seismic capacity of the blocks to at least 67% NBS.
- Veneer at height (gable ends) have the veneer ties checked.
- Cosmetic repairs be undertaken as required.

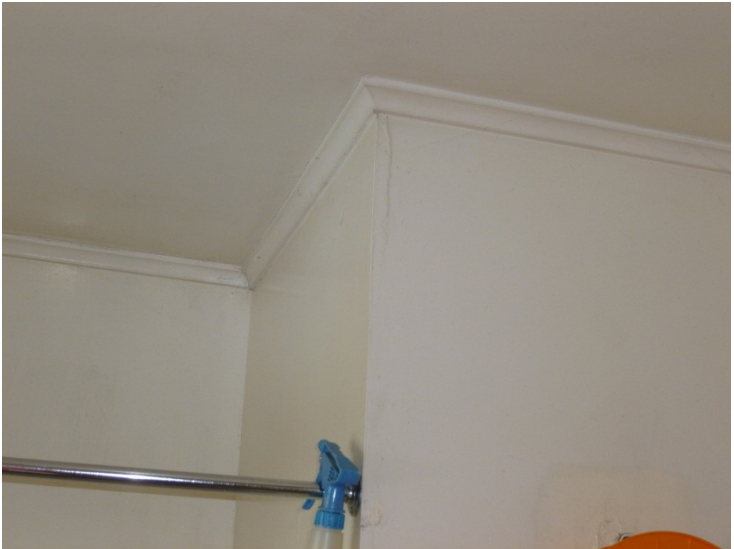
11.	Damage to interior wall linings (Unit 9)

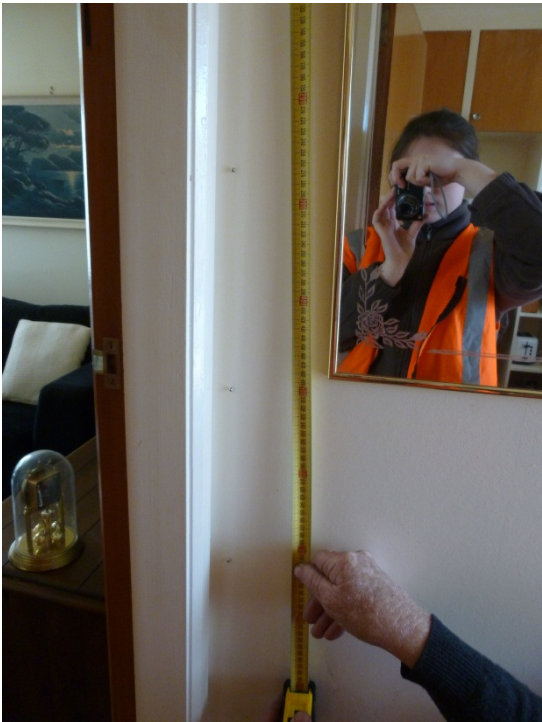
Increasing the number of nails in the plasterboard will not significantly improve the strength of the buildings.

The internal lining nail spacings were measured on site to be approximately 200mm.

12.	Plasterboard nail spacings (~200mm)
