New Brighton Library

BU 1330-004 EQ2

**Detailed Engineering Evaluation
Quantitative Assessment Report**

Date: September 2012
Reference: 6-QUCCC.67
Status: Final

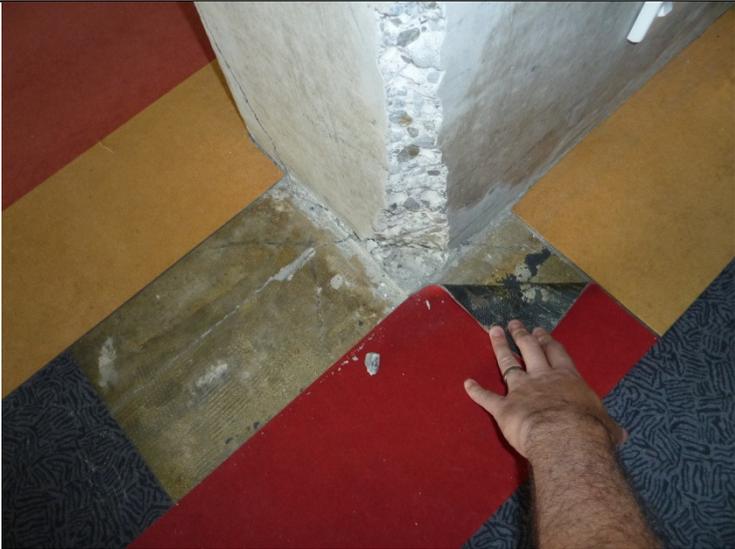
<p>7.</p>	<p>Damage to concrete columns</p>

The corners on the east side of most of the central columns in the library have begun to spall at floor level. The spalling pattern is very steep, and does not appear to extend below floor level. There is also a significant crack (up to 7mm wide) propagating down from a connection at the top of the column on gridline 4 on both sides, at the north end of the building.

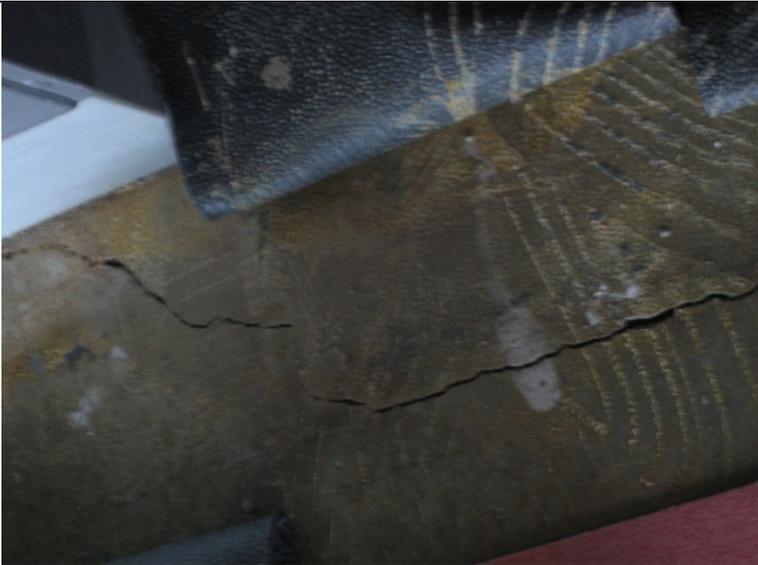
The ground floor of the library has cracks of up to 3mm wide extending down the centre of the building along a floor joint in the north-south direction from the lift pit. There are also other cracks in the floor slab not along a joint. These cracks typically do not extend very far. Slight differential vertical movement has also been observed across the cracks.

A photograph showing the base of a concrete column where it meets the floor. The concrete is cracked and crumbling, with exposed aggregate. A hand is placed on the floor next to the damage for scale. The floor consists of red, yellow, and blue carpet tiles.
<p>8.</p>	<p>Damage to floor slab</p>

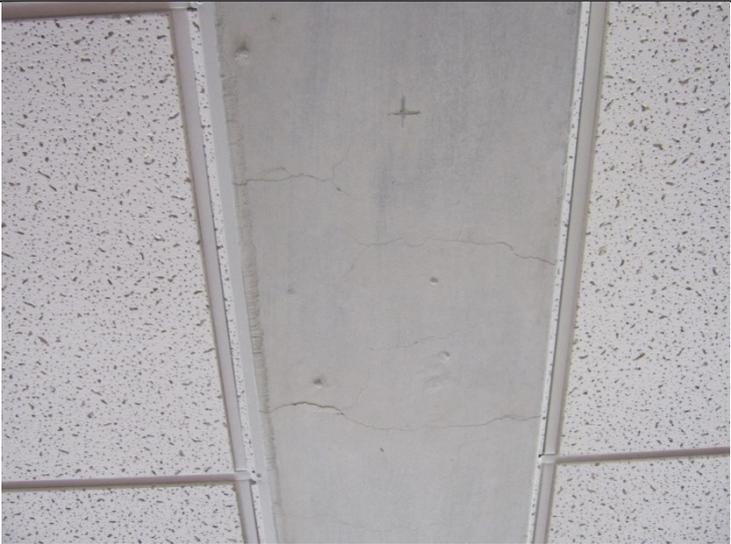
<p>9.</p>	<p>Damage to concrete beams</p>

The visible portion of the precast beams running east-west across the building in the library show signs of flexural cracking on the vertical face of the beams due to weak-axis bending. These cracks are typically up to approximately 0.5mm wide, decreasing to nothing part-way across the underside of the beam. This may indicate that some softening of the floor diaphragm may have occurred. It will be necessary to remove the floor linings above to confirm whether the topping slab has been damaged.

The model used did not predict some of the key damage observed on site: the cracking at the base of the central concrete columns; and the weak-axis bending of the precast concrete beams. A more detailed analysis, focusing specifically on those elements and the surrounding details, may enable these effects to be reproduced and the exact reason for the damage to be determined. This would then enable a suitable retrofit solution to be developed. This analysis is beyond the scope of this assessment, but we recommend that it be undertaken. In the interim, we recommend that the beam cracks be repaired to restore their stiffness and to provide corrosion protection.

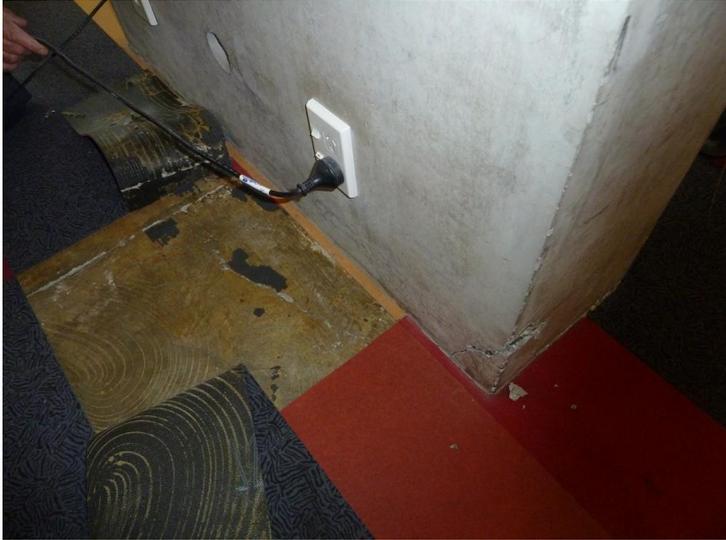
<p>11.</p>	<p>Ground floor cracking around concrete beams angling back to central movement joint</p>

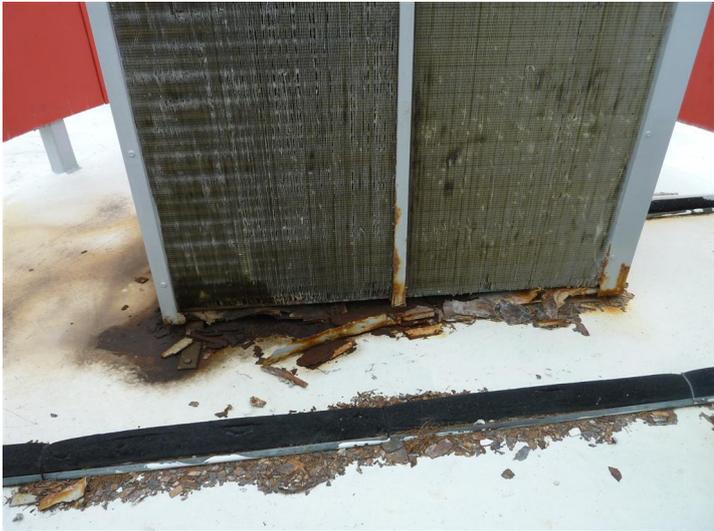
On the plant platform there has been extensive corrosion damage to the mechanical and electrical plant items. This is not seismic damage, but should be attended to before it affects the performance of the systems or causes a safety hazard.

A photograph showing a corner of a room where a concrete beam meets a wall. There is significant cracking in the concrete around the beam. A white electrical outlet is visible on the wall, and a red carpet is partially visible in the foreground.
<p>12.</p>	<p>Extensive corrosion of plant on roof</p>

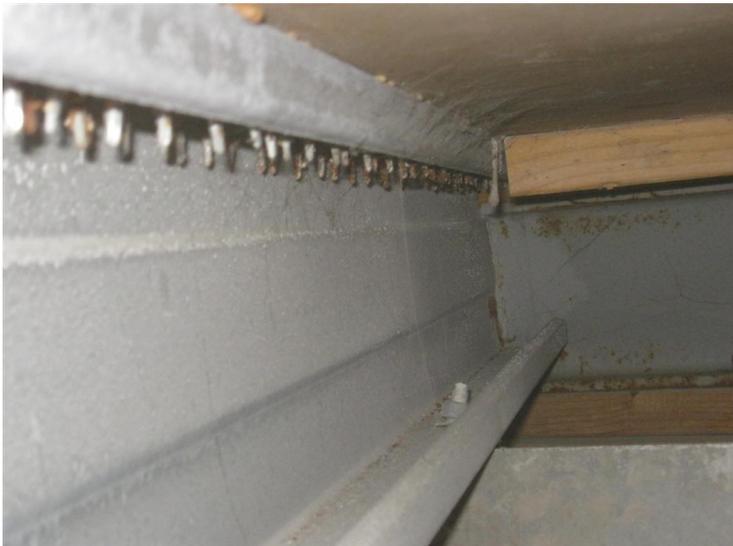
We observed that there was not a purlin where expected from the structural drawings on the return section of the south-west wall. Instead, there was timber framing. It is unclear what connection the timber framing had to the wall.

Initially, the south-west wall was modelled as shown on the structural drawings, with the top connected to the roof framing via the purlins. From this analysis, the capacity of that connection was shown to be 21% NBS. The connection was then remodelled as disconnected at that location to simulate what would happen if the connection failed. Under this model, the additional load was redistributed to the other lateral load resisting elements. The capacity of the fixings at the south-east wall was calculated to be 34% NBS, taking into account the higher demands. The building was then remodelled with the fixings on both the south-west and south-east walls disconnected. The roof was then relying on the steel braces and central concrete columns bending about the weak axis. From this analysis, the capacity of the steel braces was critical, at 36% NBS. The building was then remodelled with the fixings on the south walls disconnected and without the steel braces. The roof was then relying solely on the central concrete columns bending about the weak axis. From this analysis, the capacity of the building was at 29% NBS.

A photograph showing a close-up of a metal structure on a roof. The metal is heavily corroded, with large areas of rust and peeling material. A black pipe or cable runs along the base of the structure.
<p>13.</p>	<p>12mm Trubolt purlin connection to south-west wall</p>

The lack of collectors between the roof diaphragm and the south walls is not a robust design and we recommend that this be addressed.

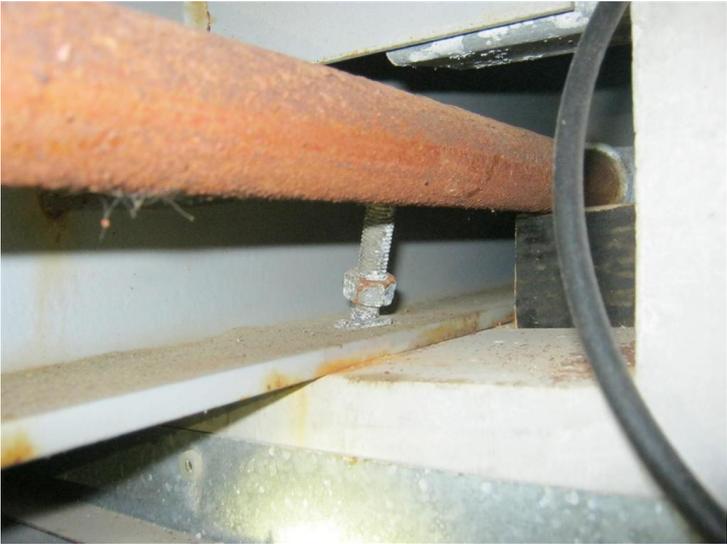
The connection between the rafter and the south-east wall was also inspected. The nut at this location had not been fully tightened onto the bolt, and there was some rust on the fixing and steel. No damage was observed. The fixing on only one side of the rafter could be observed.

<p>14.</p>	<p>12mm Trubolt connection from rafter to south-east wall</p>

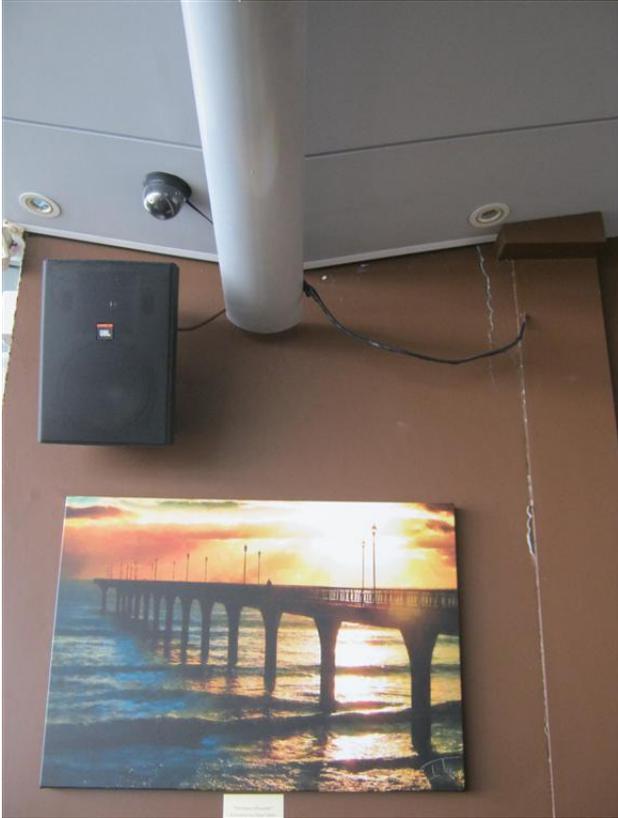
There is a crack propagating down the west side of the north face of the column. The crack is 7mm wide at the top of the column. At the top of the column, on the north side of the rafter, the nuts are not tight onto the bolts, but the bolts appear intact.

A close-up photograph showing a 12mm Trubolt connection. A thick, rusted metal rod is bolted through a wooden rafter and a concrete wall. The bolt is secured with a nut and washer. The surrounding area shows some rust and wear on the metal and wood.
<p>15.</p>	<p>Crack propagating from top of central concrete column on gridline 4</p>

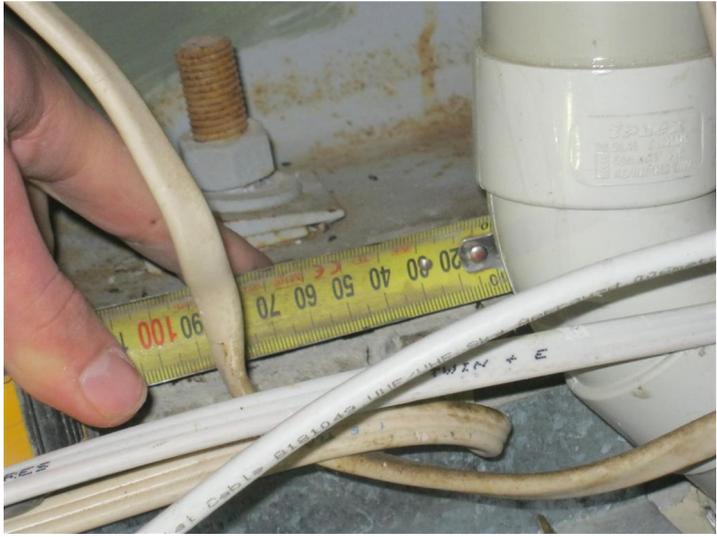
The top of the central concrete columns are connected to the roof framing by pairs of M16 bolts. At first this was modelled as a full moment-resisting connection. However, the capacity of the fixings was inadequate to develop the full moment, so it was re-modelled as a pinned connection. The moment capacity of the columns, which was enough to resist the moment developed at the capacity of the fixings, is reported under the reduced moment resulting from the connection being modelled as pinned.

<p>16.</p>	<p>16mm bolt connection from which the crack propagates on the central concrete column on gridline 4</p>

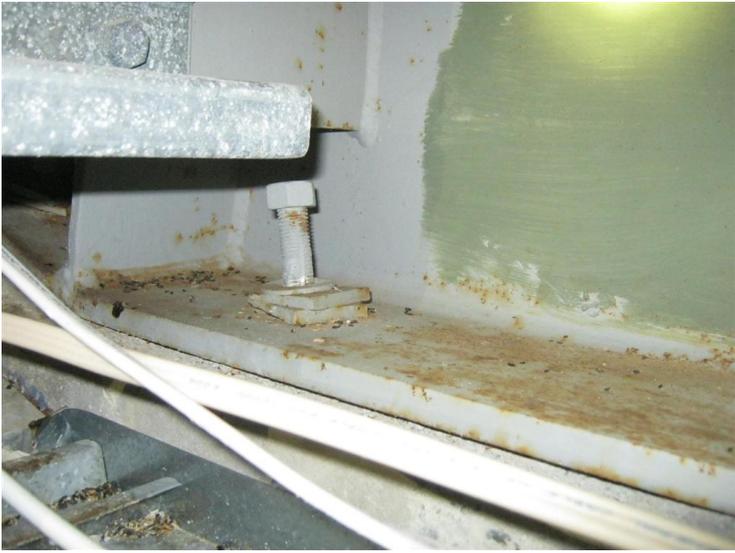
<p>17.</p>	<p>Loose nut on bolt rafter to central concrete column connection</p>

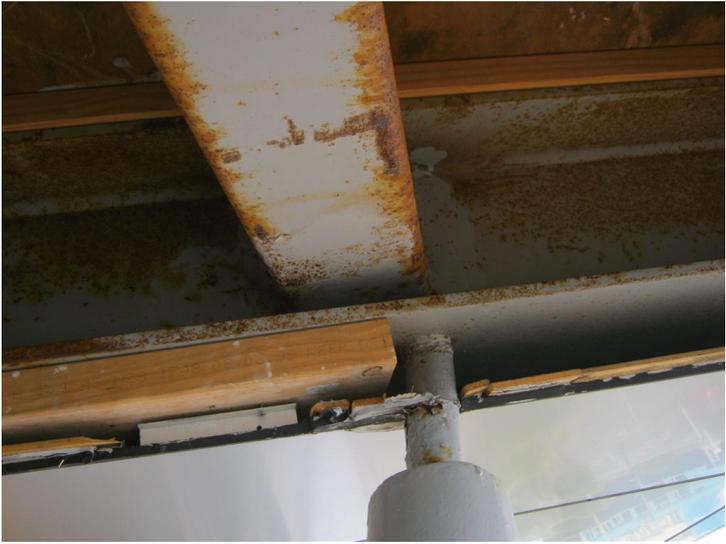
This connection differed to the consent issue structural drawings. The steel brace was fixed to the underside of the rafter via a fully welded connection rather than a bolted connection. There was no damage observed to any part of this connection or the horizontal collector elements.

<p>19.</p>	<p>Steel brace to roof framing connection</p>
