New Brighton Pier - Toilets  
Qualitative Engineering Evaluation

**Reference:** 228661  
**Prepared for:**  
Christchurch City Council

**Date:** 15 October 2013

17 May 2012 – New Brighton Pier - Toilets Site Photographs

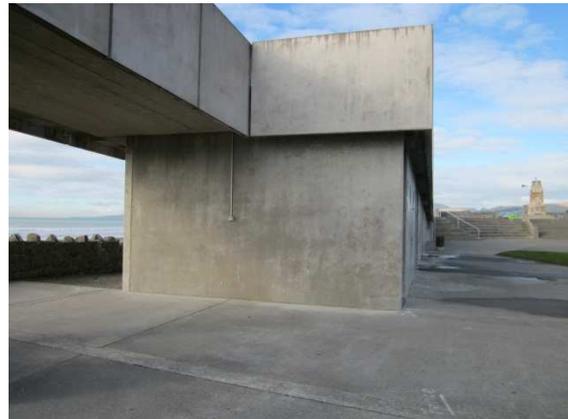
Northern eastern elevation of the New Brighton Pier - Toilets.

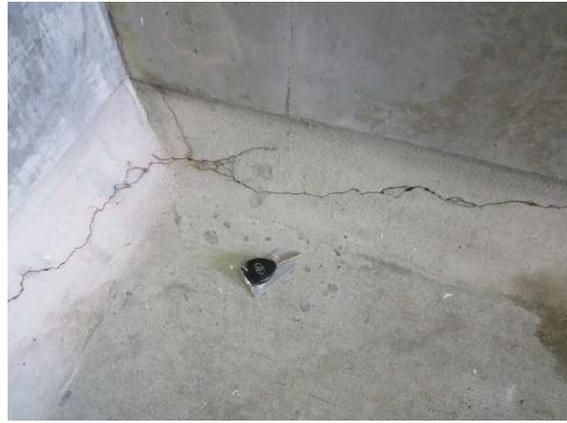
The New Brighton Pier - Toilets was in service at the time of the damage assessment. The building has performed well and has suffered no noted seismic related damage. The only damage noted was shrinkage cracking on the concrete floor which would have been age rather than seismic related

A close up of the shrinkage crack in the interior corner of the building.

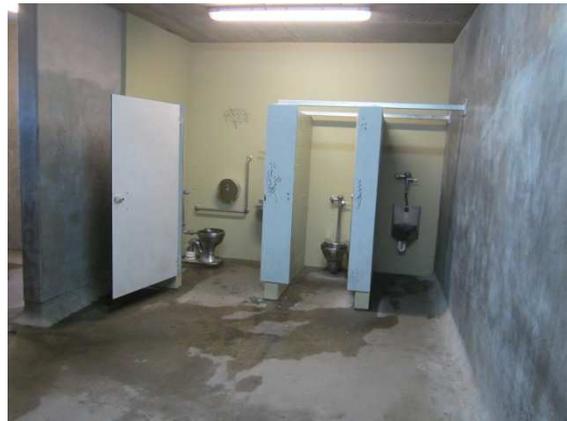
Another interior view of the toilets.

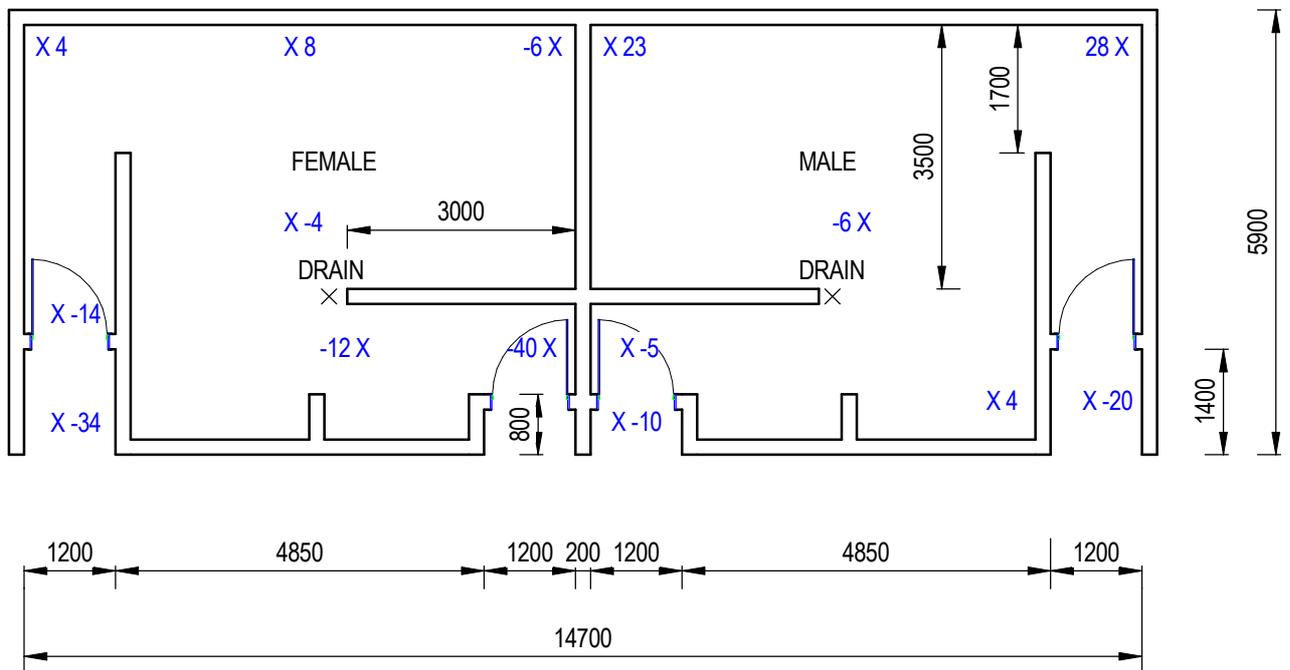
PROJECT
NEW BRIGHTON PIER TOILETS
TITLE
LEVEL SURVEY

A floor level survey was undertaken to establish the level of unevenness across the floors. The results of the survey are presented on the attached sketch in Appendix A. All of the levels were taken on top of the existing floor coverings which may have introduced some margin of error.

The floor levels for the New Brighton Pier - Toilets are considered to be acceptable despite not being within the recommended tolerances. This is because the toilet block floors have an in-built fall for drainage, often outside the DBH recommendations.
