Christchurch City Council  
PRK\_3744\_BLDG\_002 EQ2  
Okuti Valley School - Bowling Club Main Rooms  
173 Okuti Valley Road

QUANTITATIVE REPORT  
FINAL

- Rev C
- 02 May 2013

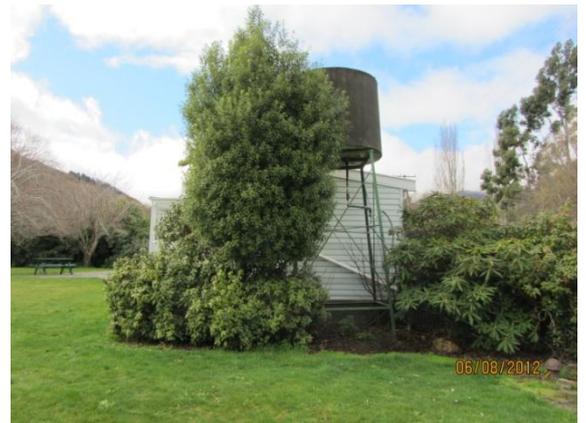
- Crack in lining and cornice above window on the south wall (see photo 14 and 15).
- Timber in the window frame has deteriorated (see photo 16 and 17).
- Crack at wall lining joint on the west wall (see photo 18 and 19).
- Water tank on the west side of the building is leaning northwards (see photo 4) and there is a risk it may fall against the building in an earthquake event.

Photo 4: West Elevation (2). Note the leaning watertank.

The adjacent external water tank appears to be out of level and at risk of collapse and as such it is recommended that it is removed or propped so that it is no longer provides a risk to the building.

- a) We consider that barriers around the building are not necessary.
- b) The adjacent water tank should be checked, propped or demolished to ensure that it does not pose a risk to the Okuti Valley School Building. Until this is done we recommend that the building is not occupied.

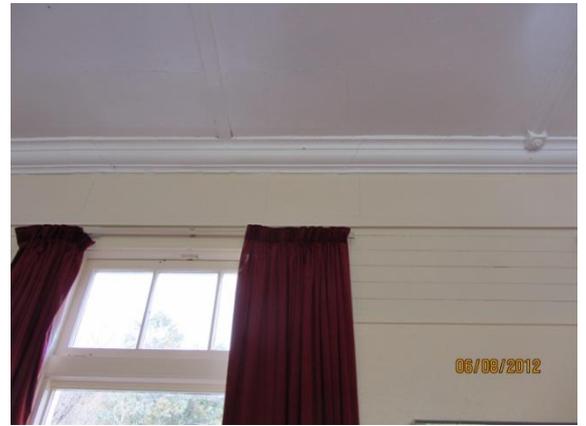
Photo 14: View of the cornice on the south wall

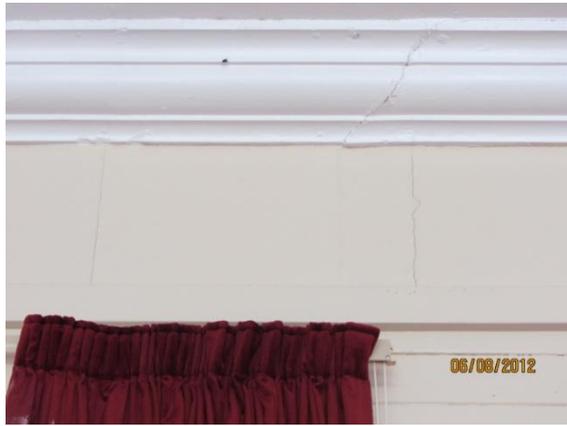
Photo 15: Close up view of photo 14 showing crack in lining and cornice.

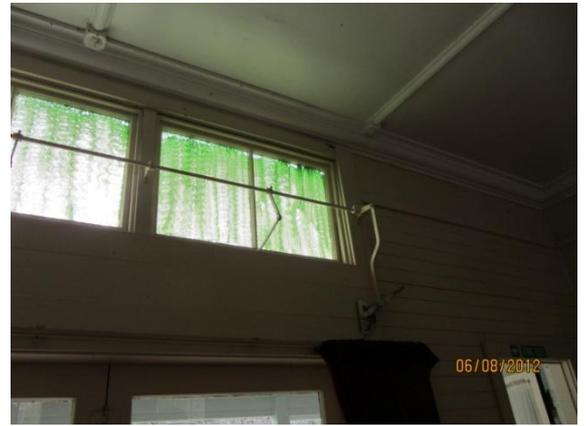
Photo 16: View of north wall and ceiling

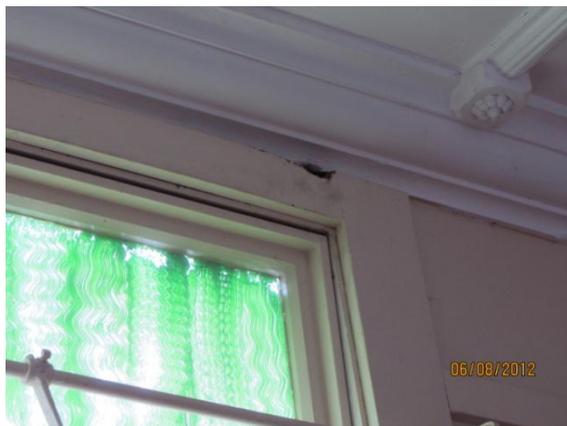
Photo 17: Close up view of photo 16 showing deteriorated timber window frame.

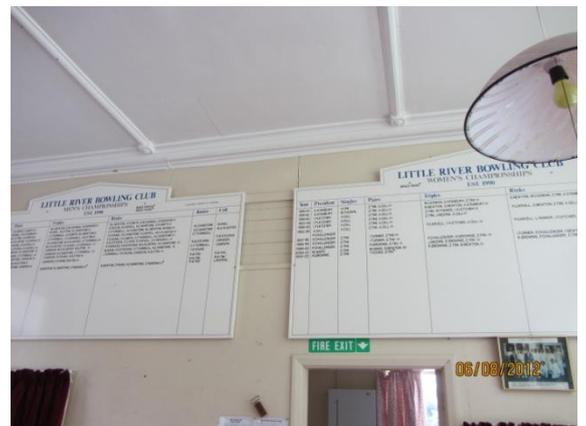
Photo 18: View of west wall and ceiling.

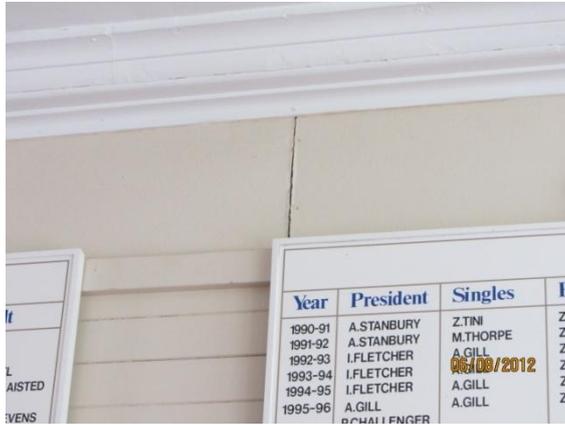
Photo 19: Close up view of photo 18 showing crack in joint lining.

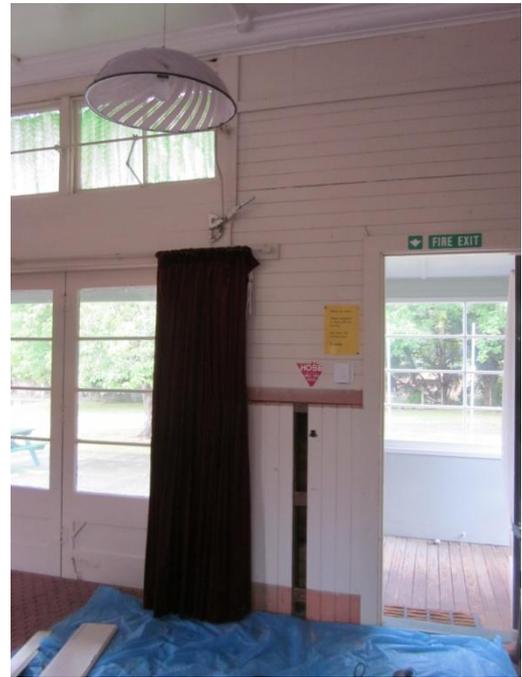
Photo 22: View of north wall in the east corner of building showing location of intrusive investigation, confirming the lack of bracing element behind the tongue and groove lining.

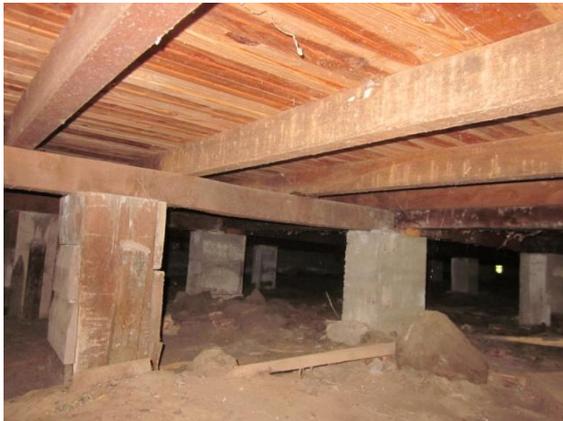
The intrusive investigation could not confirm the connection detail between the floor and the perimeter foundation. Based on the age of the building it is expected that these connections will be inadequate to provide lateral resistance during an earthquake event, however the buildings foundations appear to have performed well during the Canterbury earthquakes. The consequences of this type of foundation failing will unlikely endanger human life, and therefore will not make the building earthquake prone.

Photo 22: View of foundation in the east part of the building
