**Okuti Valley Reserve
Shelter
PRK 3666 BLDG 003**

Detailed Engineering Evaluation

Qualitative Assessment Report

Date: December 2013
Reference: 6-QC159.00
Status: Final

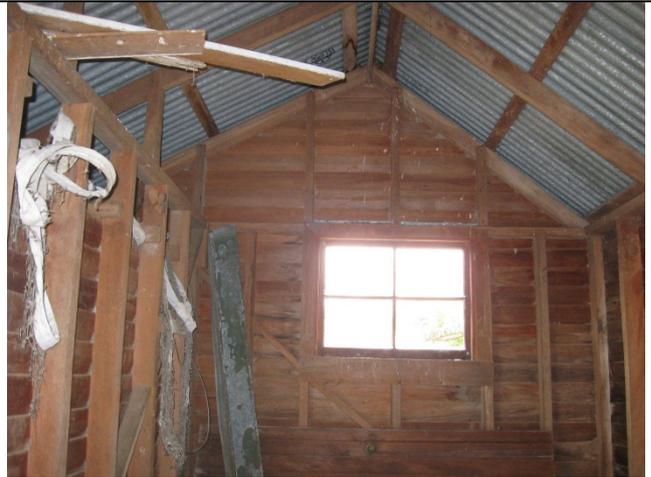
Timber framed. No internal cladding

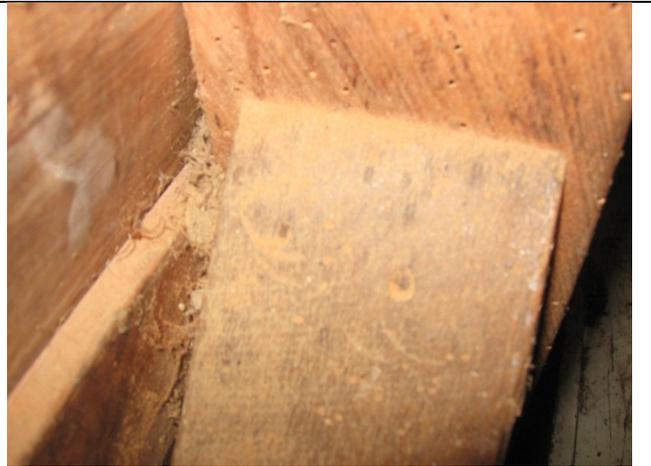
Bracing fixed with skew nail

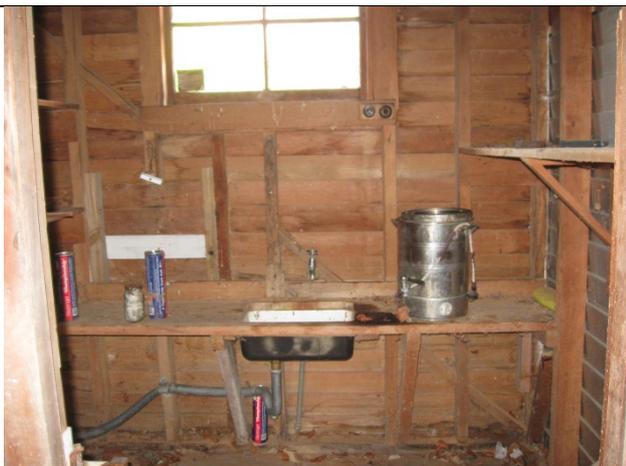
- We observed that one of the timber diagonal braces had been cut. Due to the location of the brace and the lightweight nature of this type of building we would not deem this to reduce the lateral capacity significantly.

Cut diagonal brace

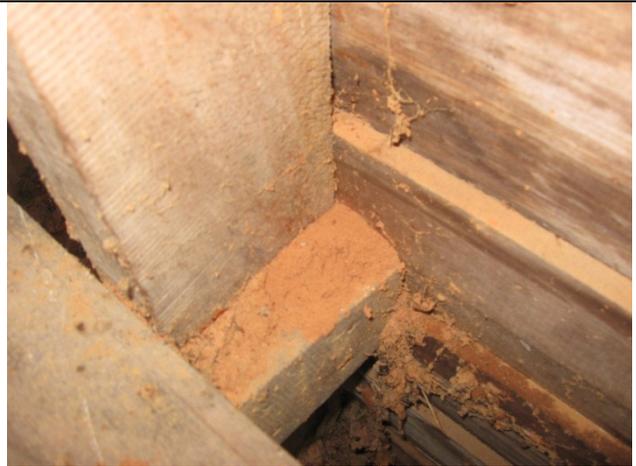
- There appears to be significant borer infestation in the building. This was evident from the flight holes observed through most of the internal timber framing, and large frass deposits in some areas.

Dust from borer observed

- Due to deterioration of the timber framing as a result of prolonged exposure to weather and use, we recommend that remedial repairs be carried out and a regular maintenance programme be activated to ensure longevity of the structure.
- Re-instate the diagonal brace that has been cut.
- Investigations be undertaken to determine the extent of borer infestation and timber replacement where necessary.

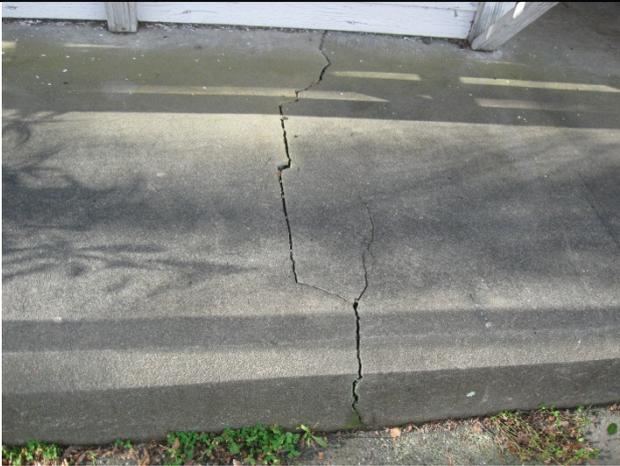
- A 10mm wide crack was observed running across the entire width of the building in the floor slab. Without prior photos or inspections we cannot definitively confirm when this crack was formed. Based on our inspection we would expect that the crack is a result of ground movement and/or inadequate footings as opposed to seismic actions.

10mm crack in slab – external

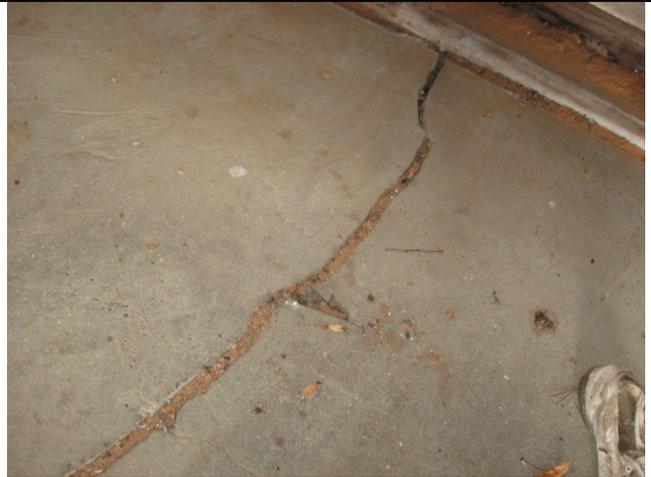
10mm crack observed in slab – internal

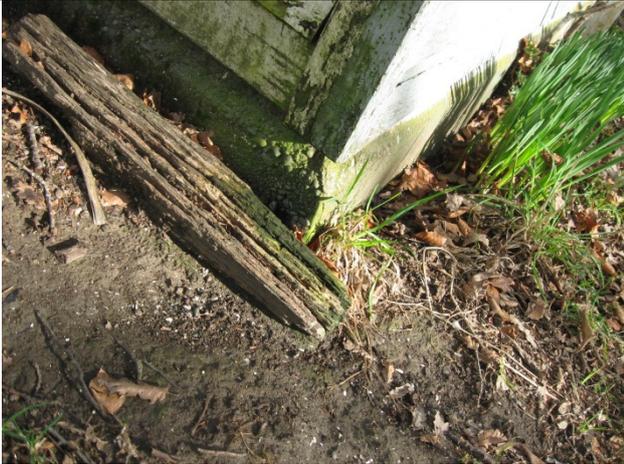
- Significant deterioration as a result of prolonged exposure to weather and use was observed throughout the building. This included significant paint peeling, rotten timber boards and bent gutters.

Rotten wood observed

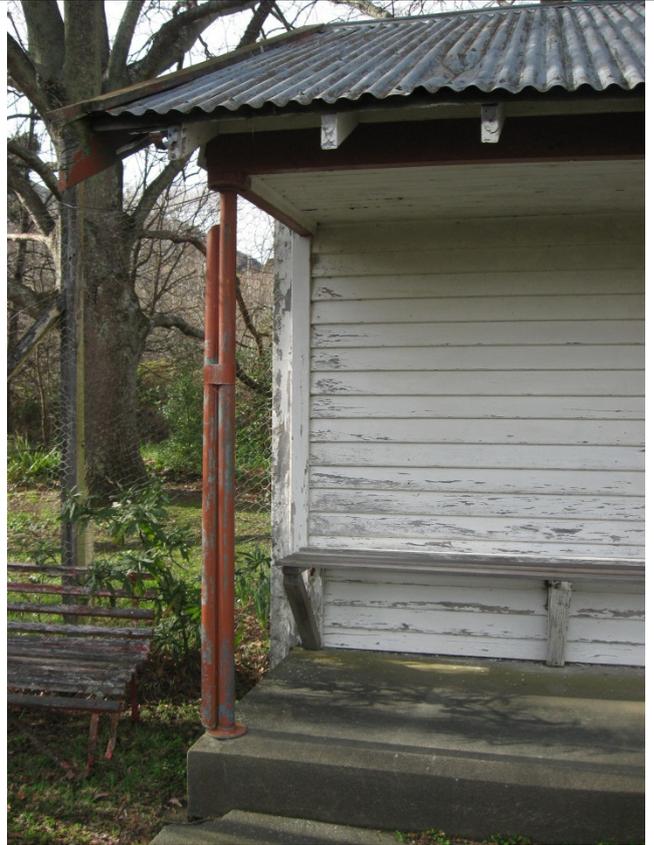
Peeled painting

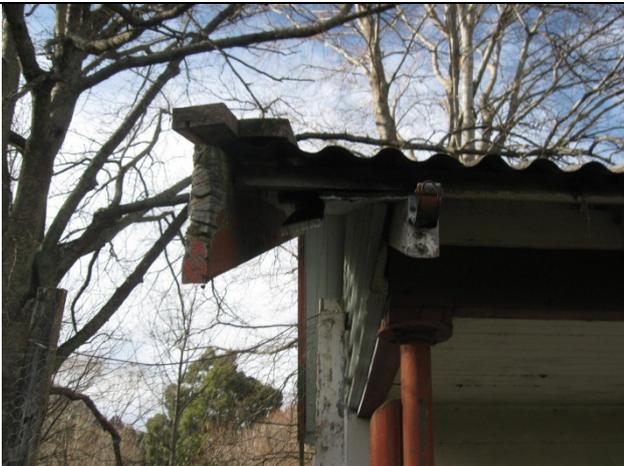
Rotten wood skirting

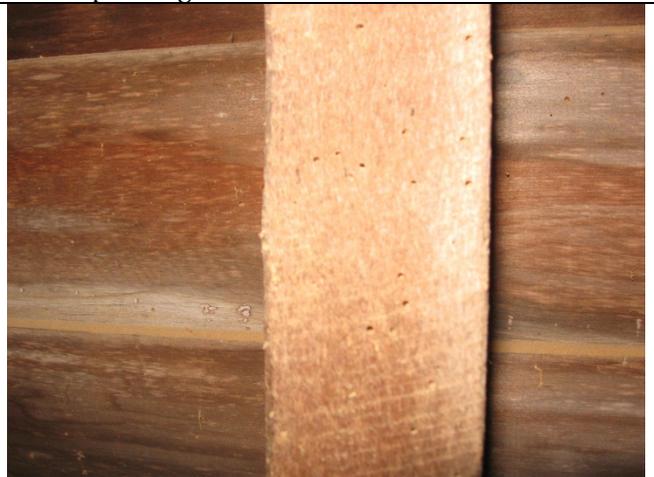
Extensive borer's holes observed throughout building
