**Ouruhia Reserve
Cricket Shelter
PRK 0391 BLDG 002 EQ2**

Detailed Engineering Evaluation

Quantitative Assessment Report

Date: April 2013
Reference: 6-QUCC1.70
Status: Final

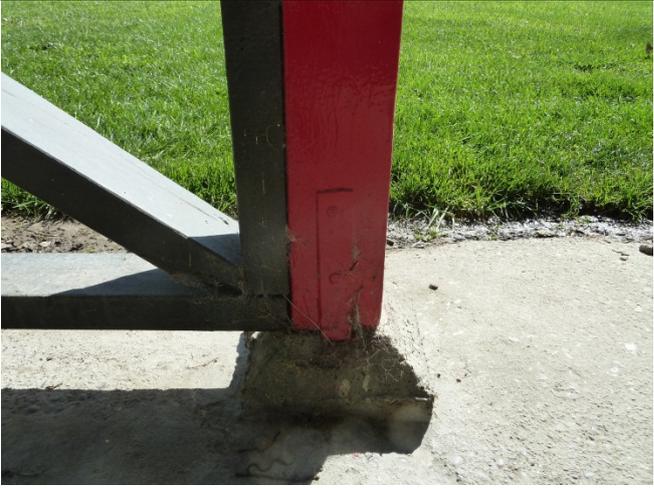
<p>7.</p>	<p>Bowmac bracket connection at base of verandah post</p>

The verandah has a slab on ground with the timber roof supported between the main building and a four-post timber frame along the outside edge. The posts are supported at the base by 'Bowmac' brackets into the concrete slab.

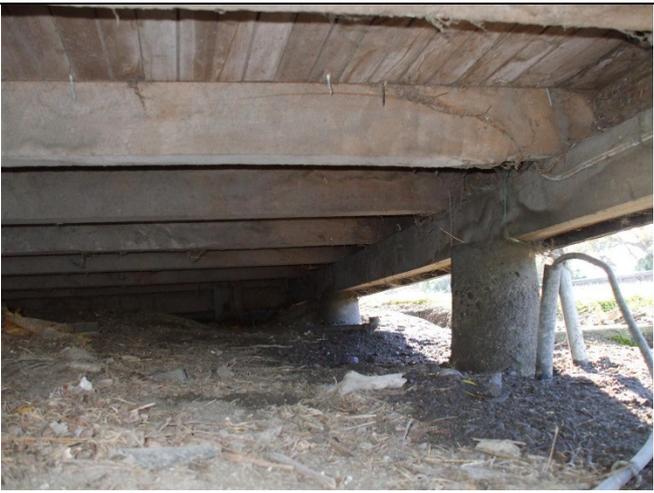
<p>9.</p>	<p>Timber floor framing (chipboard floor over boards on timber joists & bearers)</p>

The subfloor consists of timber flooring on timber joists and timber bearers supported by short concrete piles. There is no apparent connection between the bearers and the piles, which is not in accordance with the current building code.

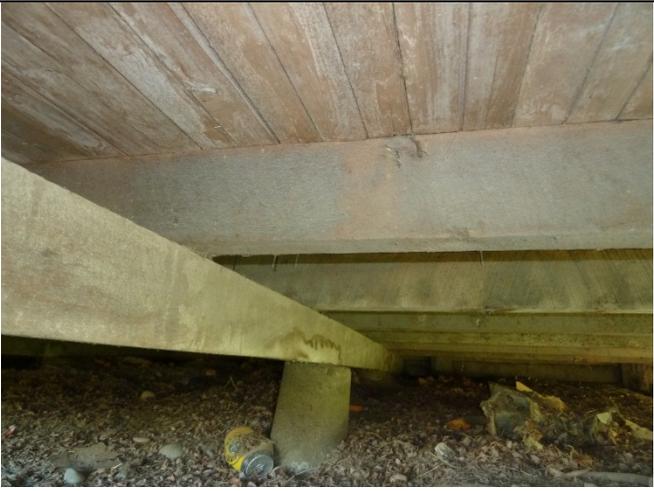
It is noted that there is a lack of connection between the bearers and the foundations to provide effective seismic load transfer. Although failure at this connection is unlikely, a failure could result in the building falling off the piles, which is likely to cause extensive damage to the building, but is unlikely to result in building collapse. This deficiency is not compliant with the Building Act and should be remedied as soon as possible.

<p>10.</p>	<p>No apparent connection between bearers and piles</p>

The floor bearer to pile connection should be investigated and fixings installed to the existing subfloor concrete pile foundations.

- a) Investigate the existing timber floor bearers and install fixings to the subfloor concrete piles.
- b) The splits in the rafters should be measured, recorded and monitored to determine if they are worsening, and if so, repair and/or replacement may be required.

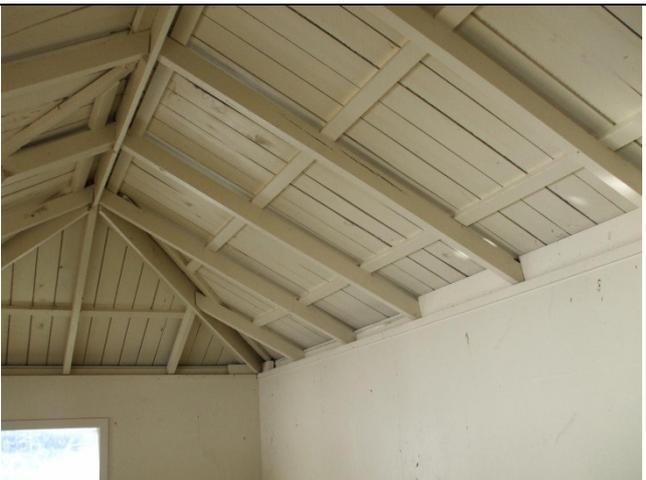
Splitting was observed in several roof members including rafters and sarking. The most critical splitting observed has occurred in a roof rafter – refer to photo 12. This splitting is deemed to not have been caused by recent earthquake activity.

Splitting was observed in several timber roof members including rafters and sarking. The most critical splitting observed occurred in a roof rafter – refer to photo 12. It is deemed that this is a result of age and usage, and not from recent earthquake damage.

It is unlikely that the split rafters would have any effect on the seismic performance of the building as they are not primary seismic resisting members. The splits should be measured, recorded and monitored to determine if they are worsening, and if so, repair and/or replacement may be required.

<p>12.</p>	<p>Some timber rafters show splitting –not a result of earthquake actions</p>

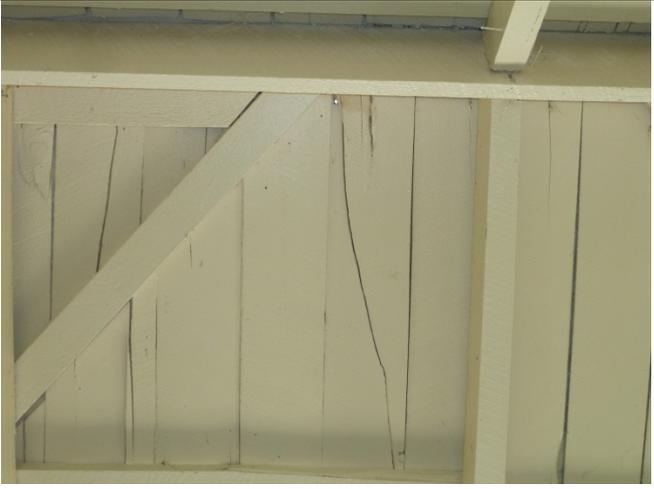
<p>13.</p>	<p>Split sarking–not a result of earthquake actions</p>

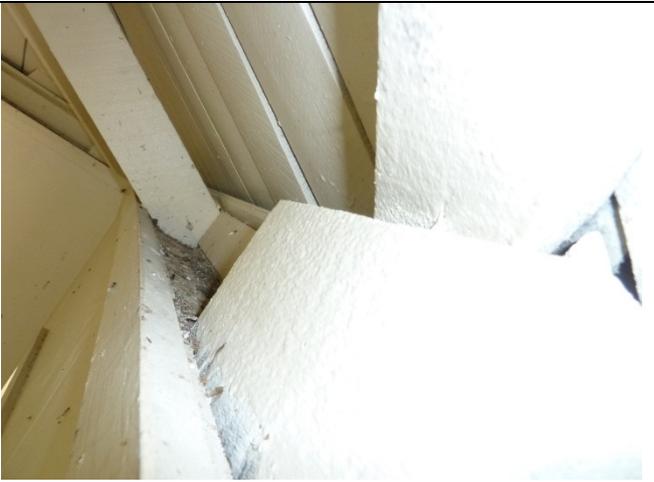
<p>A photograph showing the corner of a side wall where it meets the roof rafters. The wall is covered in white insulation, and the rafters are made of wood. There is some debris and damage visible at the corner.</p>
