Ouruhia Domain Toilets
Qualitative Engineering Evaluation

Reference: 229177
Prepared for:
Christchurch City Council

Functional Location ID: PRK 0391 BLDG 001 EQ2

Date: 22 November 2012

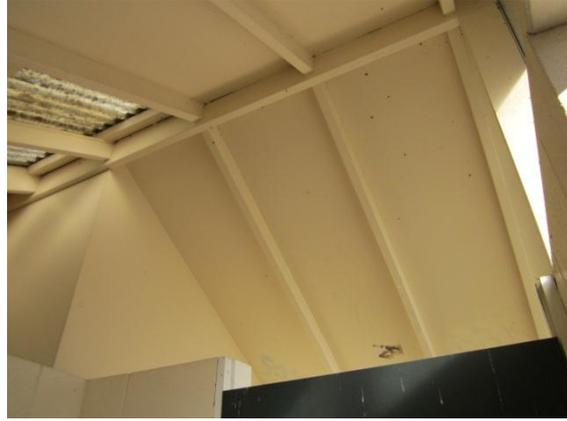
Interior view of the Ouruhia Domain Toilets.
