Ouruhia Hall
BU 0391-03 EQ2
Detailed Engineering Evaluation
Quantitative Report
Version FINAL

225 Guthries Road, Belfast

Christchurch City Council

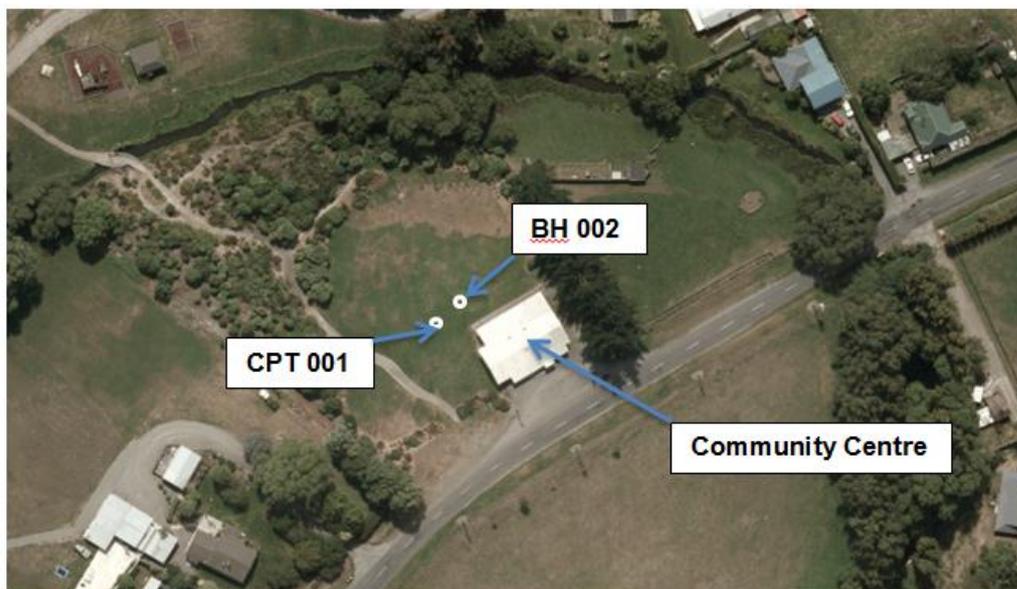
Figure 6 Post February 2011 Earthquake Aerial Photography ²

There are no obvious signs of liquefaction on the aerial photography taken following the 22nd February 2011 earthquake (Figure 6).

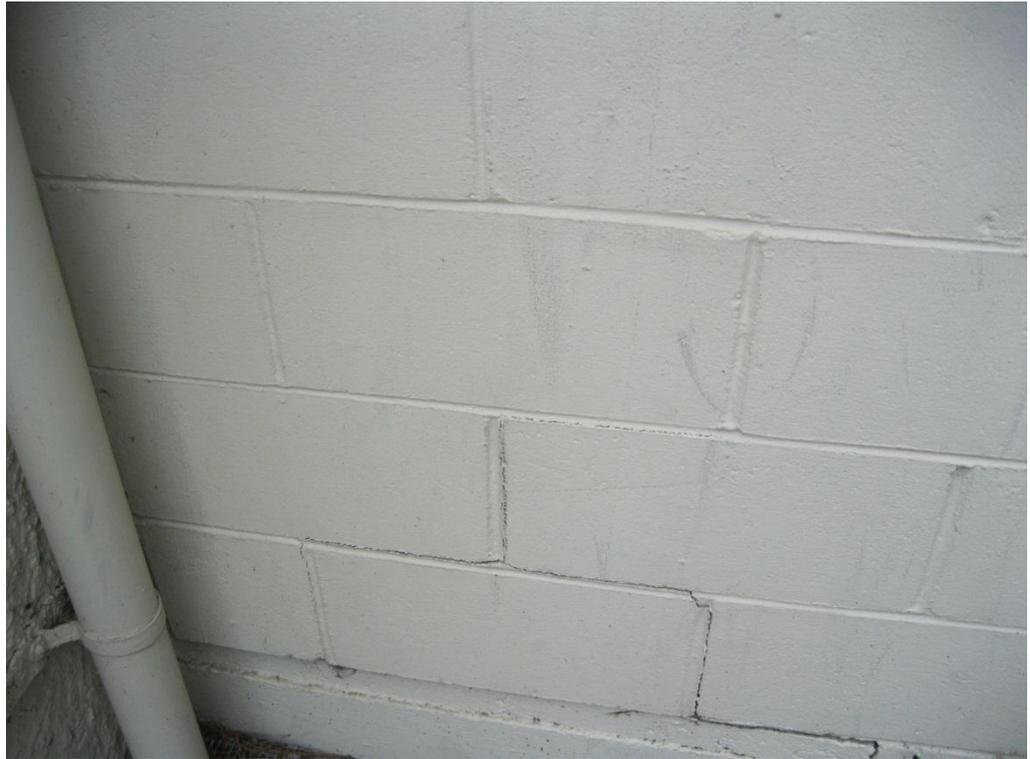
Cracking along mortar lines was noted to the concrete walls to the storage area in the south-eastern corner of the building. These appear to be existing cracks that may have opened up slightly during the recent seismic activity. This is evident in Photograph 7 in Appendix B.

Photograph 7 Cracking along mortar lines

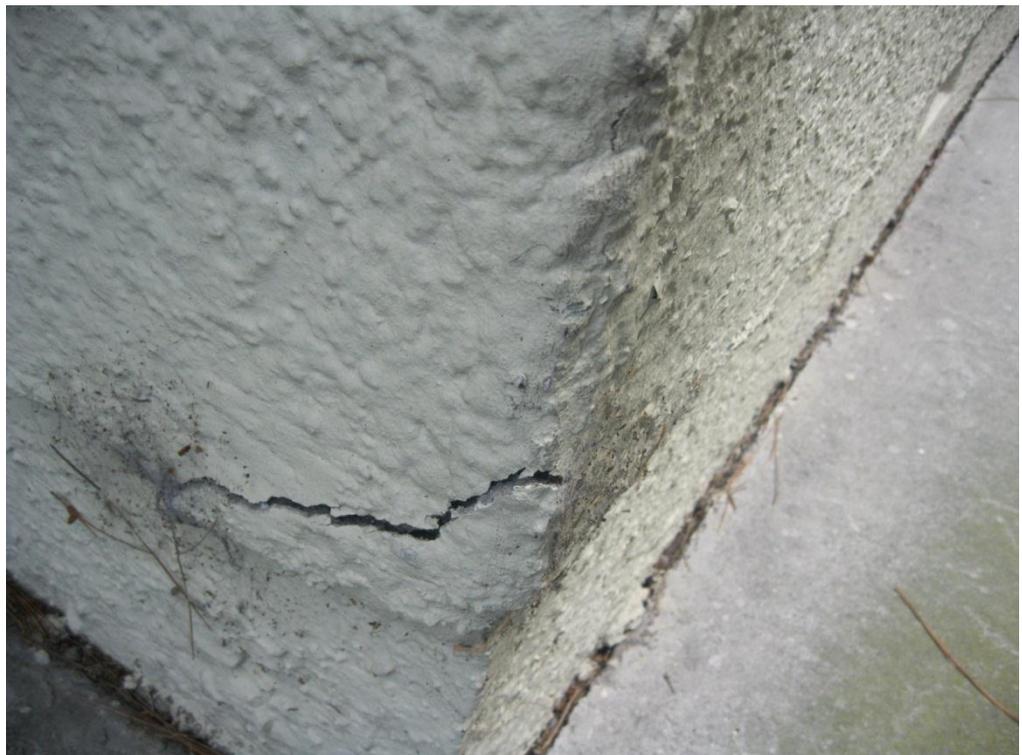
Cracking and spalling of the exterior stucco plaster system was noted in several locations around the building. Some of these are new cracks, whilst the remainder are existing cracks that may have opened up slightly during the recent seismic activity. This is evident in Photos 8 and 9 in Appendix B.

Photograph 8 Cracking in Stucco Plaster

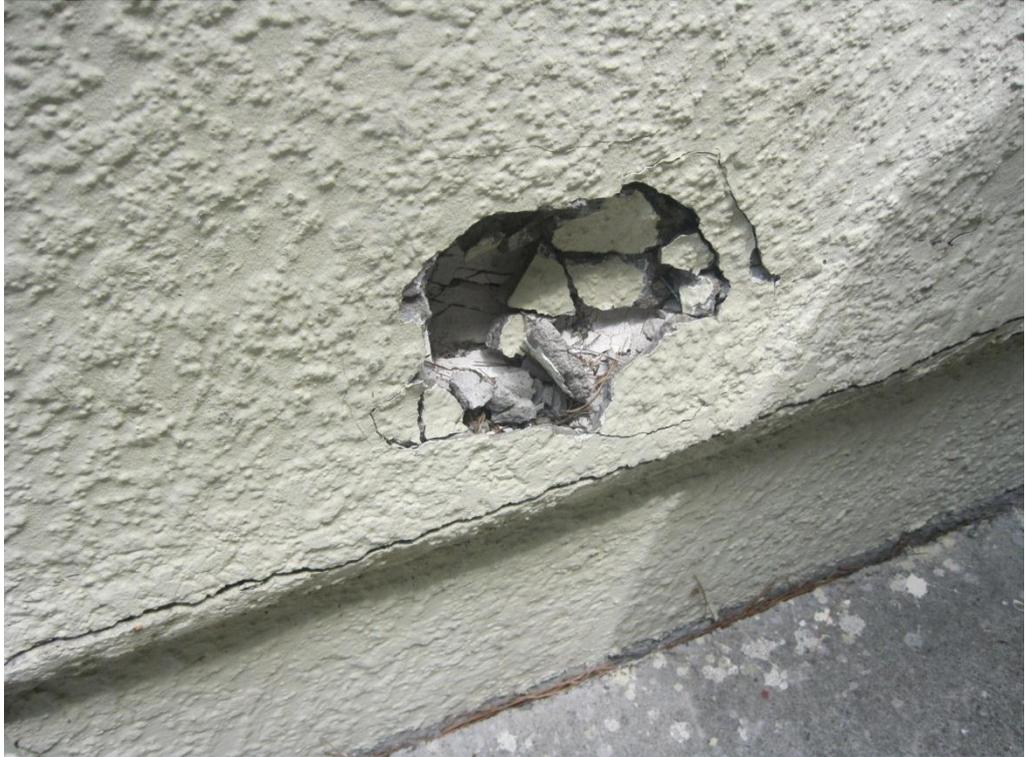
Photograph 9 Existing damage to exterior cladding

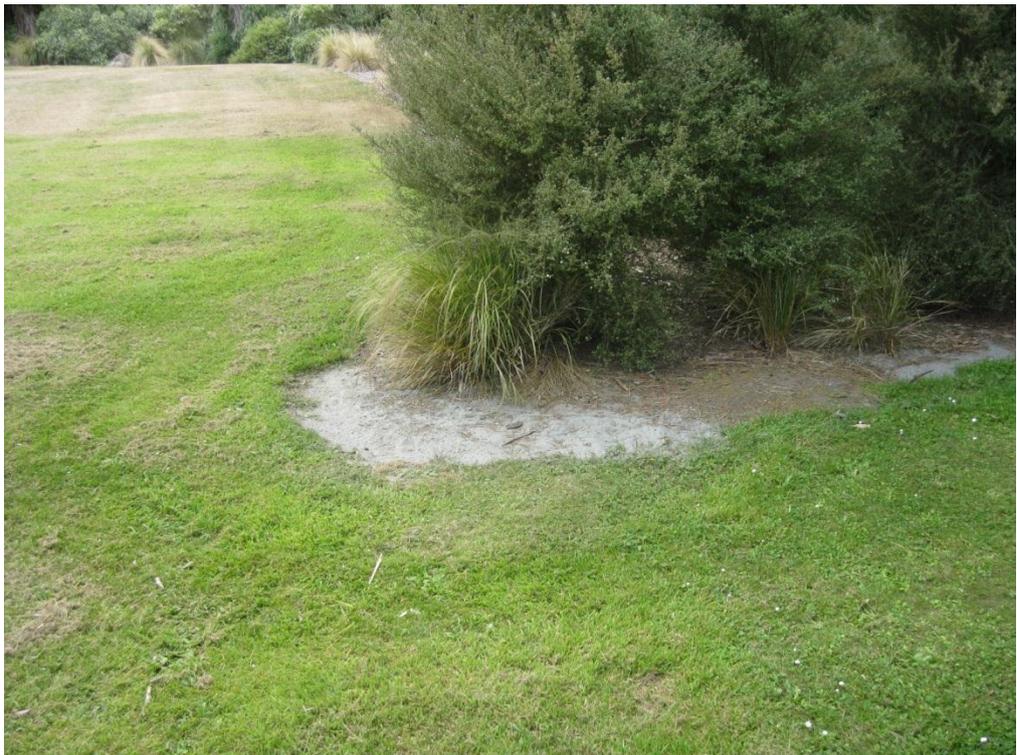
Approximately 1 m³ of liquefaction was noted in the reserve area to the north of the building. This can be seen in Photograph 10 in Appendix B. Discussions with the hall manager indicate that this occurred as a result of the 23rd December 2011 aftershock.

A small number of “sand boils” on the lawn and in the garden were observed during the site inspection; these are surface evidence of liquefaction. According to the building manager, these sand boils occurred in the 23rd December 2011 aftershock.

Photograph 10 Evidence of Liquefaction in the rear paddock
