**Papanui Memorial Reserve Toilet**  
**PRK 0586 BLDG 001 EQ2**  
Detailed Engineering Evaluation  
Qualitative Report  
Version Final

500 Papanui Road  
Papanui

Christchurch City Council

**Date**  
18<sup>th</sup> September 2012

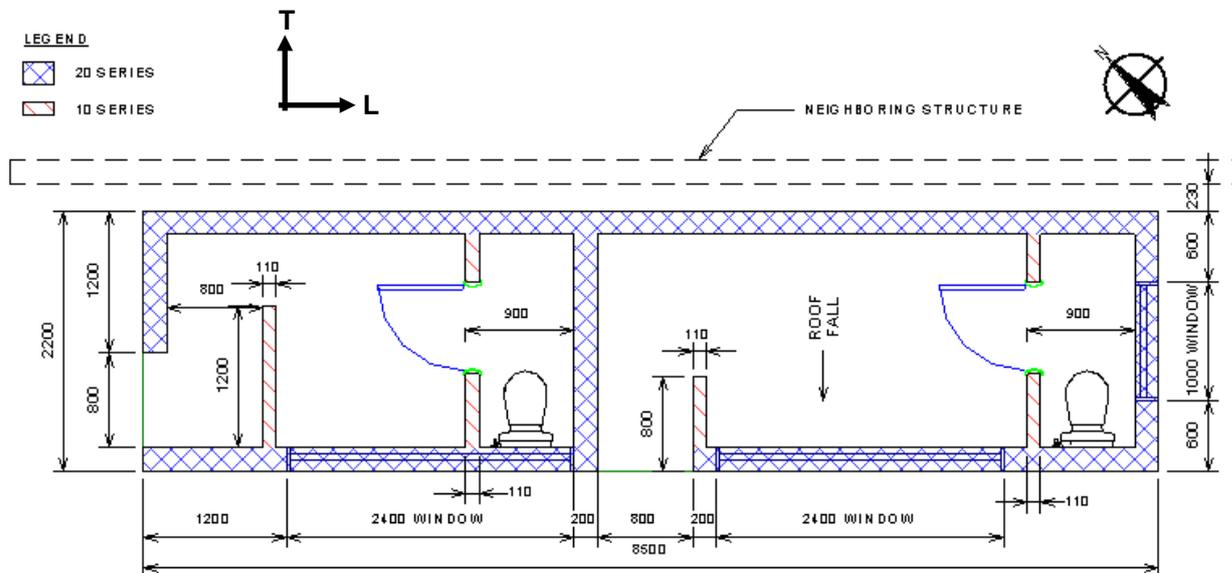
**Figure 2 Plan Sketch Showing Key Structural Elements**

The building is approximately 8.5m in length by 2.2m in width, with a height of 2.2m. The building occupies an area of 18.7m<sup>2</sup> approximately. The site for the building is level. The building is located adjacent to a two storey structure with a separation distance of 230mm.

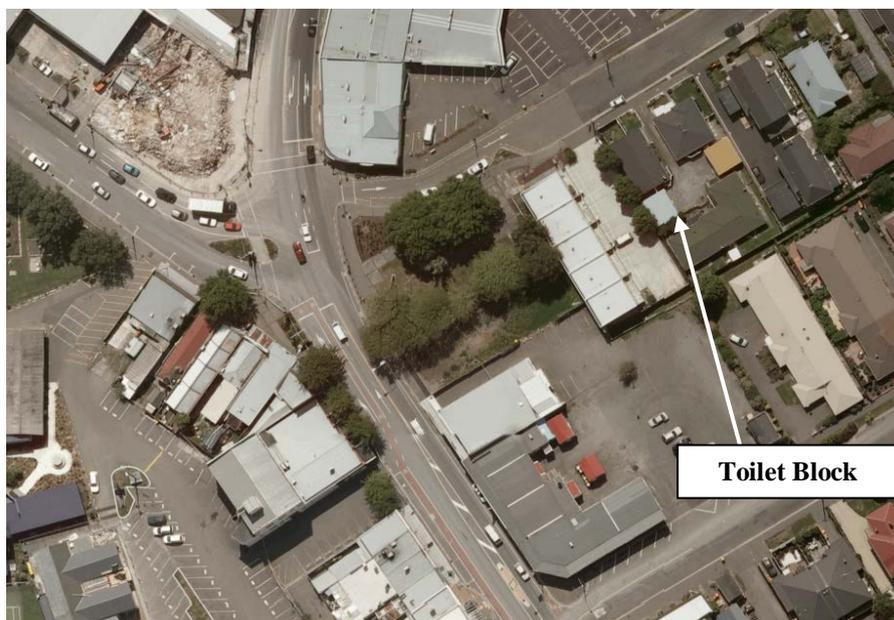
**Figure 3 Post February 2011 Earthquake Aerial Photography<sup>4</sup>**

Aerial photography taken following the 22 February 2011 earthquake shows no signs of liquefaction outside the building footprint or adjacent to the site, as shown in Figure 1.

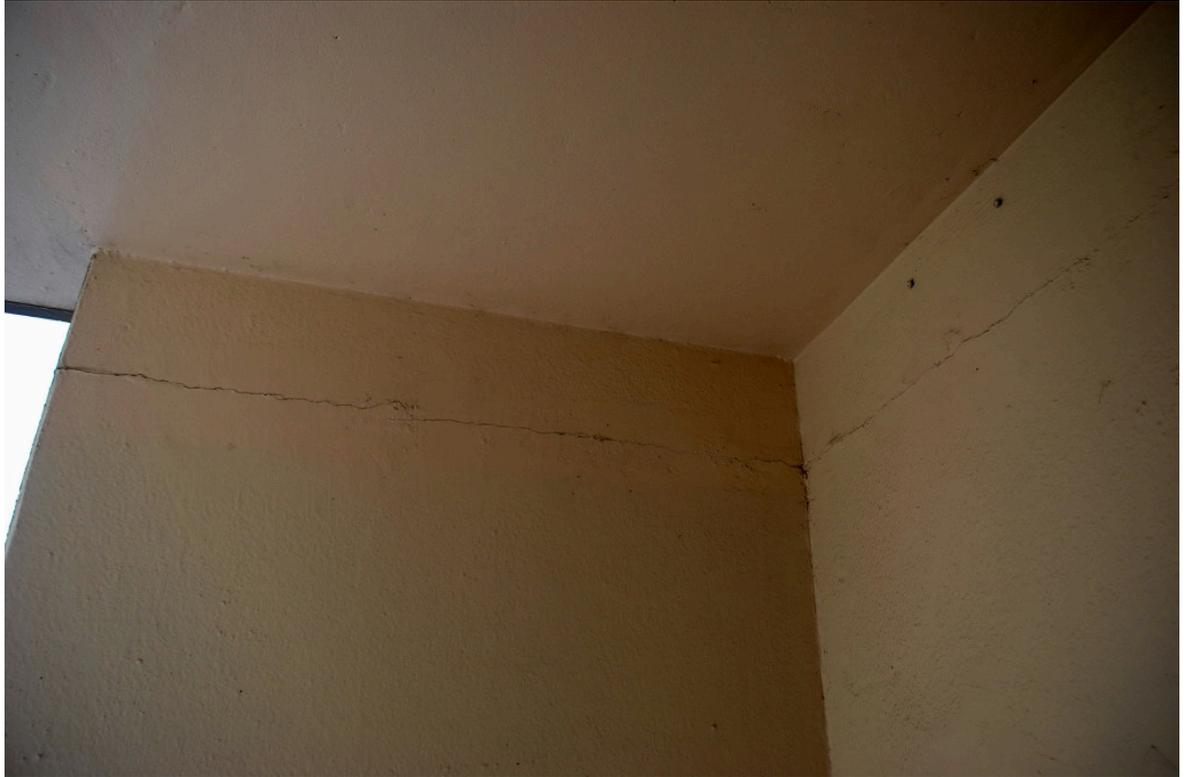
No residual displacements of the structure were noticed during our inspection of the building. Minor cracking was observed along walls at the bottom edge of top row blocks.

**Photograph 5 Horizontal cracking along the top row of blocks.**

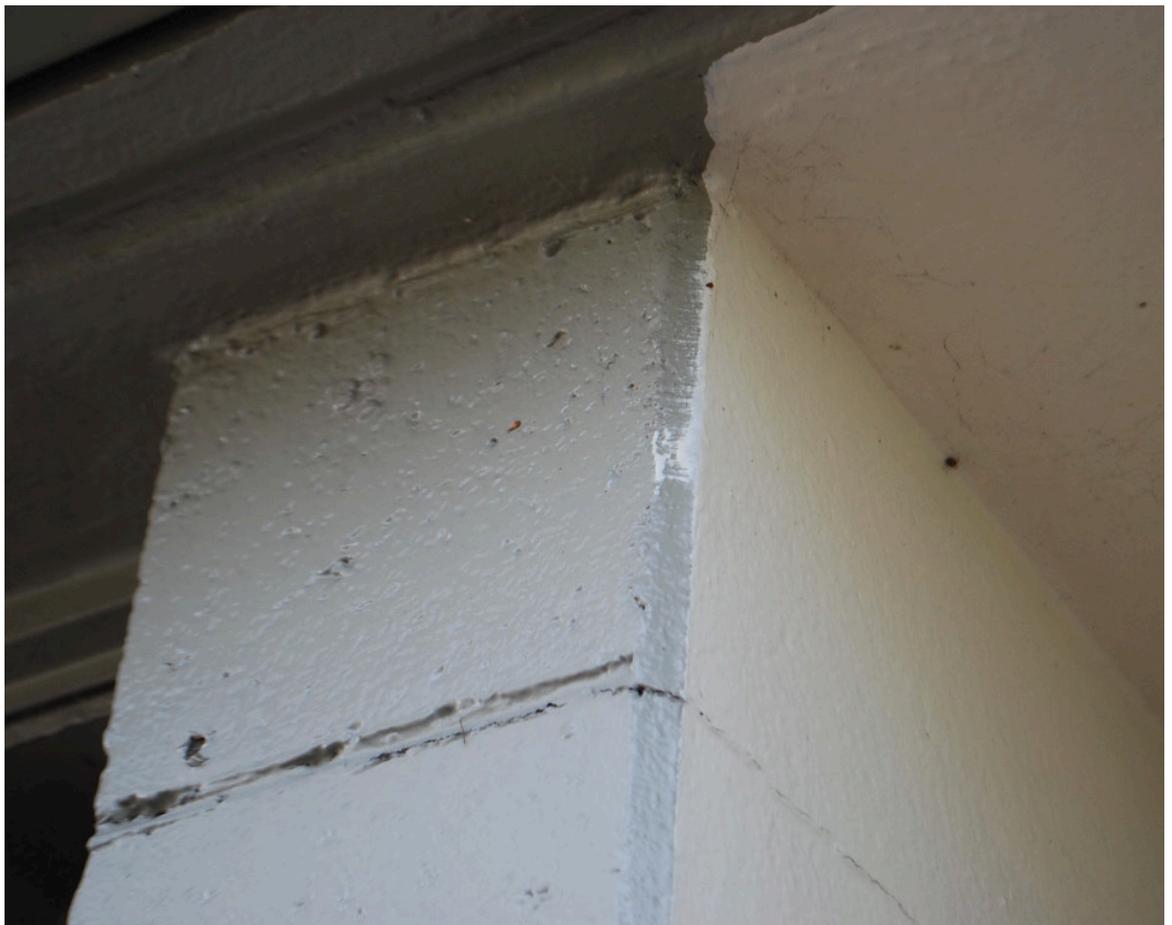
**Photograph 6 Detail view showing cracking at wall to roof connection.**

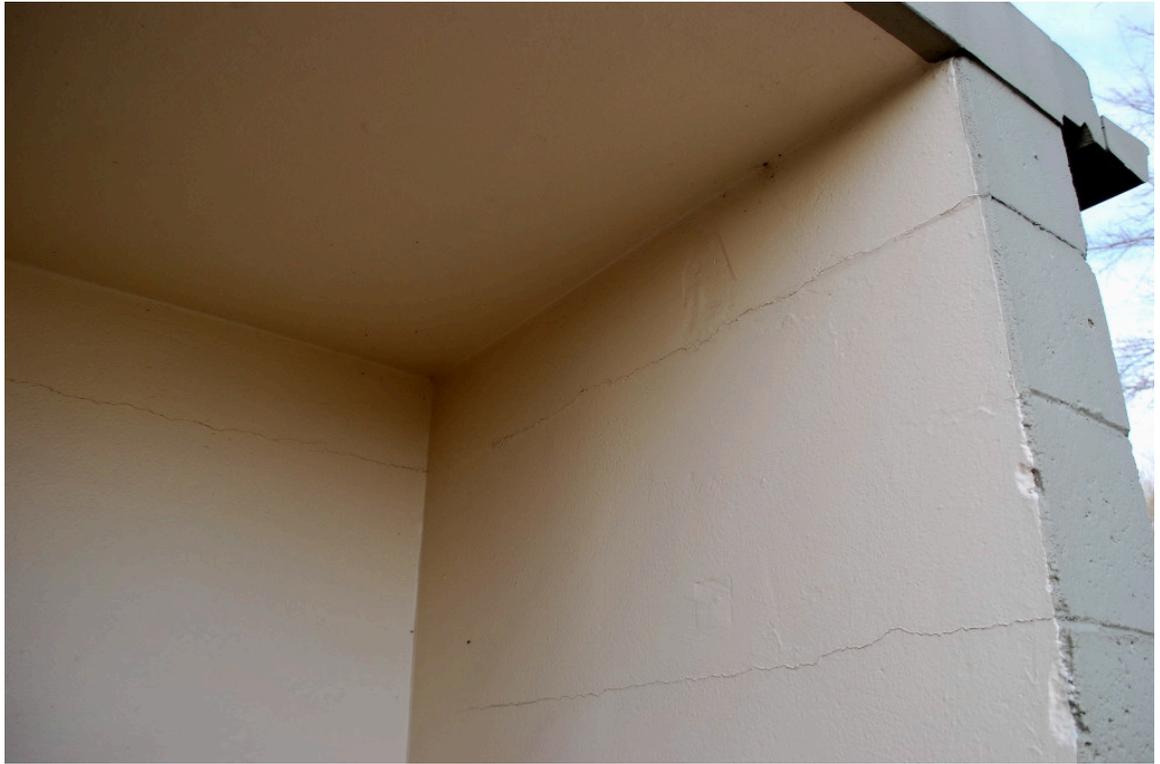
**Photograph 7 Horizontal cracking along the top and lower row of blocks.**

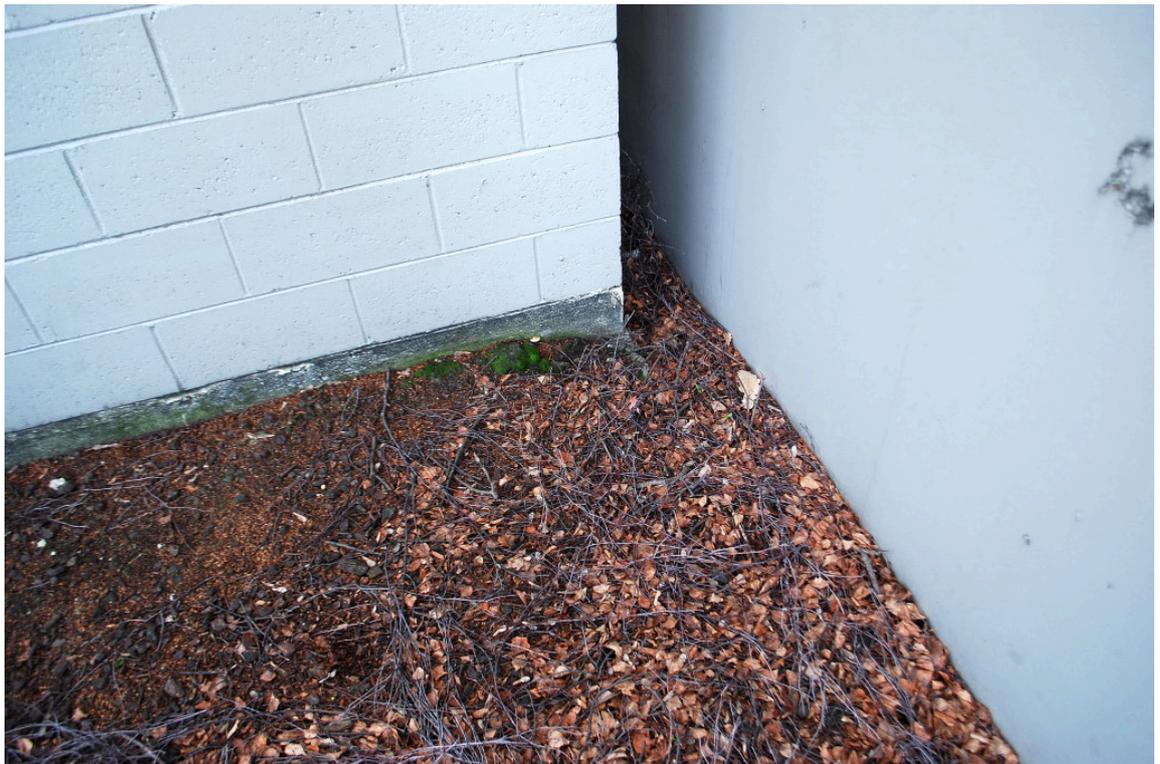
**Photograph 8 Foundations on Southeast side of building also showing Separation between neighbouring structure.**

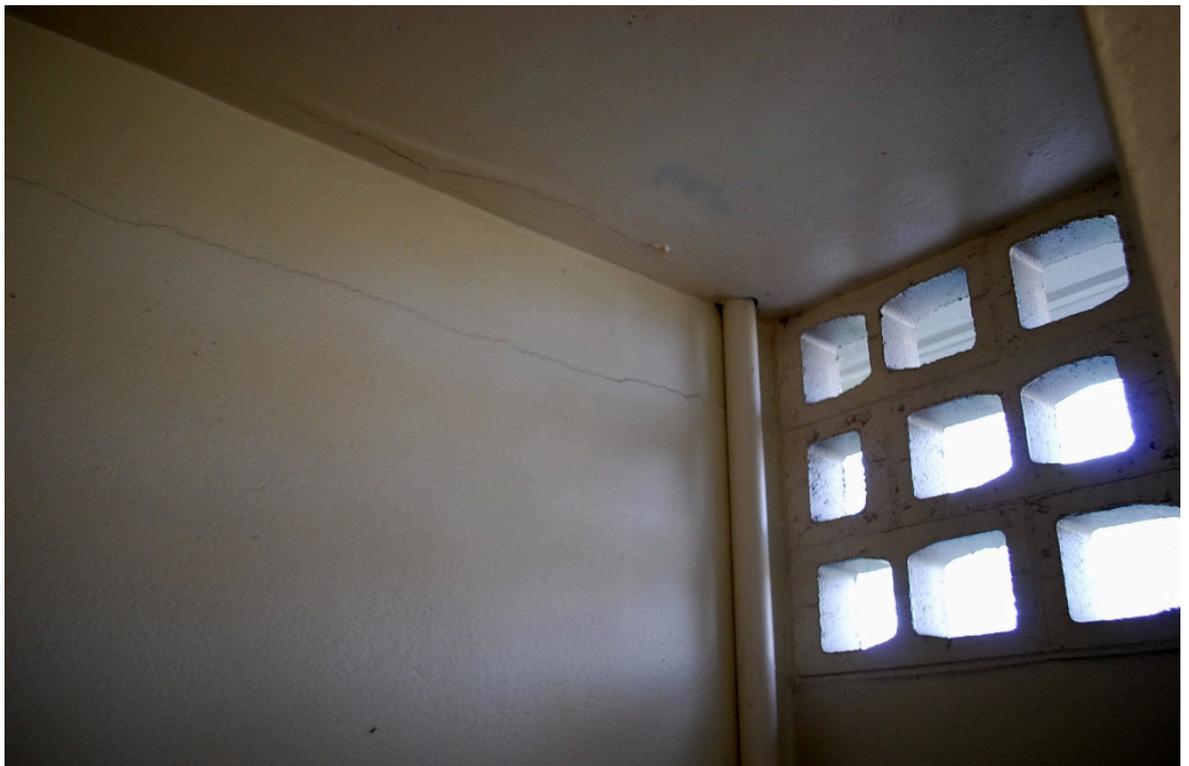
**Photograph 10 Horizontal cracking along the top row of blocks.**
