**Phillipstown Courts
Housing Complex
PRO 0818**

**Detailed Engineering Evaluation
Quantitative Assessment Report**

**263 Ferry Road, Waltham
Christchurch 8011**

Date: September 2013
Reference: 6-QC388.00
Status: Final

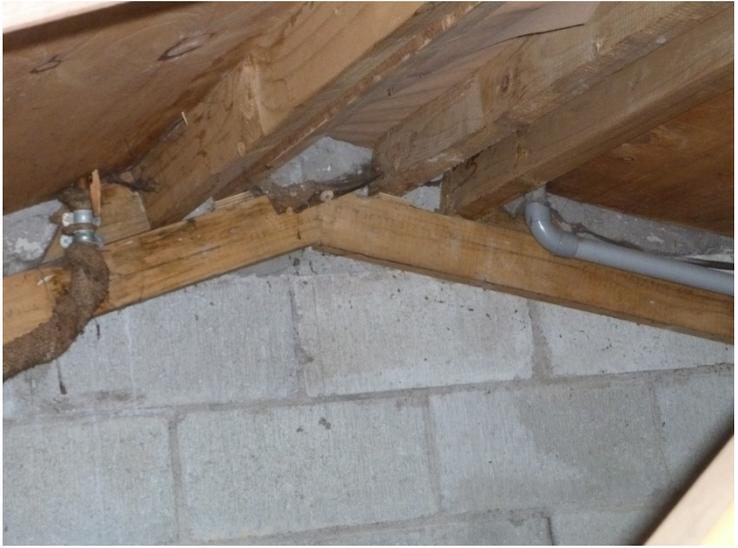
A photograph showing the interior ceiling space of a typical unit, focusing on a fire wall. The fire wall is constructed from concrete blocks and is supported by wooden beams. A white pipe is visible running along the wall. The ceiling is made of wooden planks.

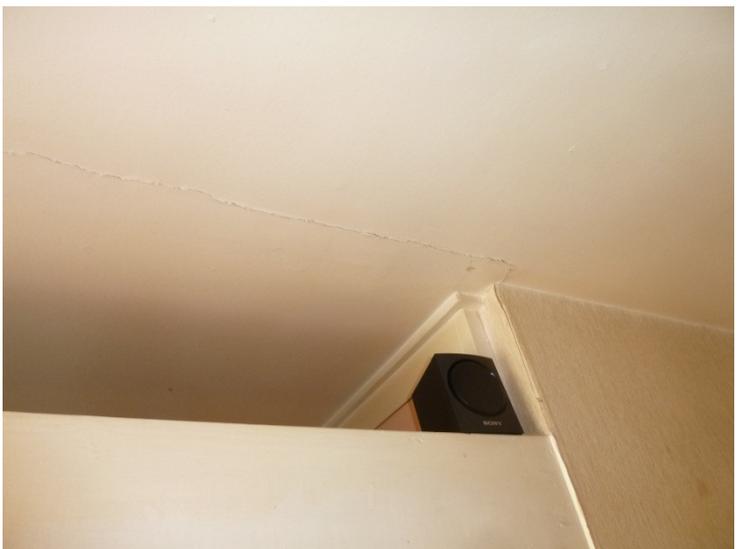
Some minor cracking of ceiling diaphragms and of GIB-lined walls was observed in some of the units that were inspected (photo 6 and 7).

6	GIB cracking in ceiling above partition wall

- All buildings be strengthened to at least 67% NBS.
- Veneer at height (gable ends) have the veneer ties checked.
- Cosmetic repairs are undertaken.

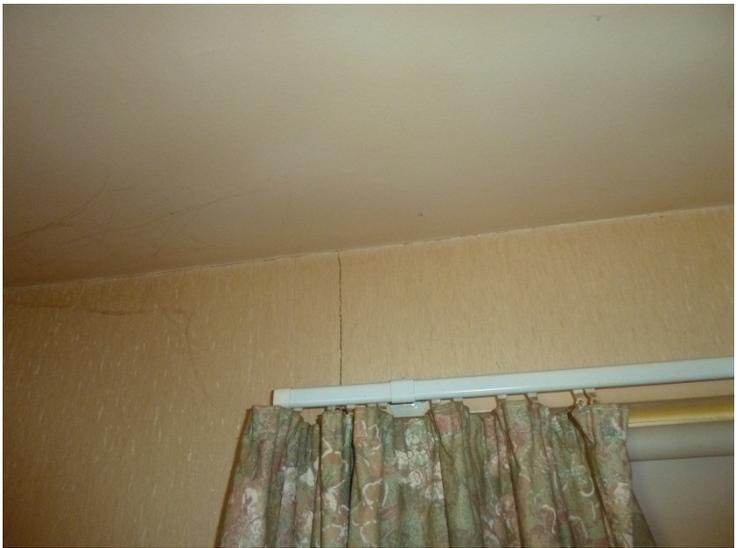
A photograph showing a close-up of a ceiling and a partition wall. The ceiling is made of GIB (Gypsum Board) and shows a significant crack that runs diagonally across the surface. The partition wall is also visible, and the crack appears to be related to the junction between the two surfaces. A black speaker is visible on the wall below the crack.
7	GIB cracking in wall from corner of window
