# Pickering Courts

## Detailed Engineering Evaluation Report

BU 0611-001 EQ2 Block A Qualitative  
BU 0611-002 EQ2 Block B Quantitative  
BU 0611-003 EQ3 Block C Quantitative

17 April 2013

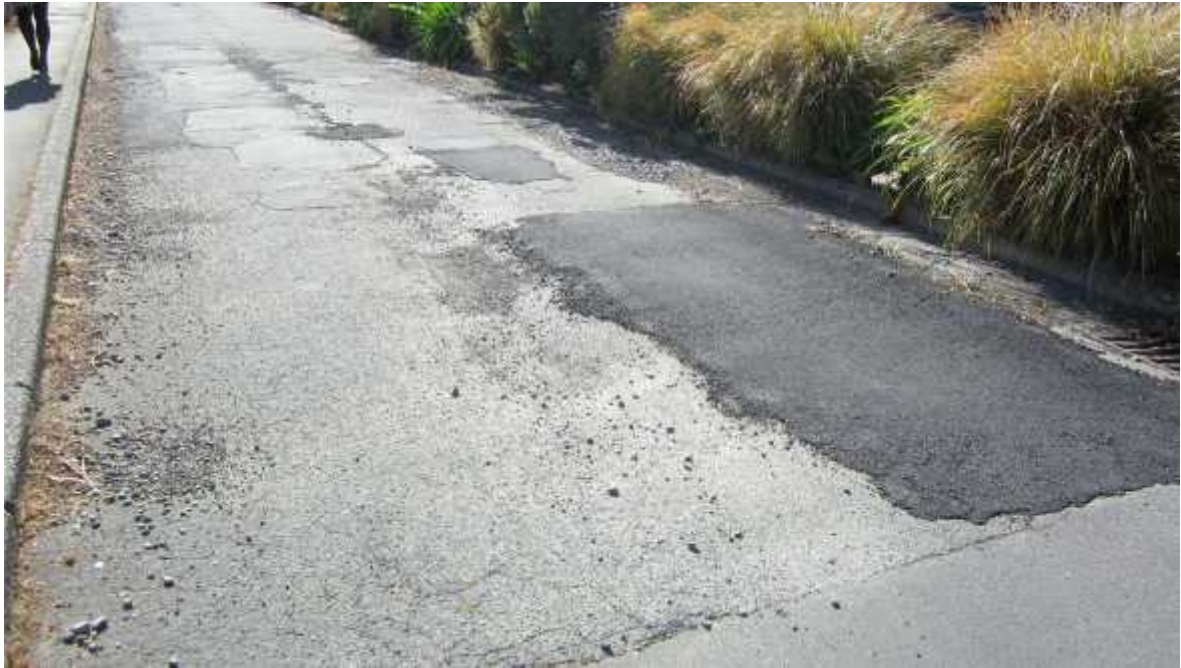
**Photo 6:** Pickering Courts driveway.

**Damage Description:** Possible earthquake damage.

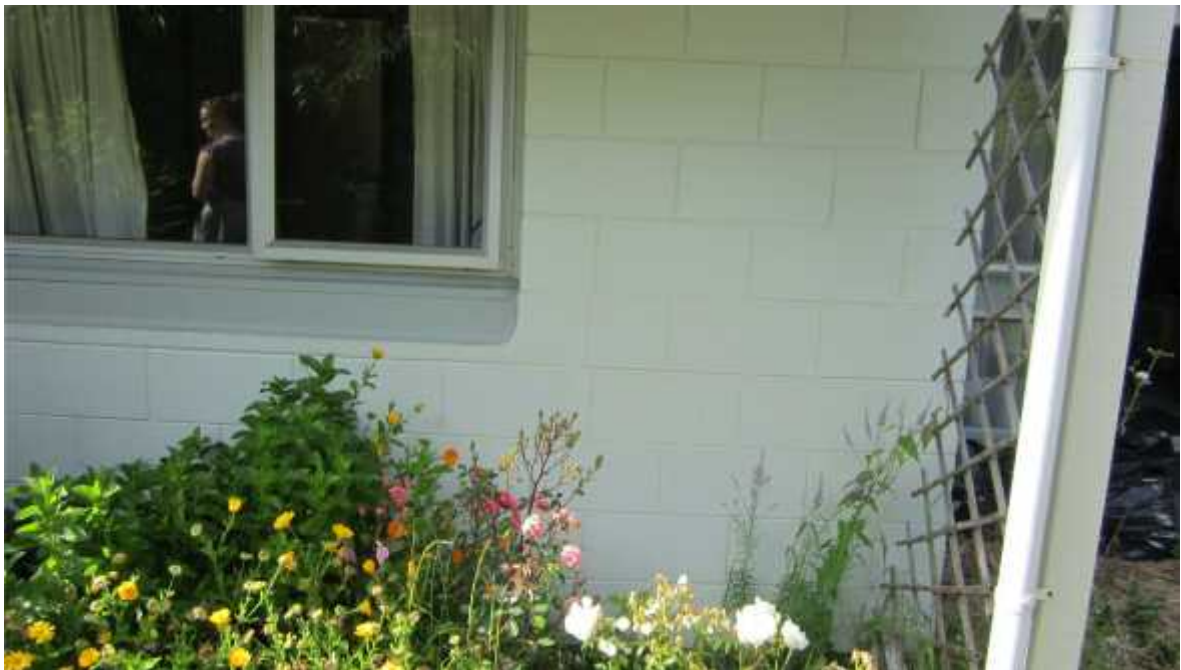
**Photo 7:** Concrete block masonry veneer – Block A.

**Damage Description:** Cracking of concrete masonry block veneer mortar.

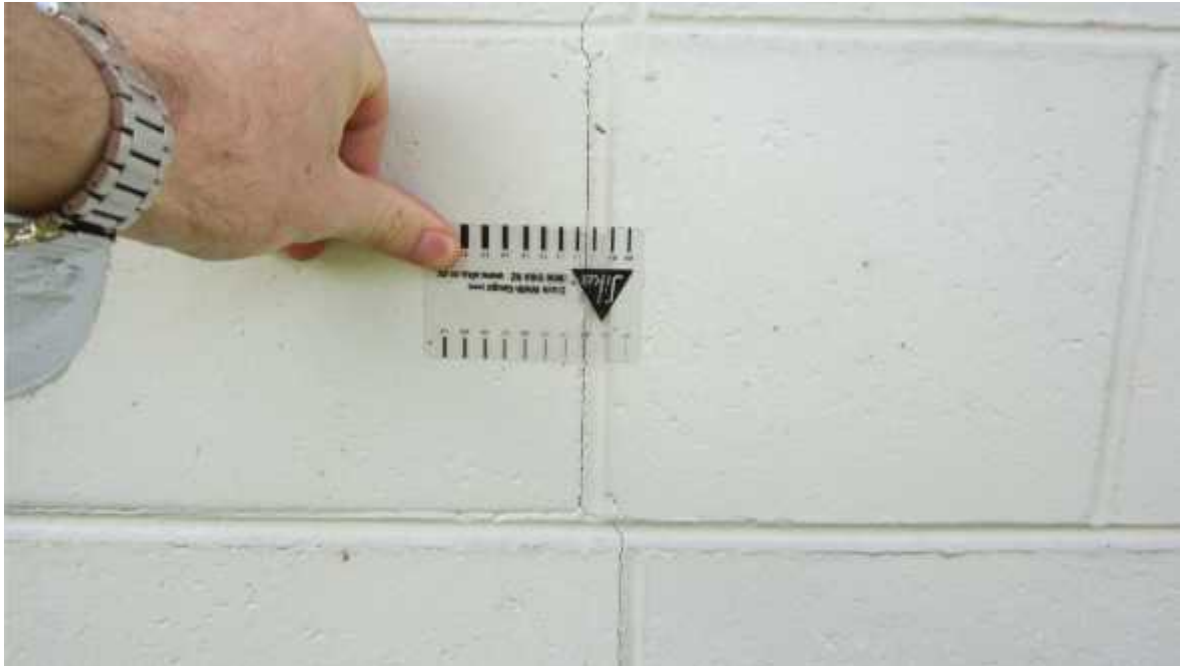
**Photo 8:** Concrete block masonry veneer – Block A.

**Damage Description:** Cracking of concrete masonry block veneer mortar.

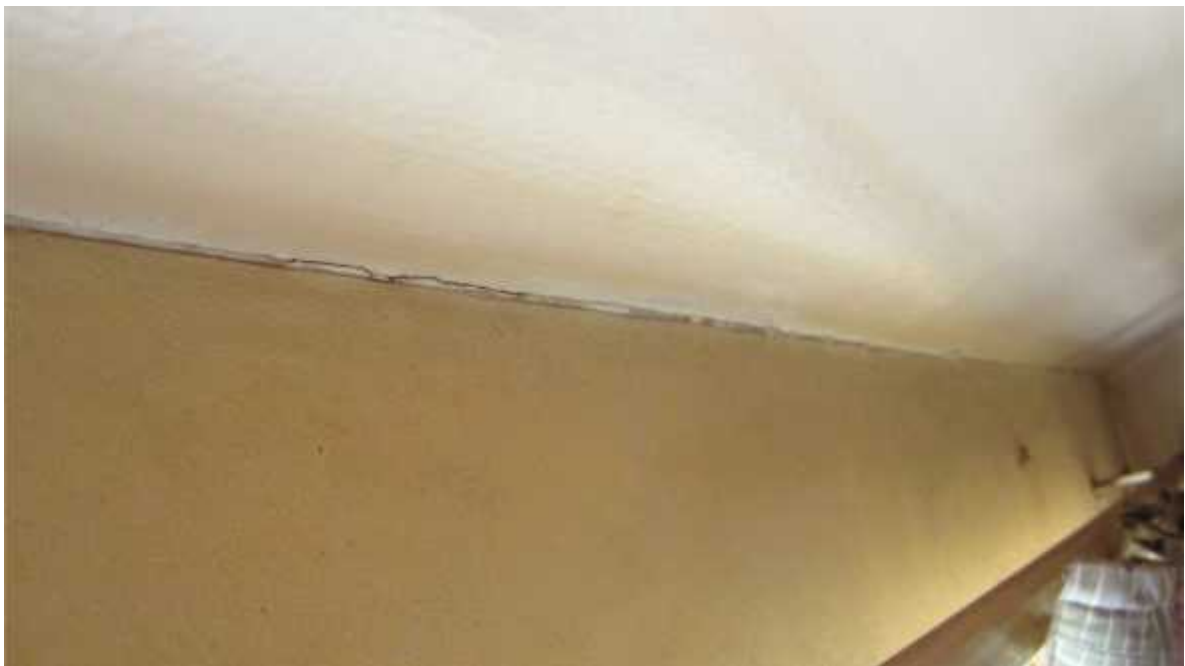
**Photo 9:** Internal wall and ceiling.

**Damage Description:** Separation of wall and ceiling linings.

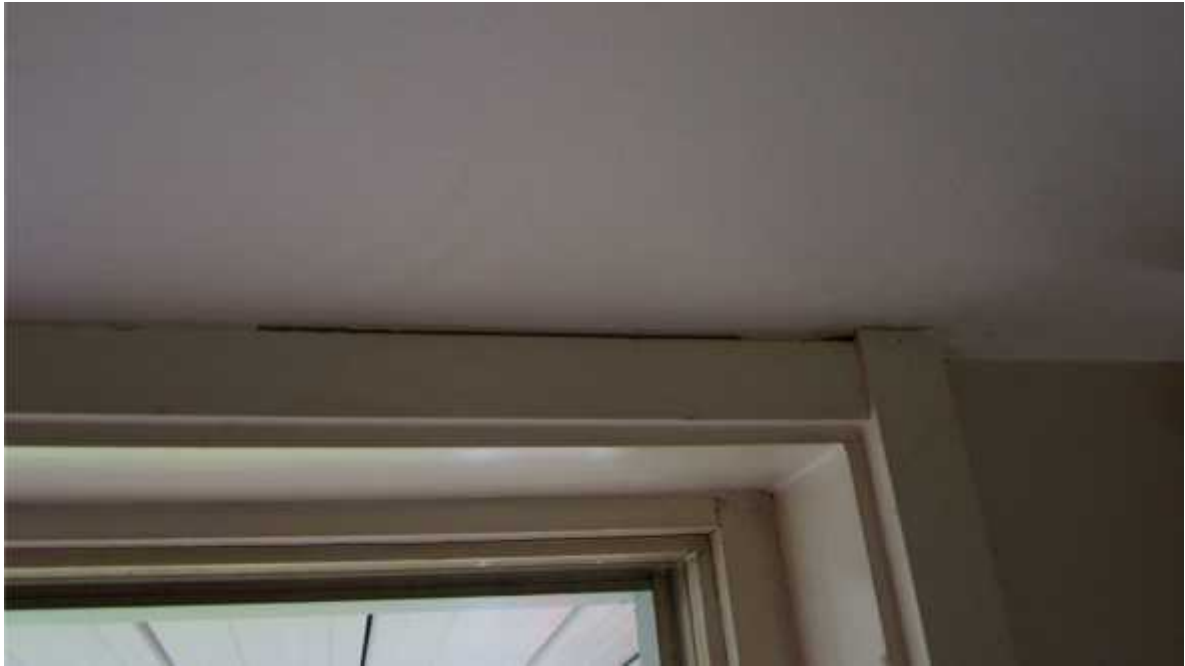
**Photo 10:** Door architrave and ceiling.

**Damage Description:** Separation of wall and ceiling linings.

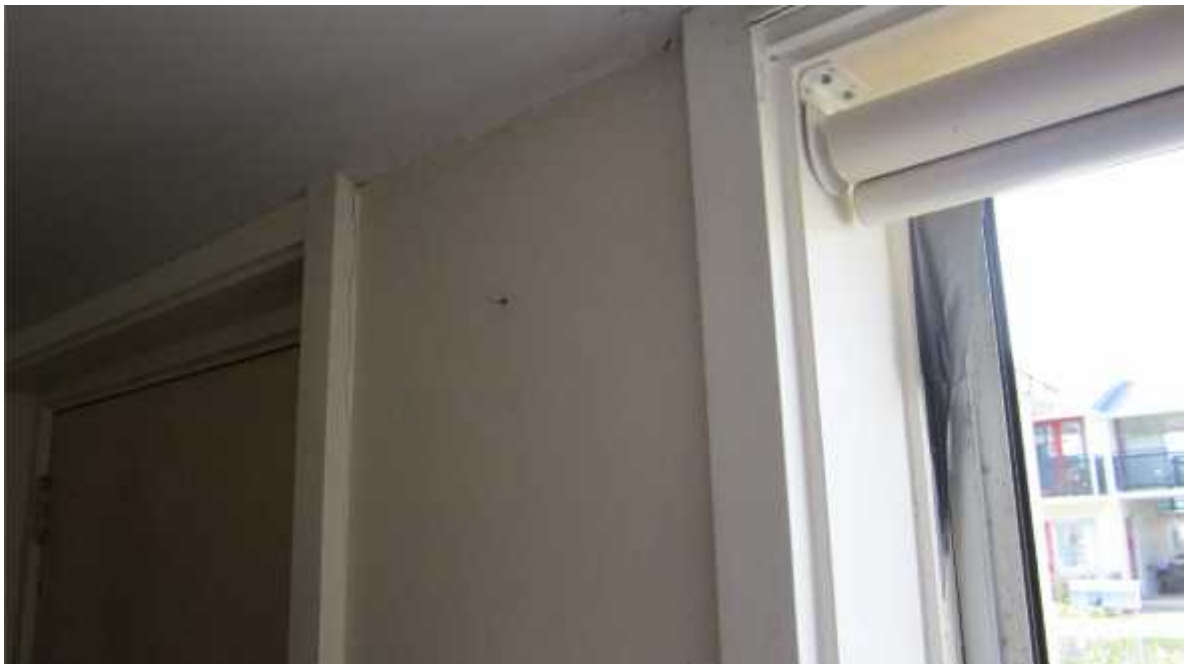
**Photo 11:** Window and door architrave and ceiling.

**Damage Description:** Separation of wall and ceiling linings.

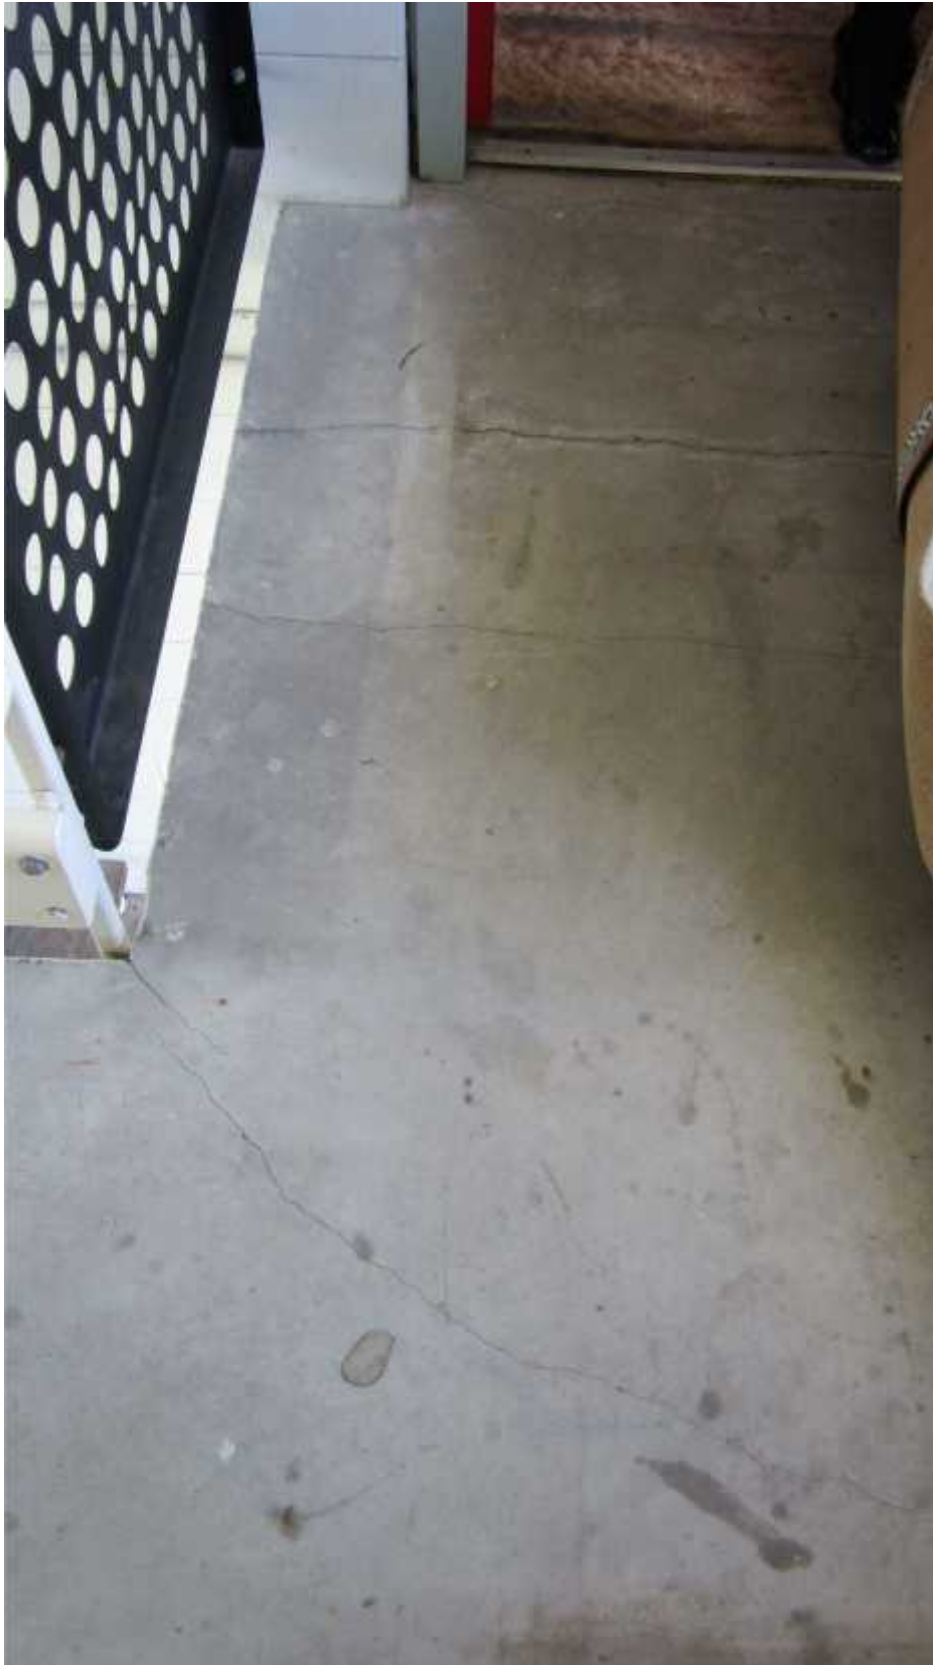
**Photo 12:** Stair landing in Block C.

The building has suffered cracking to the first floor stair landings and temporary propping has been installed. Details of the temporary propping solution were provided by email dated 21 December 2012.

**Damage Description:** Cracking of concrete slab.

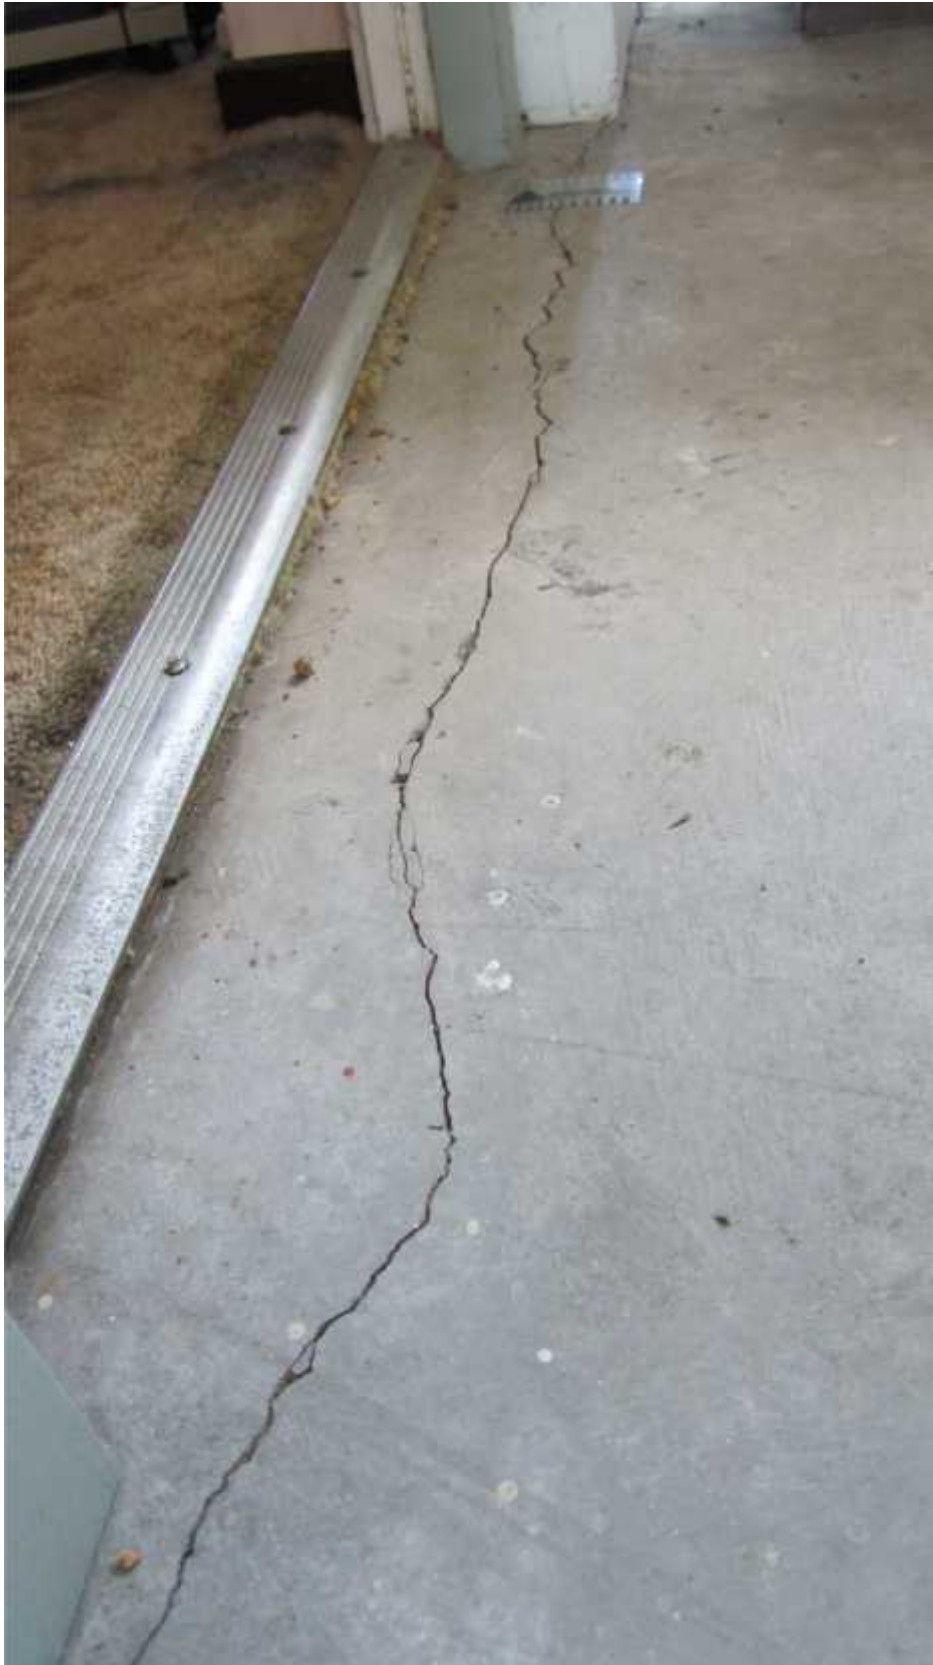
**Photo 13:** Stair landing in Block C.

**Damage Description:** Cracking of concrete slab.

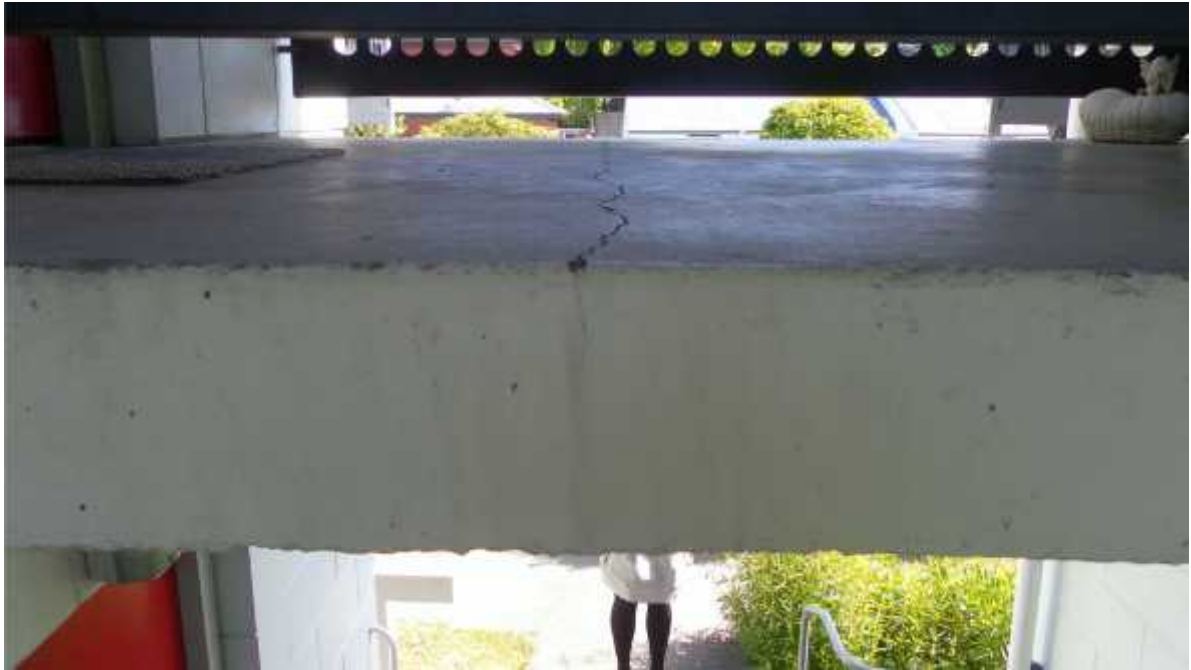
**Photo 14:** Stair landing in Block C.

**Damage Description:** Cracking of stair landing in Block C. (Temporary propping detail provided)

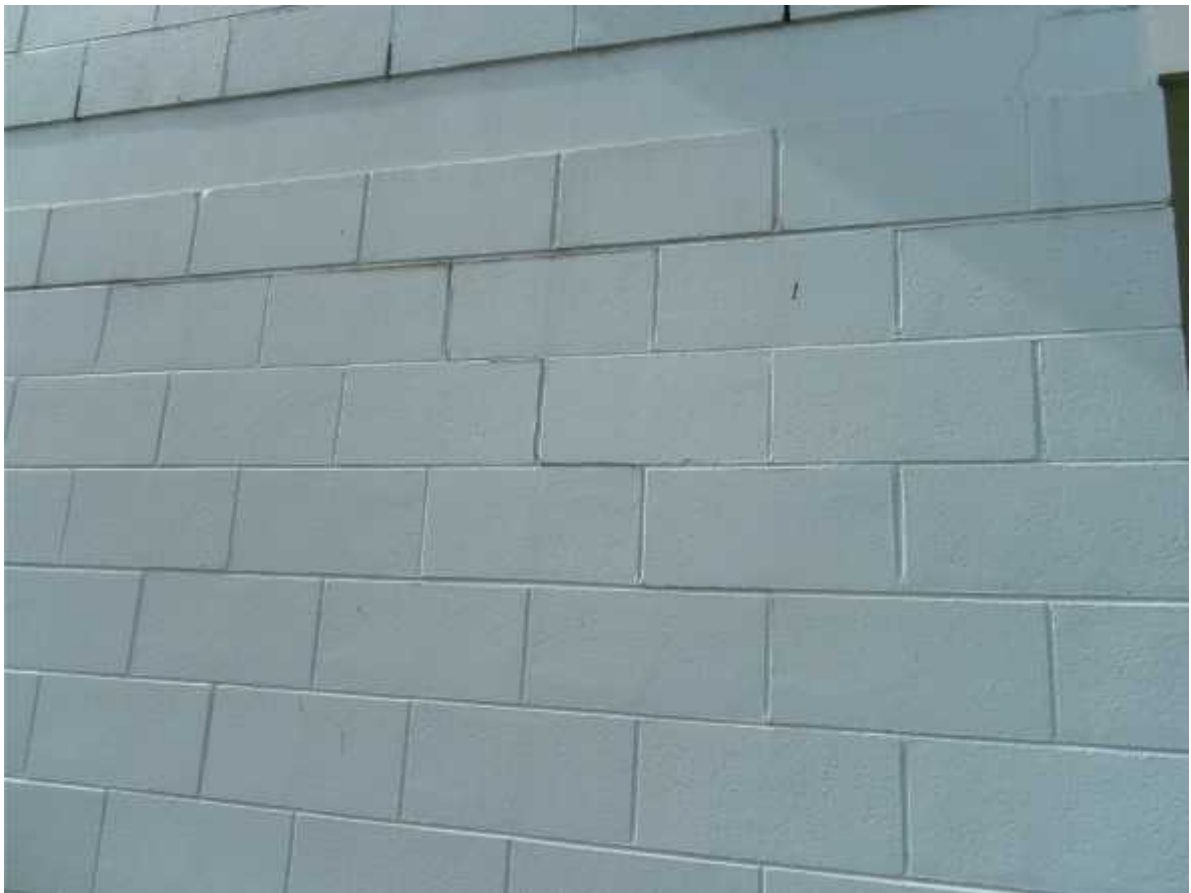
**Photo 15:** Reinforced concrete masonry block wall – northern end wall of Block B.

**Damage Description:** Stepped cracking in concrete masonry block work mortar.

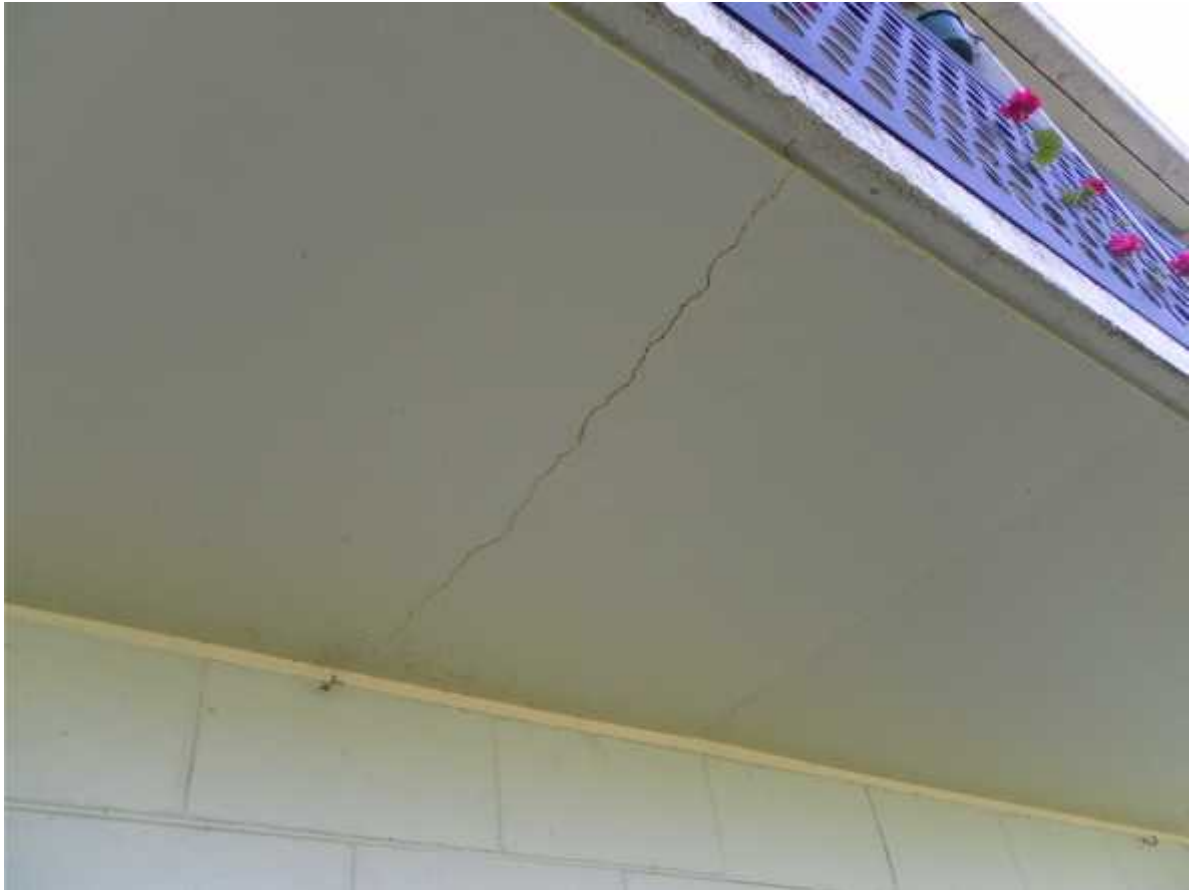
**Photo 16:** Underside of typical first floor balcony.

**Damage Description:** Cracking of concrete balcony (approximately in the middle).

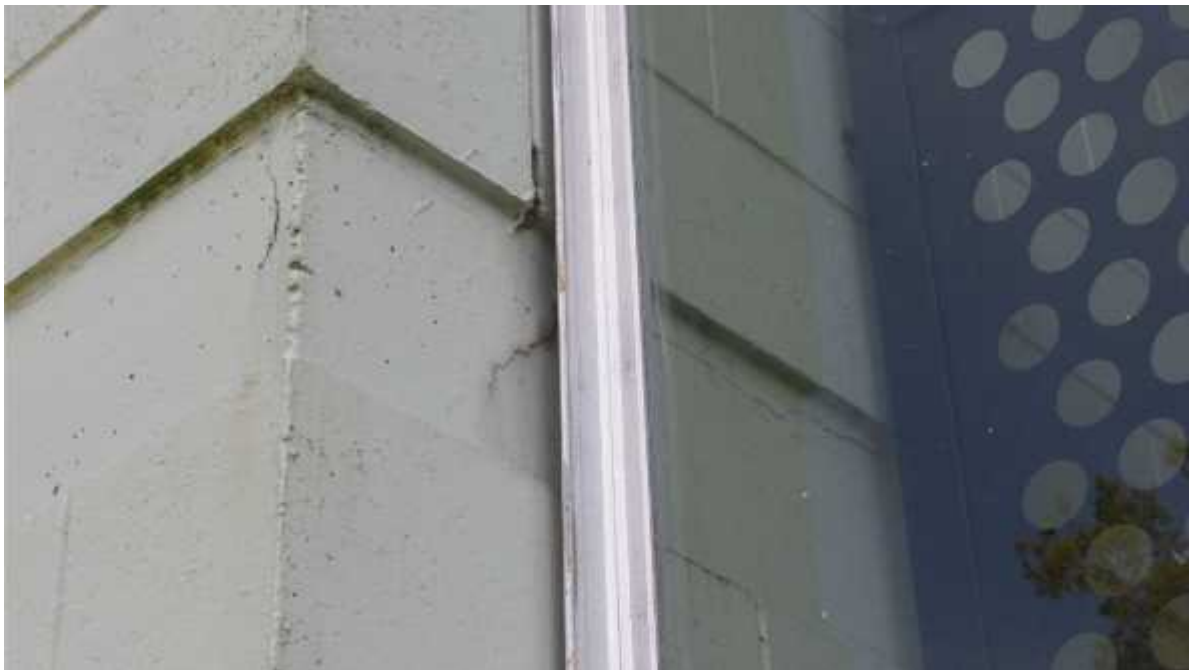
**Photo 17:** First floor slab – Block C.

**Damage Description:** Diagonal cracking to first floor slab,.

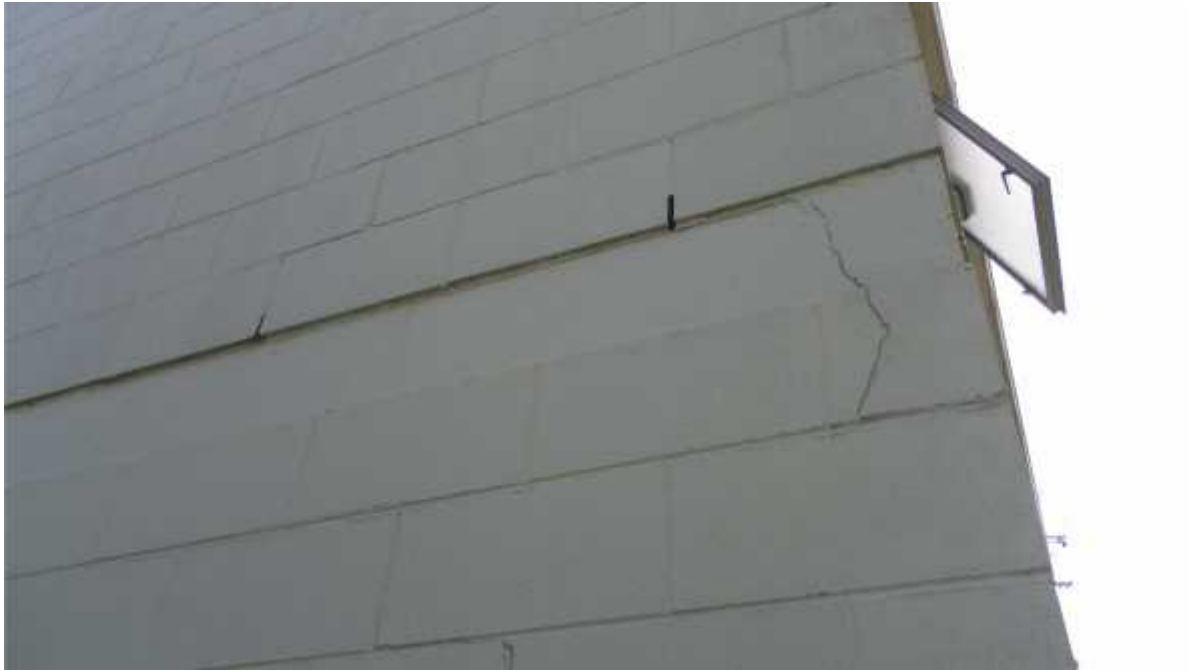
**Photo 18:** First floor slab – Western end wall in Block C.

**Damage Description:** Diagonal cracking to first floor slab and cracking of concrete masonry block.

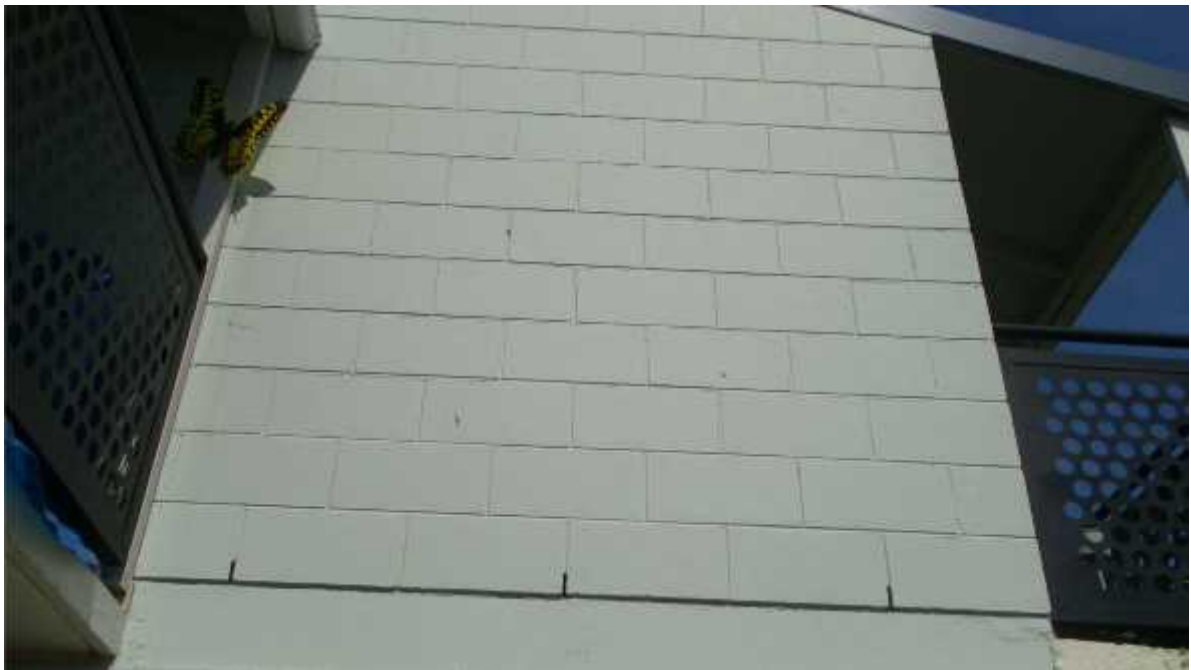
**Photo 19:** Concrete masonry block wall – Block C.

**Damage Description:** Stepped cracking in concrete masonry block work mortar.

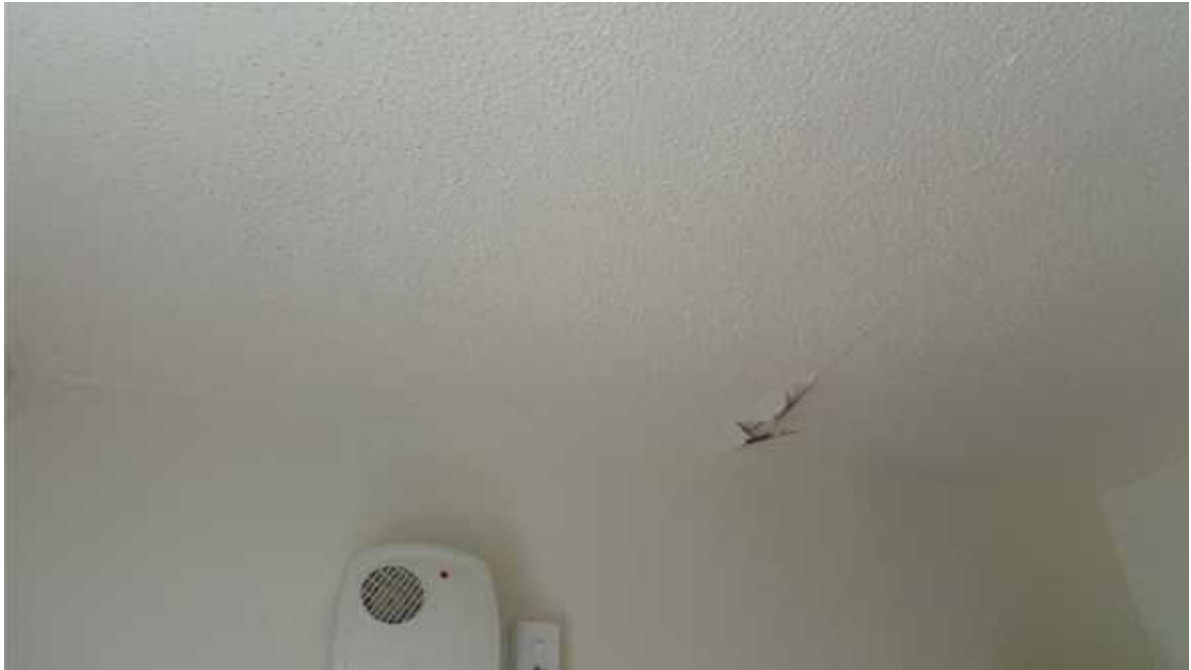
**Photo 20:** Ceiling lining.

**Damage Description:** Cracking of ceiling lining.

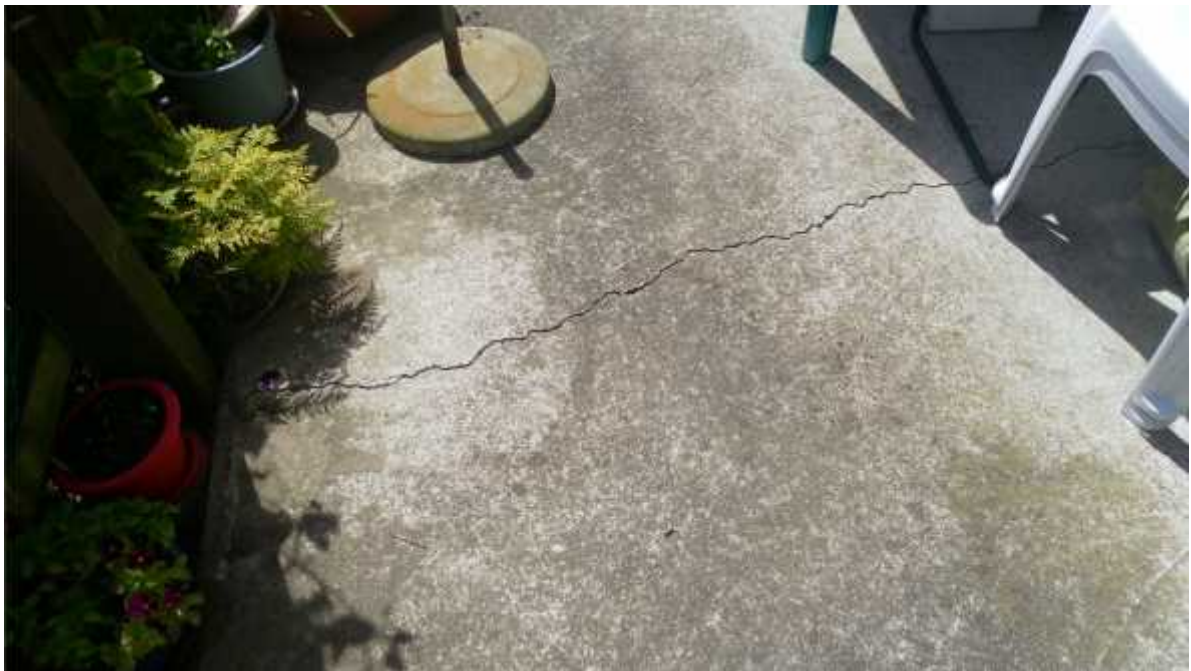
**Photo 21:** Concrete patio adjacent to Block C.

**Damage Description:** Ground cracks / cracking to concrete pavement.

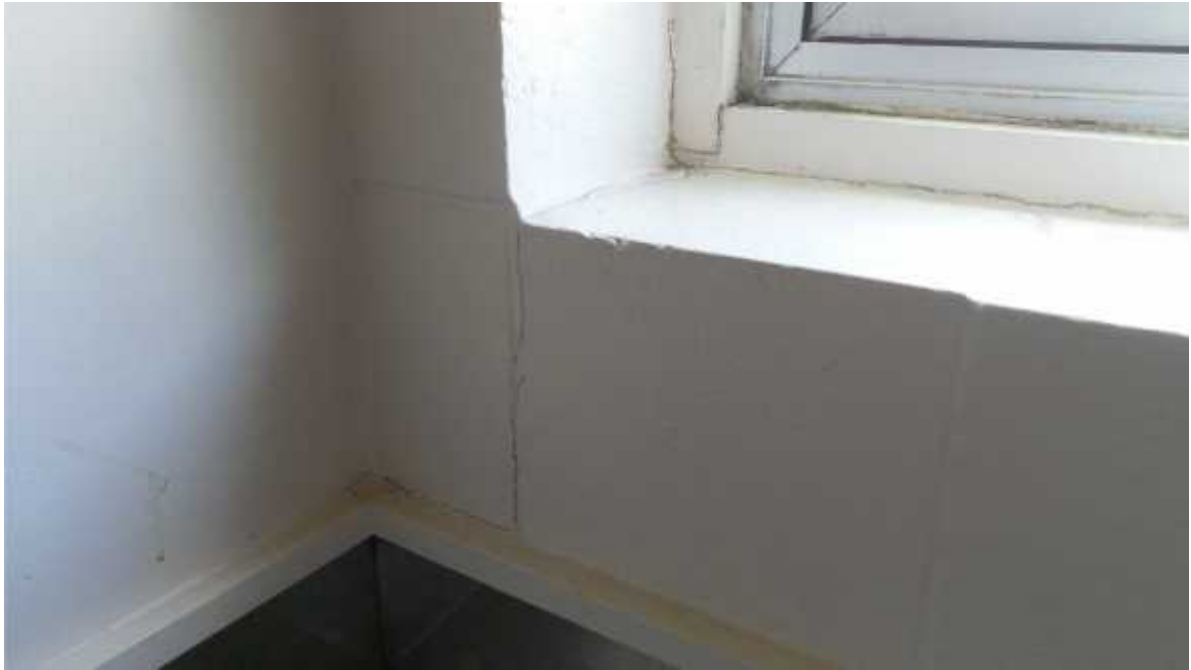
**Photo 22:** Inner skin (15series) of concrete masonry block wall – ground floor in Block C.

**Damage Description:** Cracking of concrete masonry block work mortar.
