Porritt Park Complex
BU 0706-001 EQ2
Detailed Engineering Evaluation
Qualitative Report
Version FINAL

845 Avonside Drive, Wainoni

Christchurch City Council

Date
12/09/2013

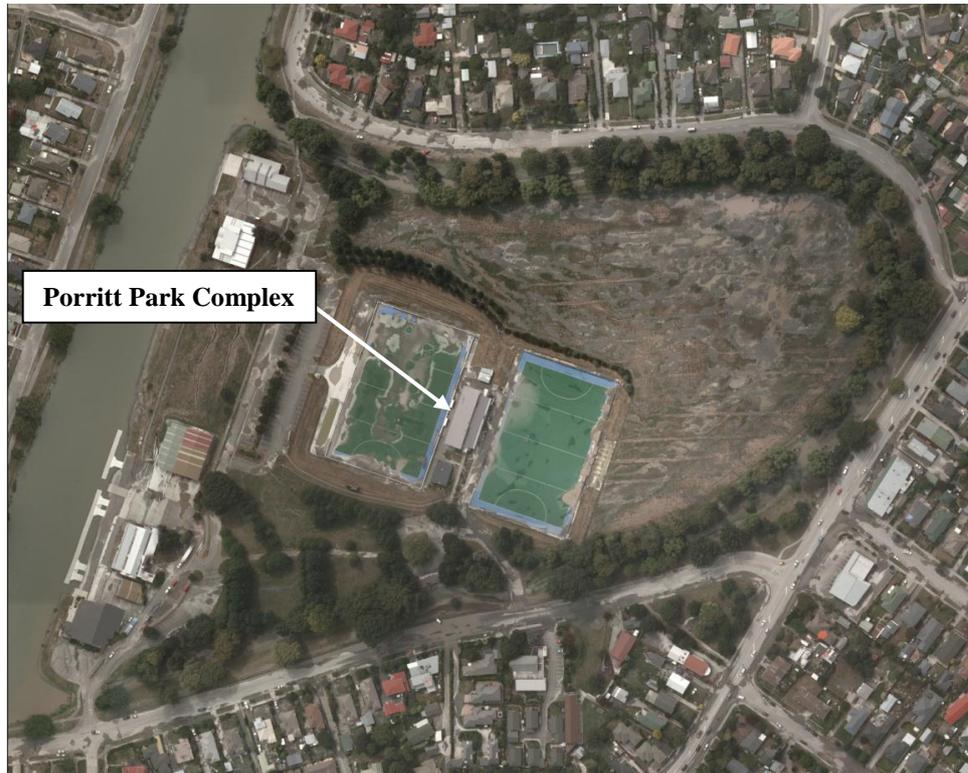
Figure 7 Post February 2011 Earthquake Aerial Photography ³

Aerial photography taken following the 22 February 2011 earthquake shows signs of major liquefaction (including lateral spreading) across the site, and throughout surrounding streets, as shown in Figure 7. Significant liquefaction-induced damage is also evident across the hockey turf surfaces.

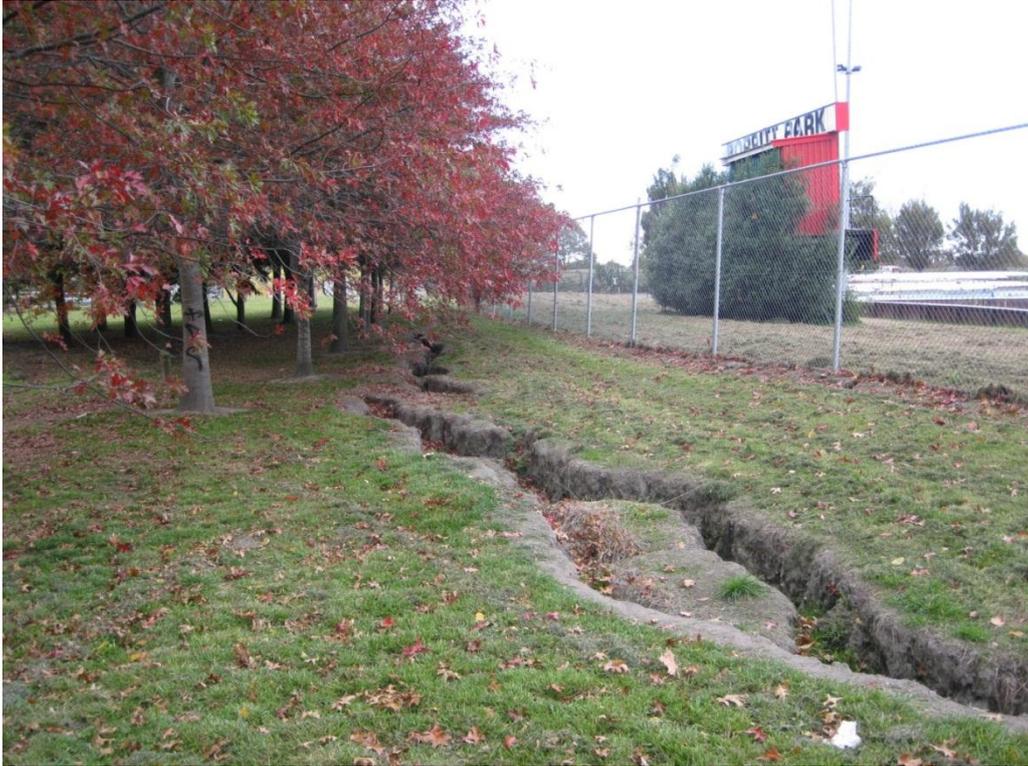
Significant ground damage was observed throughout the Porritt Park site during our inspections. Severe ground cracks and lateral spreading were observed near the river approximately 100m south of the grandstand. Extensive liquefaction and ground settlement was observed throughout the site. Significant amounts of sand and silt were still present on the ground across the site.

Photograph 1 Ground cracks near the river south of the grandstand.

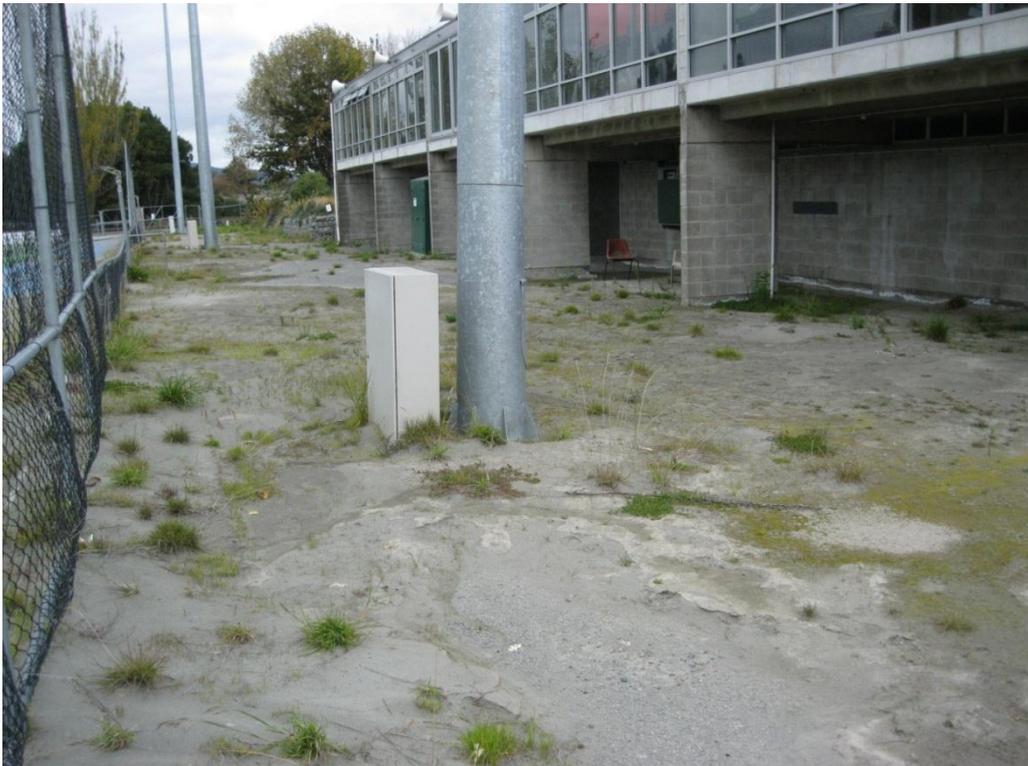
Photograph 6 Sand and silt on the ground east of the building due to extensive liquefaction.

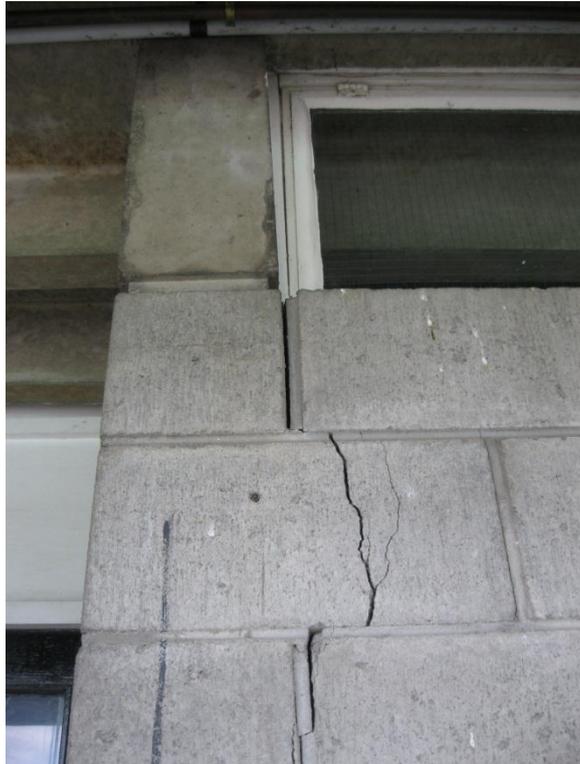
Moderate cracking was observed to be widespread throughout the reinforced concrete frames and concrete masonry structural elements in the building. Cracking was observed in the concrete masonry walls both along and across the building. Photographs 8, 23 and 24 show cracking observed on the eastern and western faces of the building. A number of these cracks extend through to the foundations.

Photograph 8 Cracking in a concrete masonry wall along the eastern face of the building.

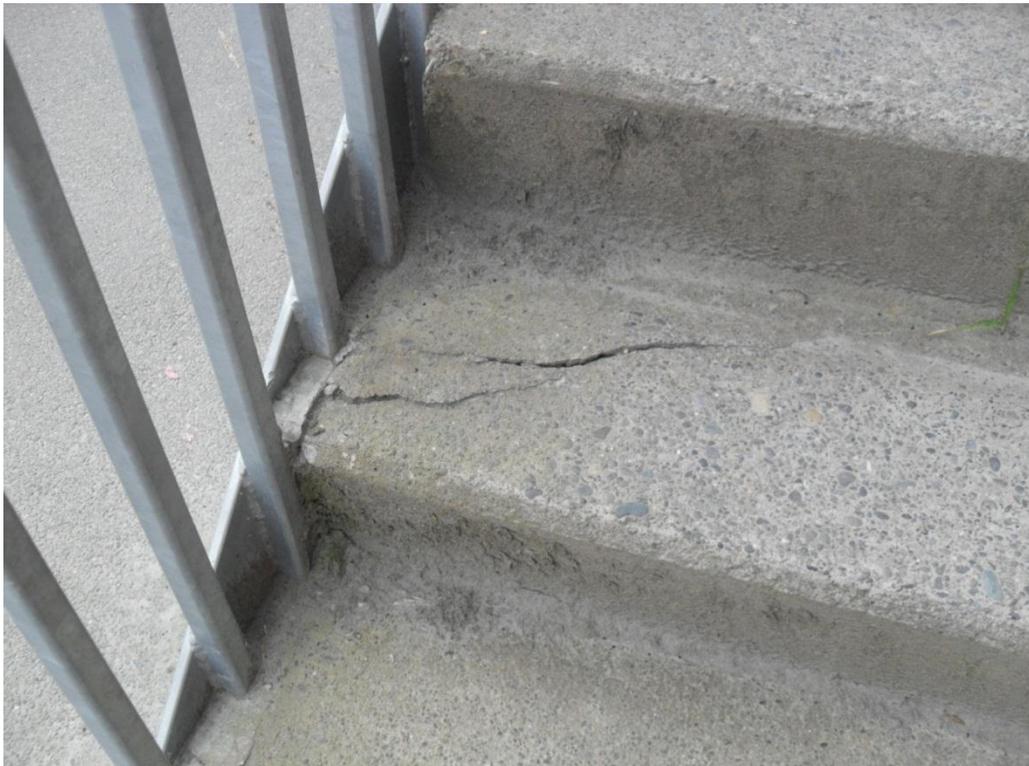
The two sets of precast concrete stairs leading to the grandstand seating area on the western side of the building have suffered damage as a result of settling differentially to the main structure. The foundations of the stairs are not linked to the foundation system of the grandstand structure and as a result they have moved relative to each other during the earthquakes, damaging the stairs and the landings. Photographs 12, 13, and 14 show the damage caused to the stairs and landing. The landings of the stairs have lifted off the supports at one end suggesting the stair foundations have been driven up by liquefaction, resulting in the stairs twisting and buckling. Photograph 15 shows cracking in the in-situ slab section of the grandstand where the stair landings connect to the grandstand structure.

The two sets of precast concrete stairs leading to the grandstand seating area on the western side of the building have suffered damage as a result of settling differentially to the main structure. The foundations of the stairs are not linked to the foundation system of the grandstand structure. No provision for movement has been made in the detailing of the stairs. As a result, any differential movement between the foundations of the stairs and the grandstand structure during an earthquake is likely to cause further damage to the stairs which may compromise egress from the grandstand.

Photograph 12 Cracking in grandstand stairs along the western side of the grandstand.

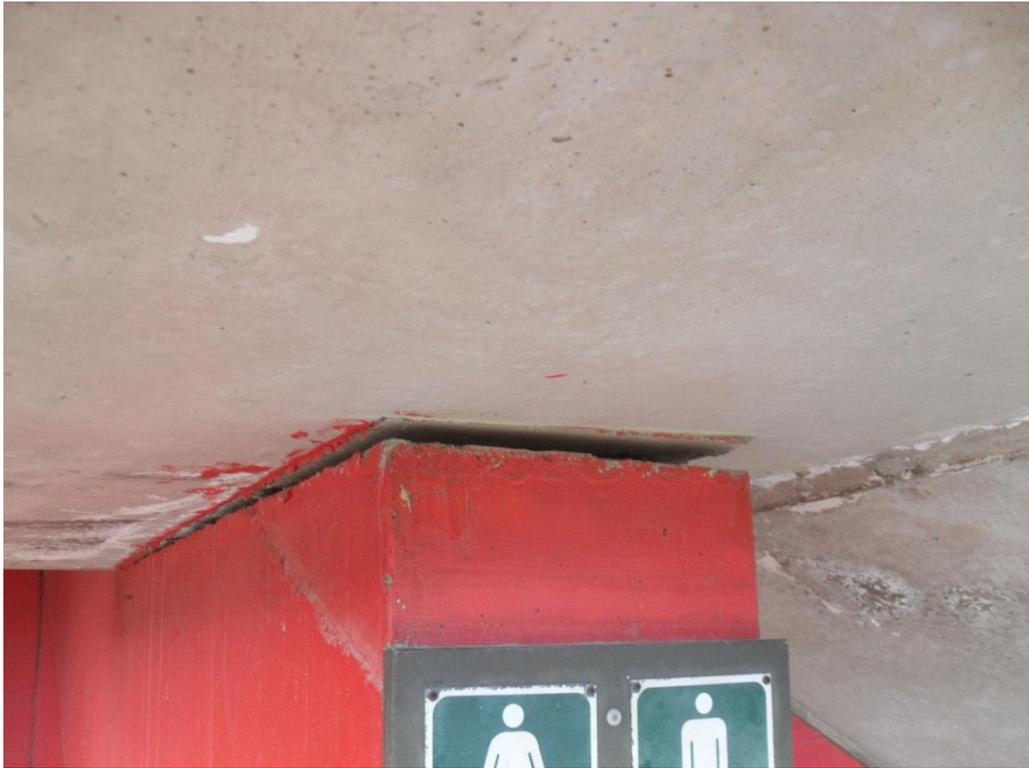
Photograph 13 Separation of the seating between the concrete beams supporting the grandstand and the southern concrete steps.

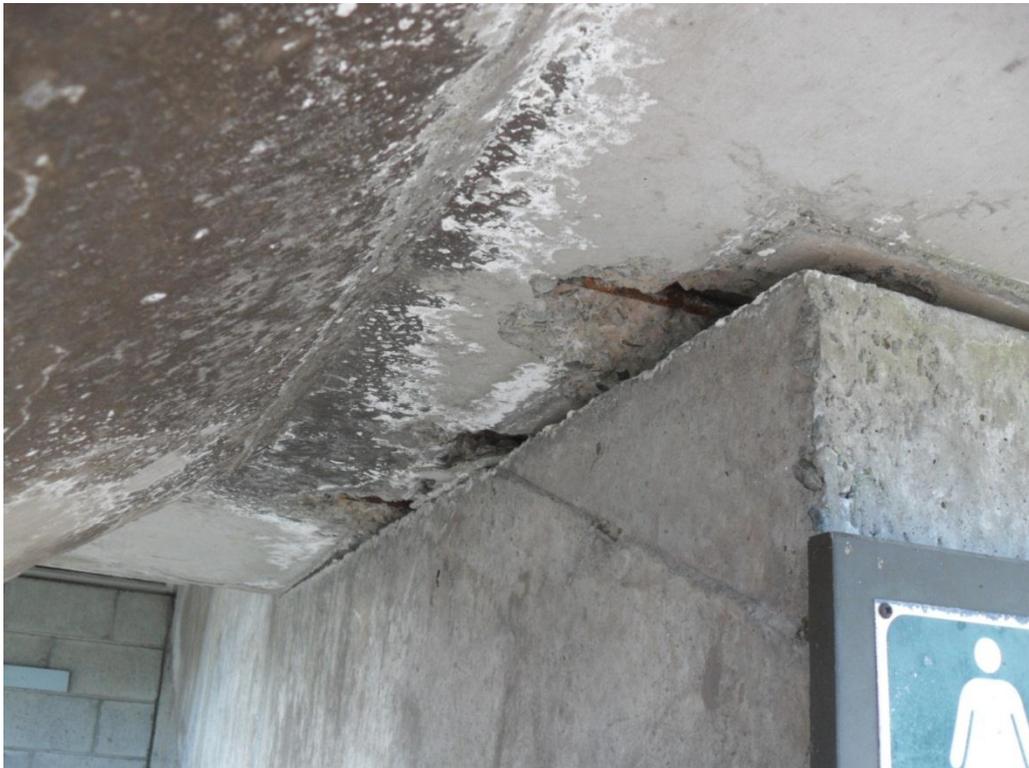
Photograph 14 Separation of the seating between the concrete beams supporting the grandstand and the northern concrete steps.

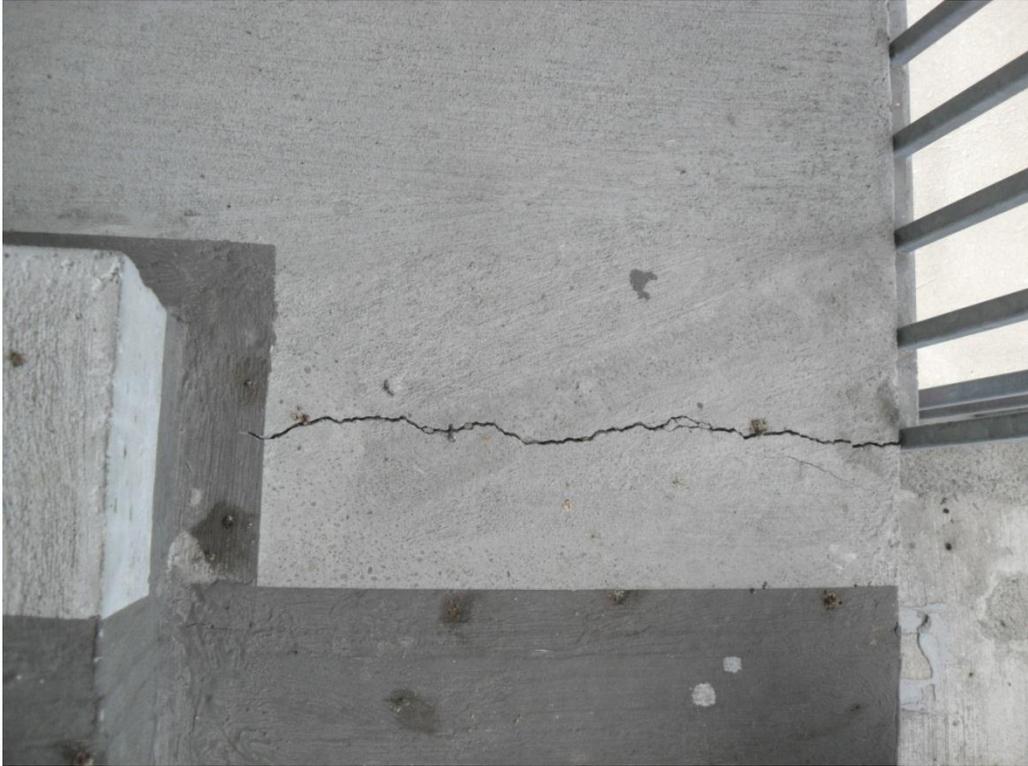
Photograph 15 Cracking in the in-situ floor slab in the middle of the grandstand.

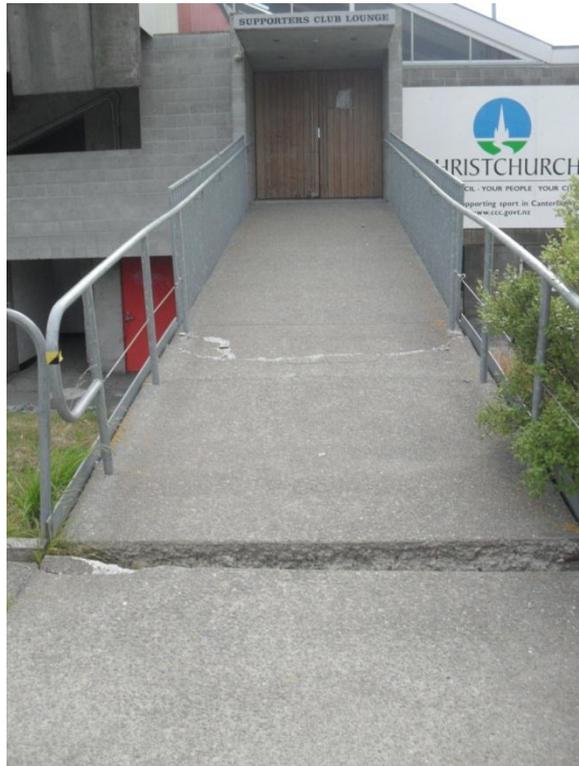
The ramp providing access to the southern side of the building has suffered damage as a result of the ground supporting the lower end of the ramp moving laterally during the earthquakes. Photograph 16 shows the ramp has moved approximately 300mm away from the path. The connection between the top of the ramp and the building has also been damaged as a result of the movement.

Photograph 16 Residual displacement of the access ramp south of the building.

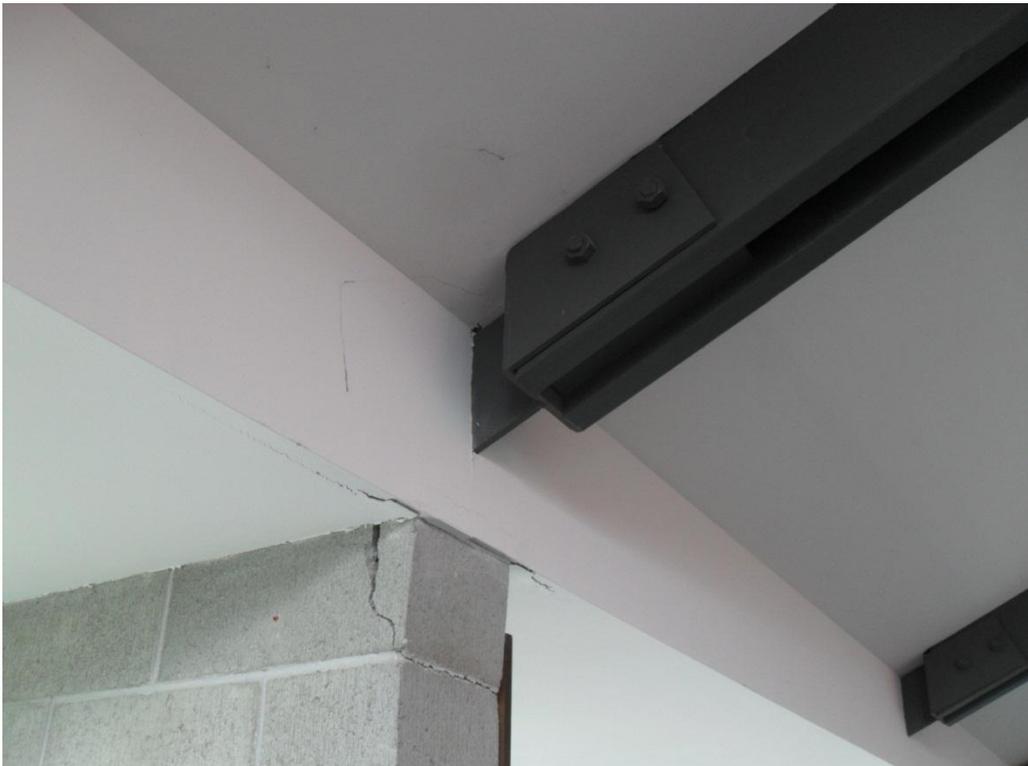
Damage was observed to a connection between the timber rafters and the concrete masonry wall in the 2nd storey area of the eastern half of the building. This is shown in Photograph 20. The damage has been caused by movement of the rafters away from the concrete masonry wall during earthquake shaking, causing the concrete masonry to fracture.

Photograph 20 Damaged connection between a concrete masonry wall and timber rafter.

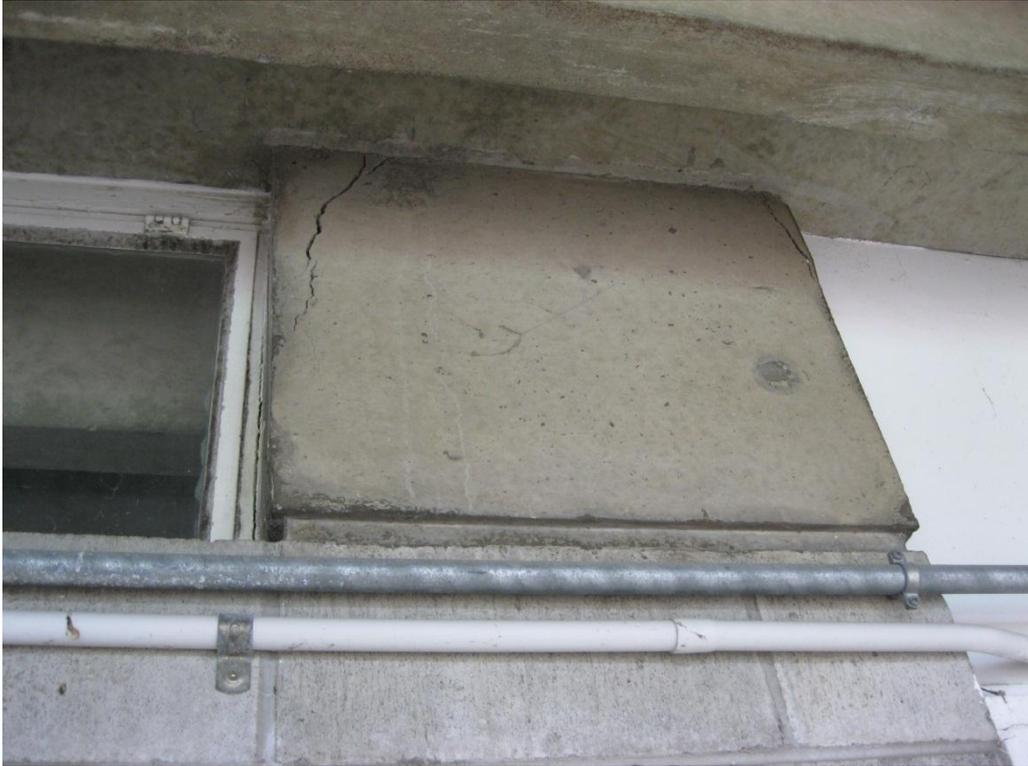
Minor cracking was observed in the precast concrete beams supporting the grandstand seating units on the western side of the building and in the beams supporting the double tee flooring units on the eastern side of the building. Photograph 21 shows an example of the cracking observed in the beams supporting the precast double tee units.

Photograph 21 Cracking in concrete beam supporting precast flooring units.

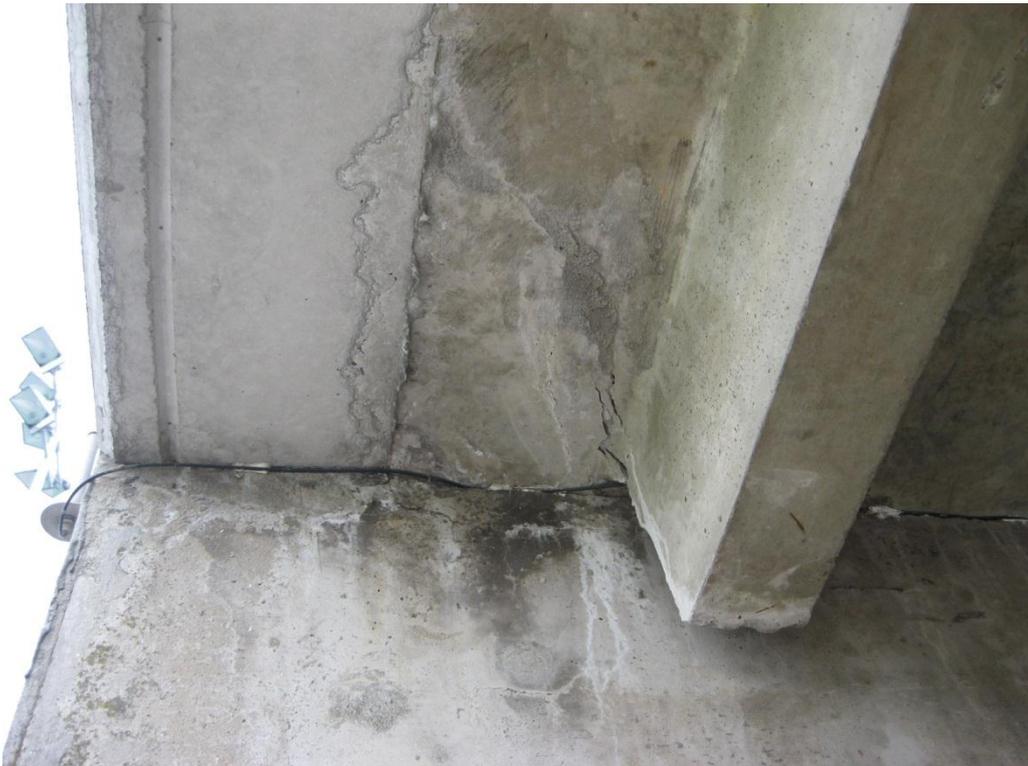
Minor cracking in the double tee precast flooring units was also noted in this area. The cracking in the double tees was generally located near the supporting beams (see Photograph 22).

Photograph 22 Cracking in precast double tee flooring unit near supporting beam.

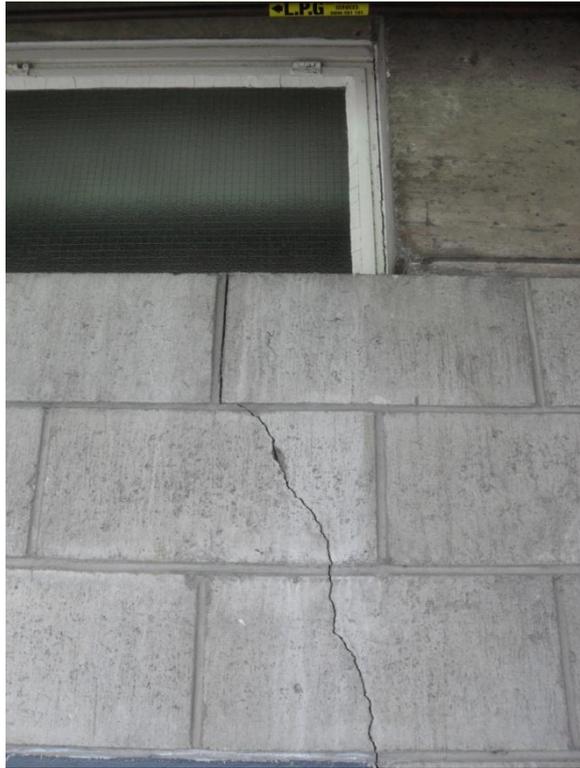
Photograph 23 Cracking in concrete masonry wall on eastern side of the building.

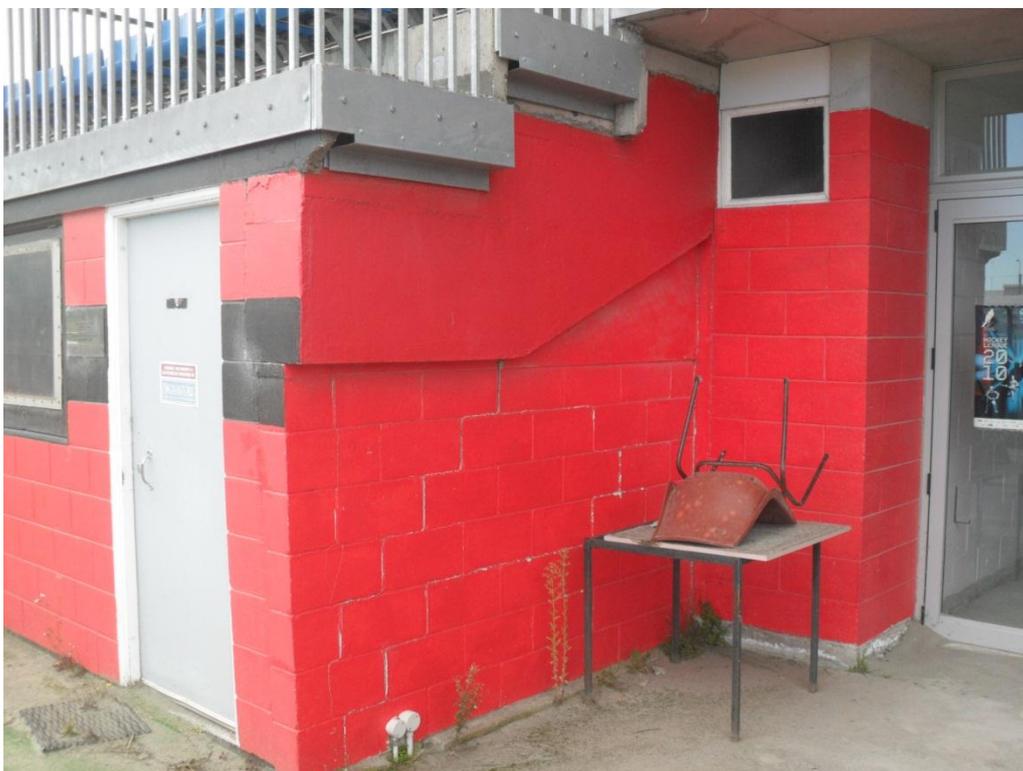
Photograph 24 Cracking in concrete masonry wall on western side of the building.

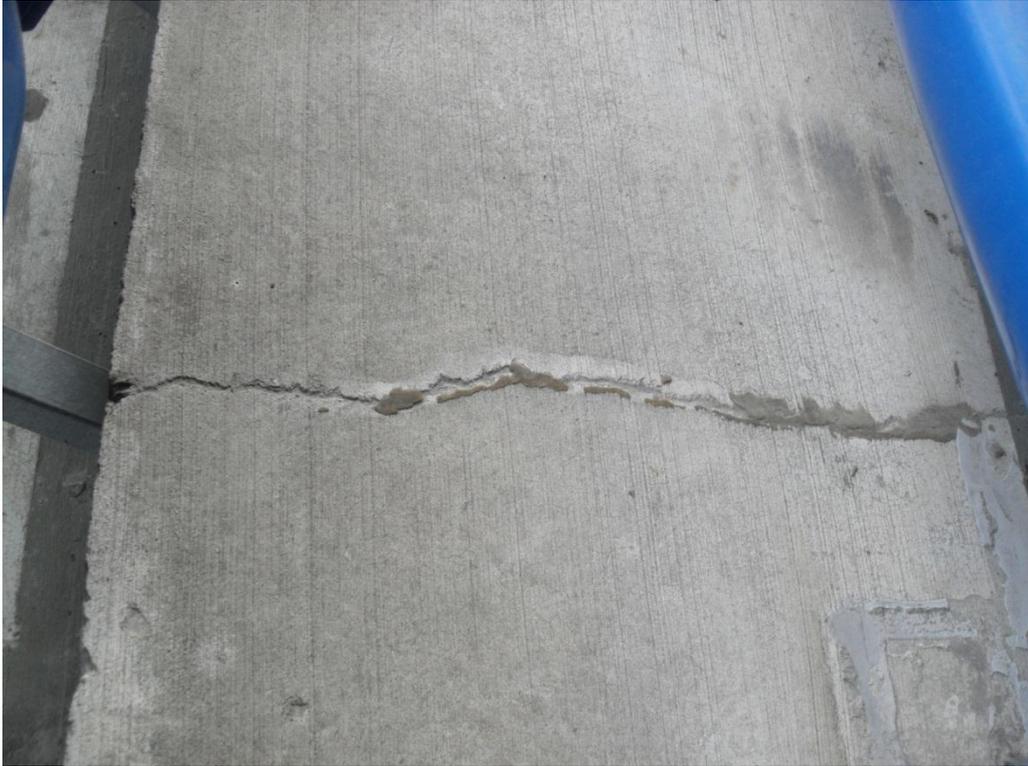
Cracking in the precast concrete seating units was observed approximately along the lines of the supporting precast beams (see Photograph 25). A large number of these cracks had been filled suggesting that they may have occurred in the September earthquake and had been repaired.

Photograph 25 Cracking in precast concrete seating units.
