Porritt Park Garage
BU 0706-003 EQ2
Detailed Engineering Evaluation
Qualitative Report
Version FINAL

845 Avonside Drive, Wainoni

Christchurch City Council

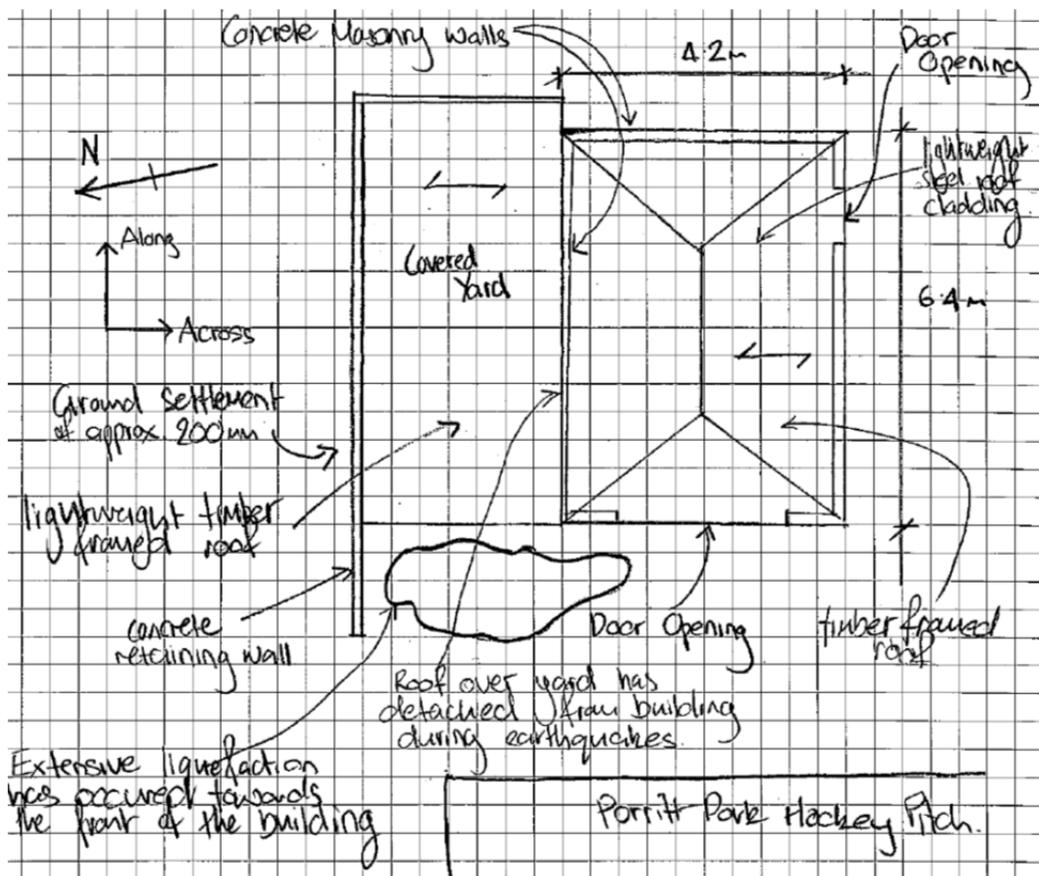
Figure 2 Plan sketch showing key structural elements

Key structural details of the building are shown in Figure 2 below.

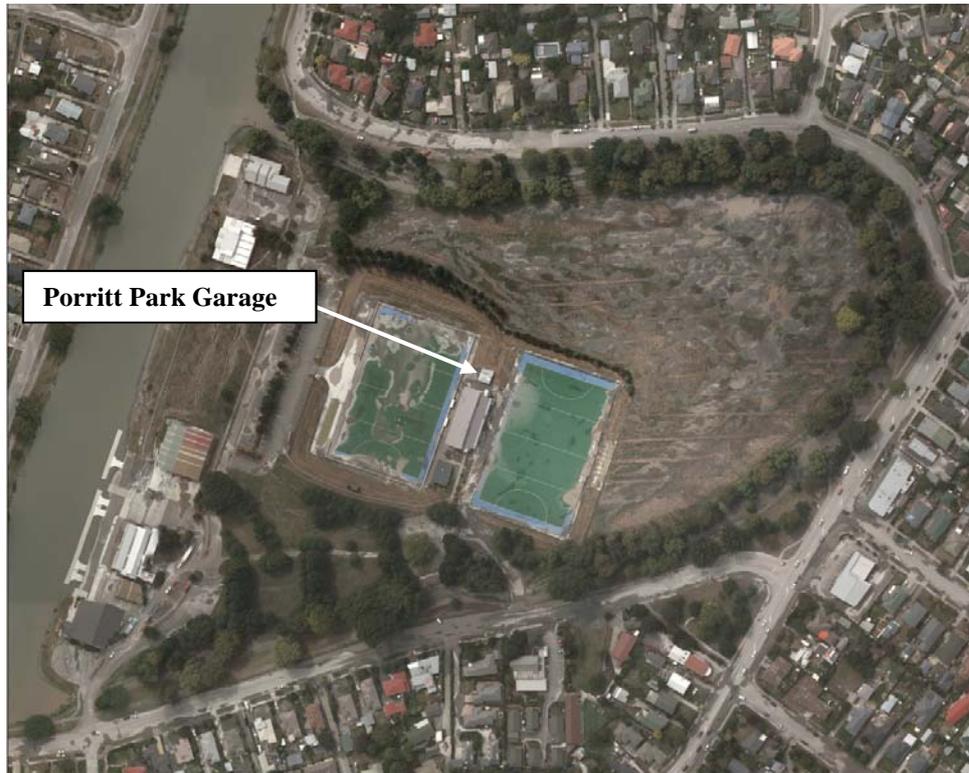
Figure 3 Post February 2011 Earthquake Aerial Photography ³

Aerial photography taken following the 22 February 2011 earthquake shows signs of major liquefaction (including lateral spreading) across the site, and throughout surrounding streets, as shown in Figure 3. Significant liquefaction-induced damage is also evident across the hockey turf surfaces.

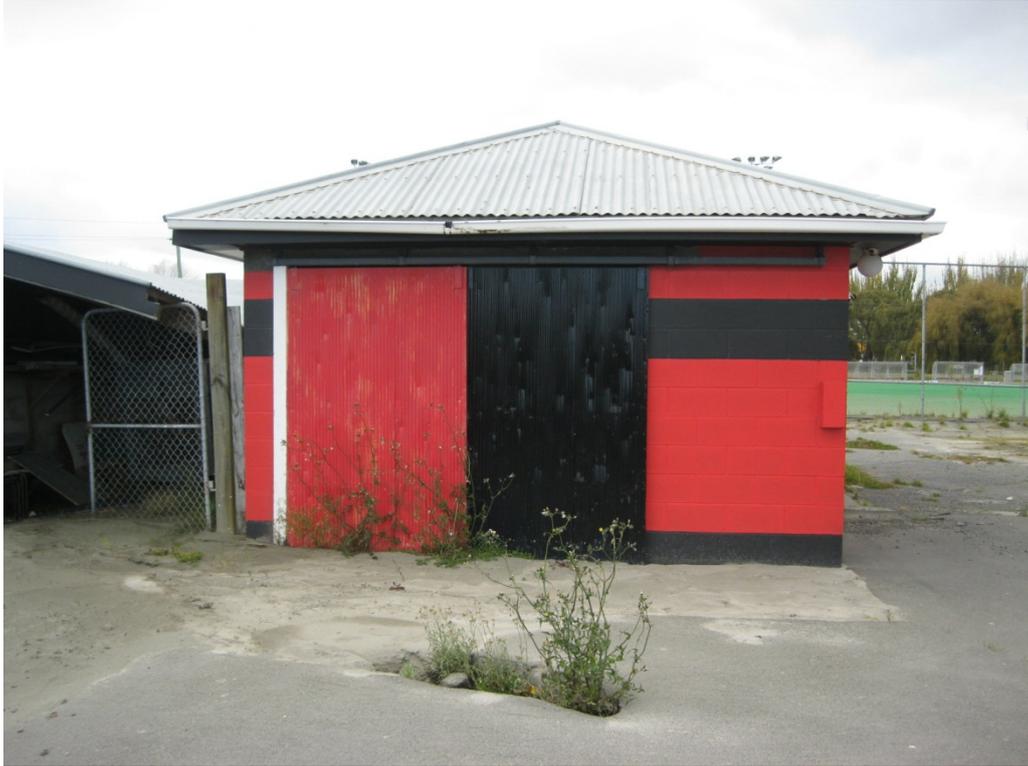
Photograph 1 North-western face of the building with door opening.

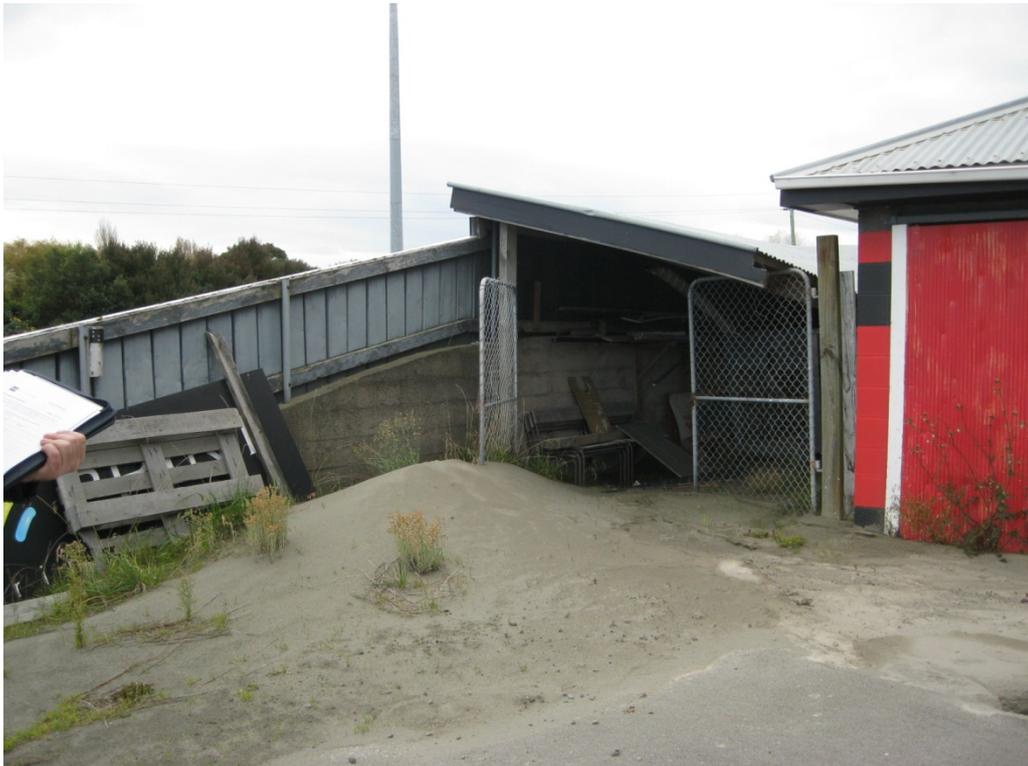
Ground damage in the form of liquefaction is widespread over the site. Significant amounts of sand and silt have been ejected in the areas around the building, particularly to the west of the building between the building and the hockey pitch. Severe ground cracks and lateral spreading were observed near the river approximately 200m south of the Garage. Settlement of the ground is evident in this area of the site. The ground behind the retaining wall approximately 4m to the north of the building has settled approximately 200mm.

Photograph 2 Sand and silt from liquefaction piled outside the building and adjacent covered yard with concrete retaining wall.

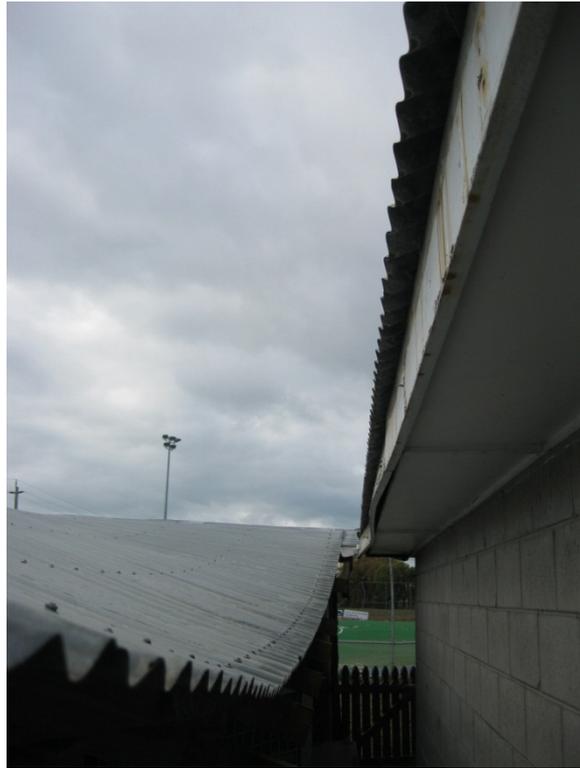
The lightweight timber framed roof over the yard adjacent to the building has detached from the north-western face of the building during the earthquakes. No other structural damage was observed during our inspection. It should be noted that the interior of the building was unable to be inspected.

The recent seismic activity in Christchurch has caused some structural damage to the building. The lightweight roof over the yard adjacent to the concrete masonry building has detached during the recent seismic activity.

Photograph 3 Detached lightweight roof over yard.

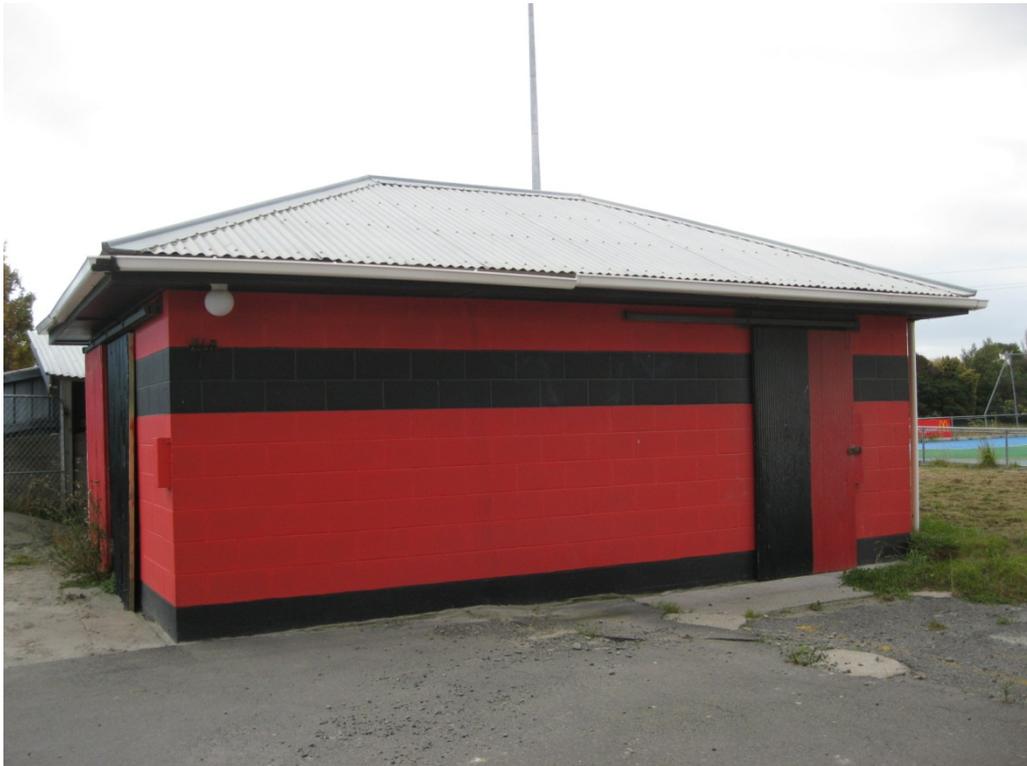
Photograph 4 South-western face of the building.

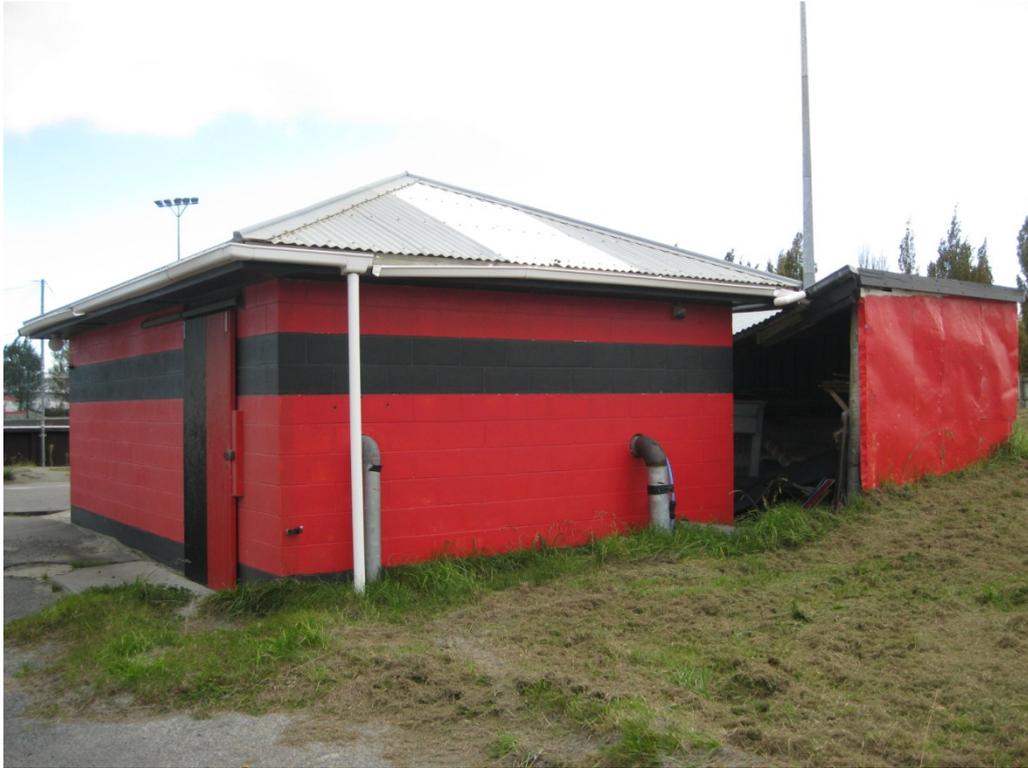
Photograph 5 South-eastern face of the building.

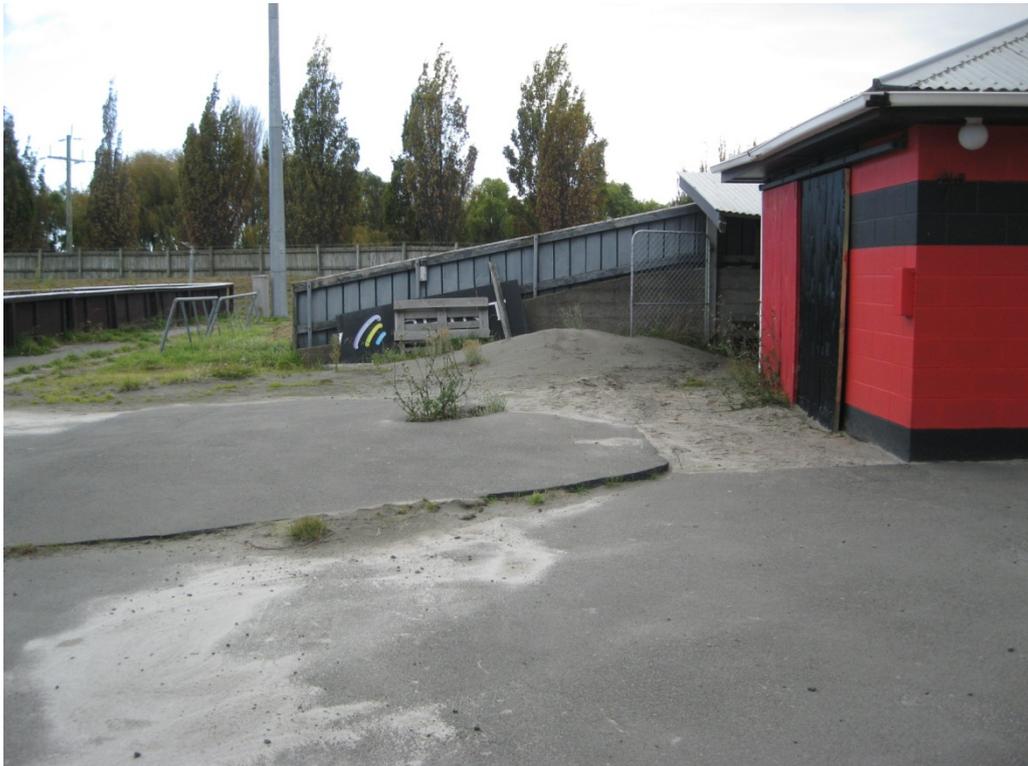
Significant ground damage was observed throughout the Porritt Park site during our inspections. Severe ground cracks and lateral spreading were observed near the river approximately 200m south of the Garage. Extensive liquefaction and ground settlement was observed throughout the site. Significant amounts of sand and silt were still present on the ground throughout the site.

Photograph 6 Ground damage outside the front of the building.

Given the land damage observed, we recommend a series of location specific geotechnical assessments, including testing and investigation, be completed.

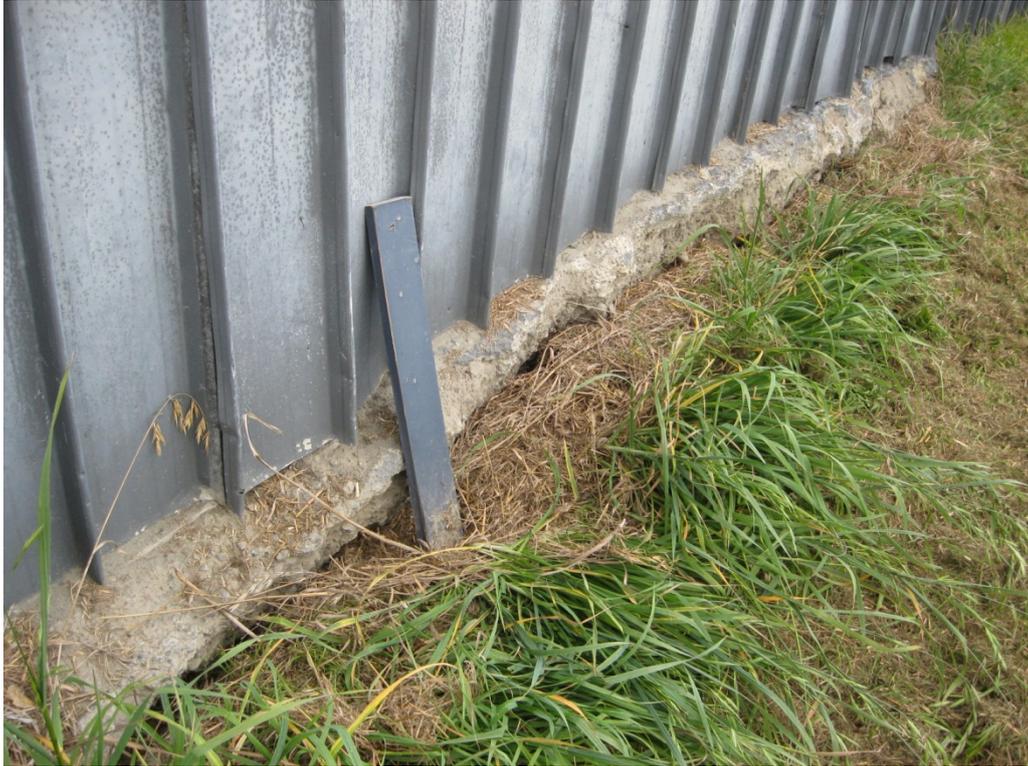
Photograph 7 Settlement of the retained ground to the north of the building.

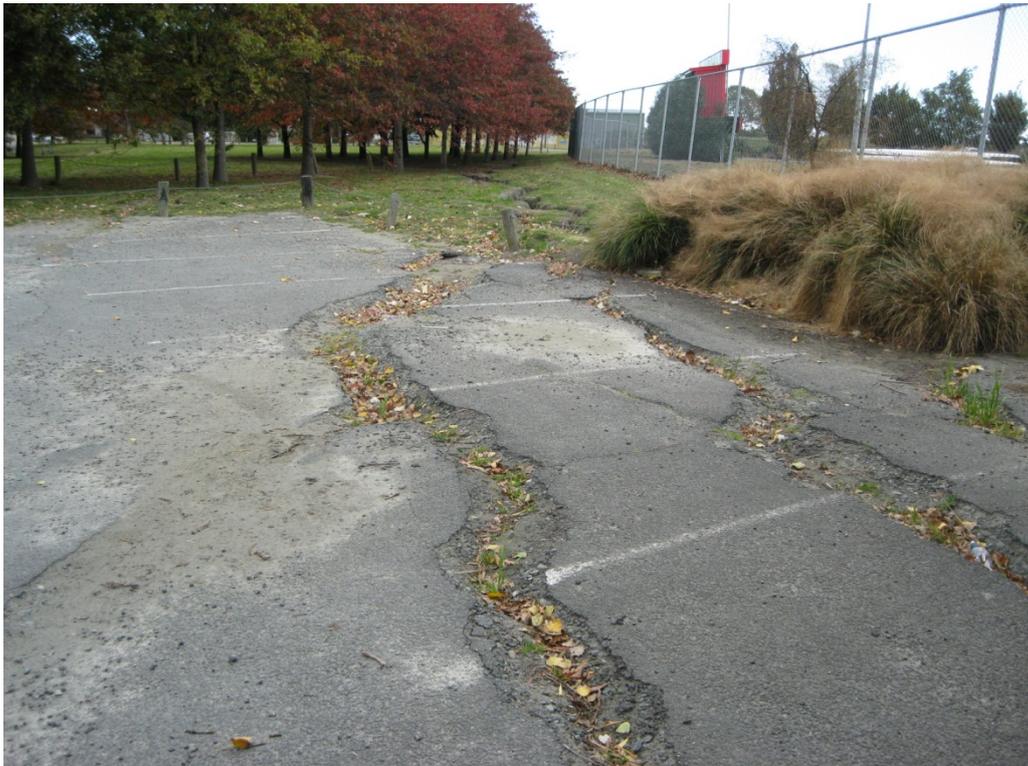
Photograph 8 Ground cracks near the river to the south of the garage.
