Rawhiti Golf Course Implement
Shed
Qualitative Engineering Evaluation

Functional Location ID: BU 1316 002 EQ2

Address: 104 Shaw Avenue

Date: 12 December 2012

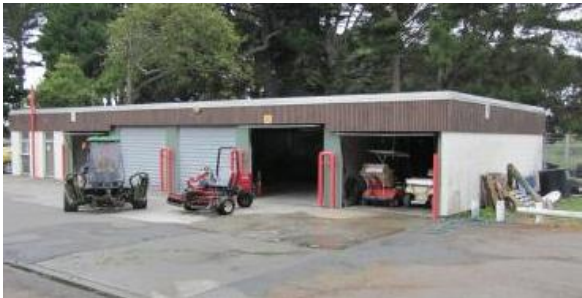
<p>East elevation of the Rawhiti Golf Course Implement Shed.</p>

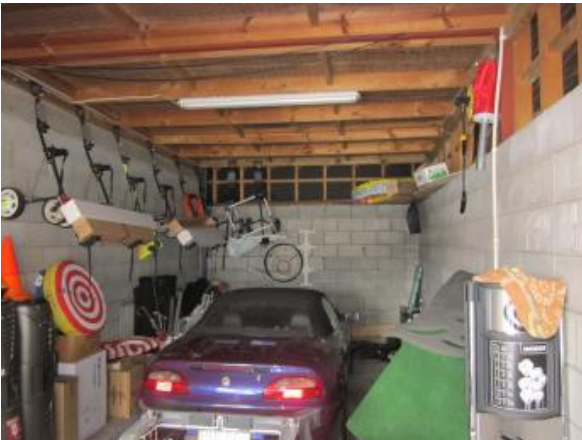
On inspection of the joint between the main structure and the external compartment (as shown in appendix A) cracks have formed.

The cracks that formed between the joint between the main building and the external compartment are most likely due to the differential movement of the two structures. The damage is minor and in our opinion does not affect the integrity of the building. These cracks do not affect the ability of the structure to resist gravity and lateral loads. The cracks in the masonry walls are also very minor and do not prevent the building from resisting loads effectively. Walls were checked acoustically by tapping and it was found that all cells were filled.

<p>Beam/Masonry wall connection (no visible damage on initial inspection)</p>	 
<p>External compartment for the sand (small cracks occurring at join with main building)</p>	 
<p>Small cracks occurring in corner of external compartment</p>	 
<p>Timber purlins (no visible damage)</p>
