Rawhiti Golf Course Implement  
Shed  
Qualitative Engineering Evaluation

Reference: 227996  
Prepared for:  
Christchurch City Council

Functional Location ID: BU 1316 002 EQ2  
Address: 104 Shaw Avenue

Revision: 2  
Date: 12 December 2012

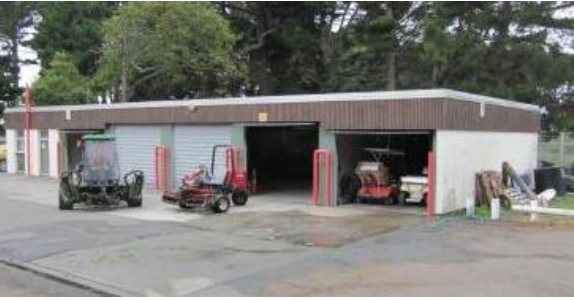
<p>East elevation of the Rawhiti Golf Course Implement Shed.</p>

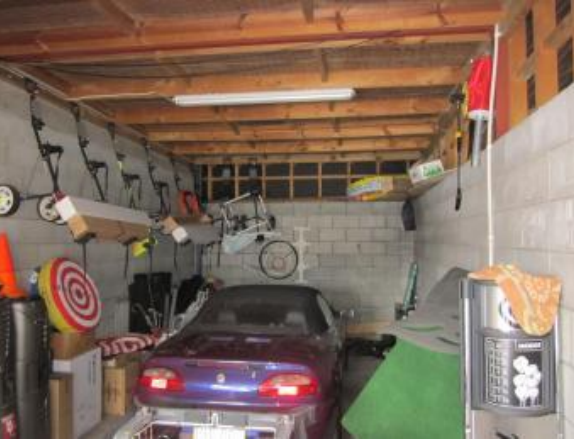
On inspection of the joint between the main structure and the external compartment (as shown in appendix A) cracks have formed.

The cracks that formed between the joint between the main building and the external compartment are most likely due to the differential movement of the two structures. The damage is minor and in our opinion does not affect the integrity of the building. These cracks do not affect the ability of the structure to resist gravity and lateral loads. The cracks in the masonry walls are also very minor and do not prevent the building from resisting loads effectively. Walls were checked acoustically by tapping and it was found that all cells were filled.

<p>Beam/Masonry wall connection (no visible damage on initial inspection)</p>	 
<p>External compartment for the sand (small cracks occurring at join with main building)</p>	 
<p>Small cracks occurring in corner of external compartment</p>	 
<p>Timber purlins (no visible damage)</p>
