Redcliffs Park Toilets PRK 1400 BLDG 003

Detailed Engineering Evaluation

Quantitative Assessment Report

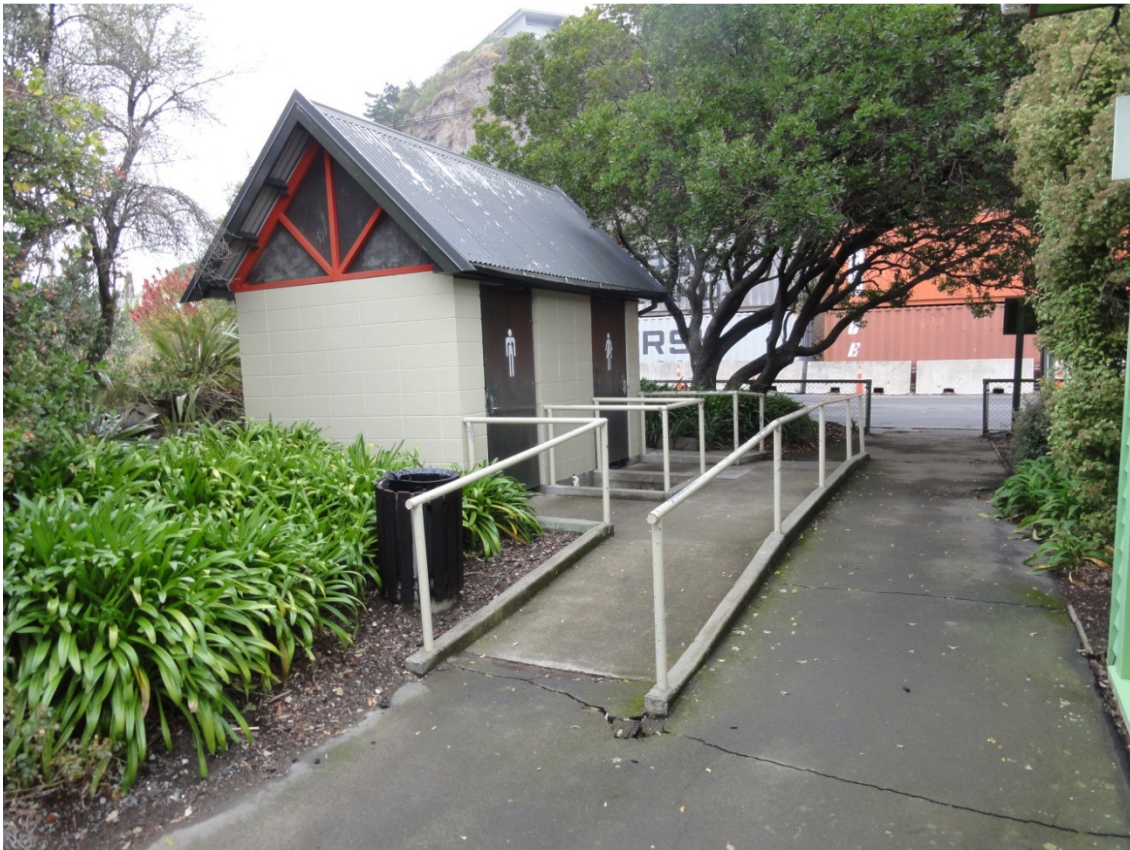
The toilet block appears to be founded on a shallow concrete pad of unknown depth. The existing foundations appear to have performed relatively well, but visual observations suggest that the building has differentially settled towards the south.

Figure 1: North eastern view of the Redcliffs Park Toilet Block.

- A level survey is undertaken to confirm the differential settlement that has been observed.
- The current foundation are accepted, based on the provision that the Structural Engineers can confirm that the toilet block has the capacity for further differential settlement, and CCC accepts that future differential settlement and damage to services may occur at this site.

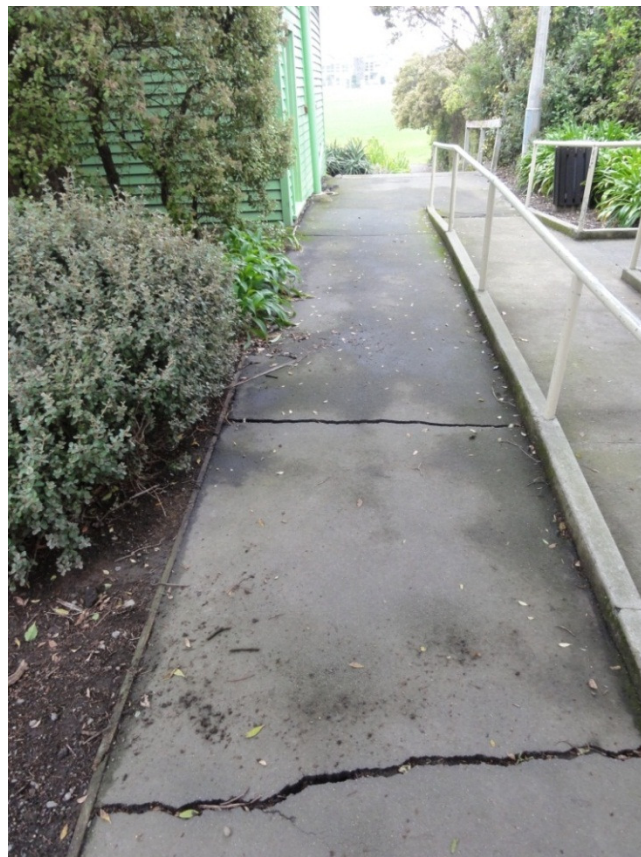
Seismic shaking is the most likely cause of the 25mm to 30mm wide cracking in the footpath directly north of the toilet block. No settlement of the footpath was observed.

Figure 2: 20mm to 30mm wide cracking of the paved footpath north of the building

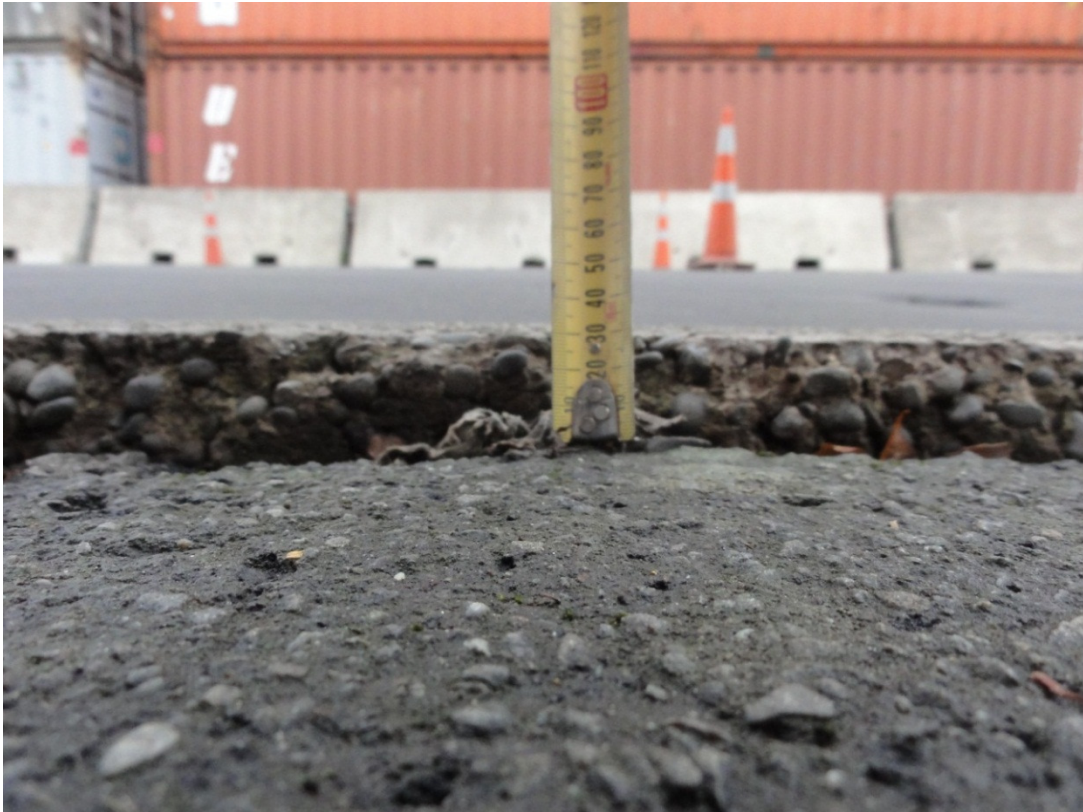
Figure 3: Main Road footpath has settled 30mm relative to the kerb.

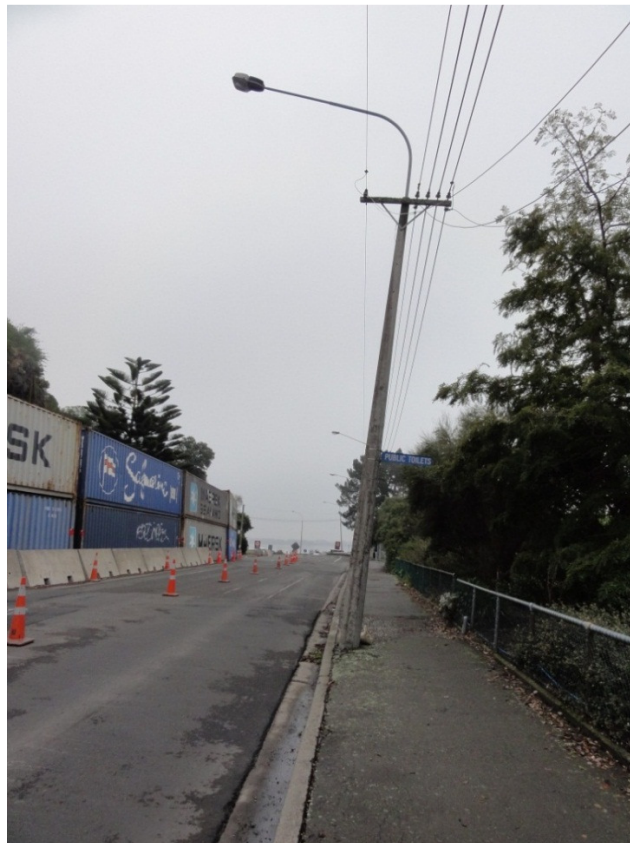
Figure 4: Street Lights along Main Road lean towards the east.

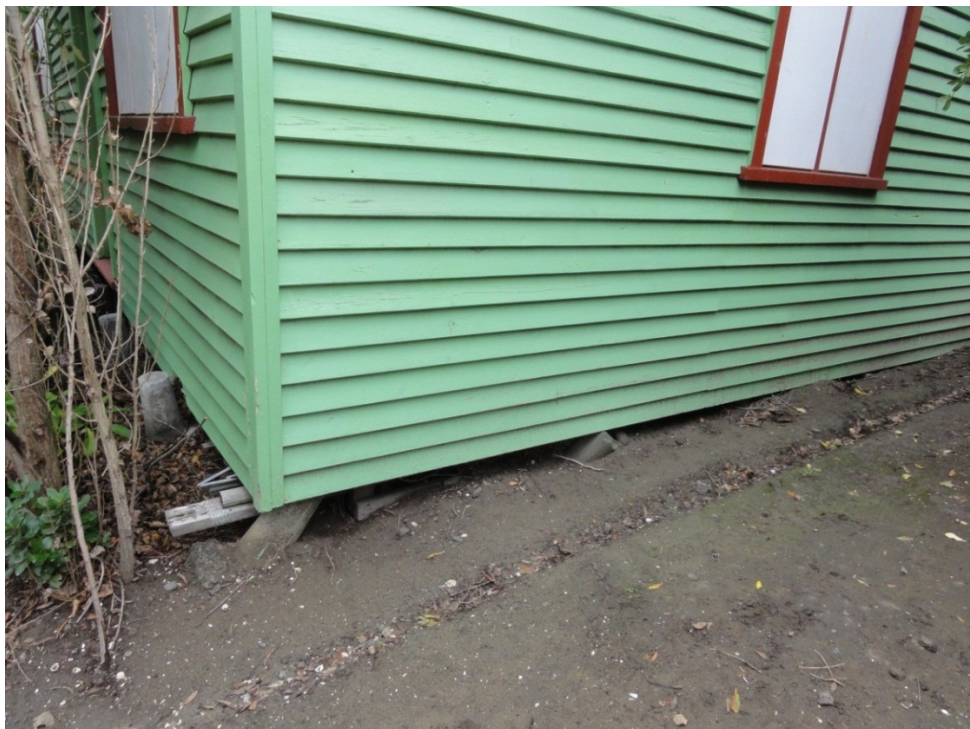
- The residential house 5m to the south east has suffered significant damage to the exterior masonry facade.
- The neighbouring building located 4m north of the toilet block appears to have been laterally offset off its piles by approximately 100mm. The piles located on the north of the building have rested in a horizontal position (Figure 6).

Figure 6: Foundation damage to the neighbouring building towards the north.
