Project: Redwood Library

Qualitative Engineering Evaluation

Project: 227998

1 July 2013

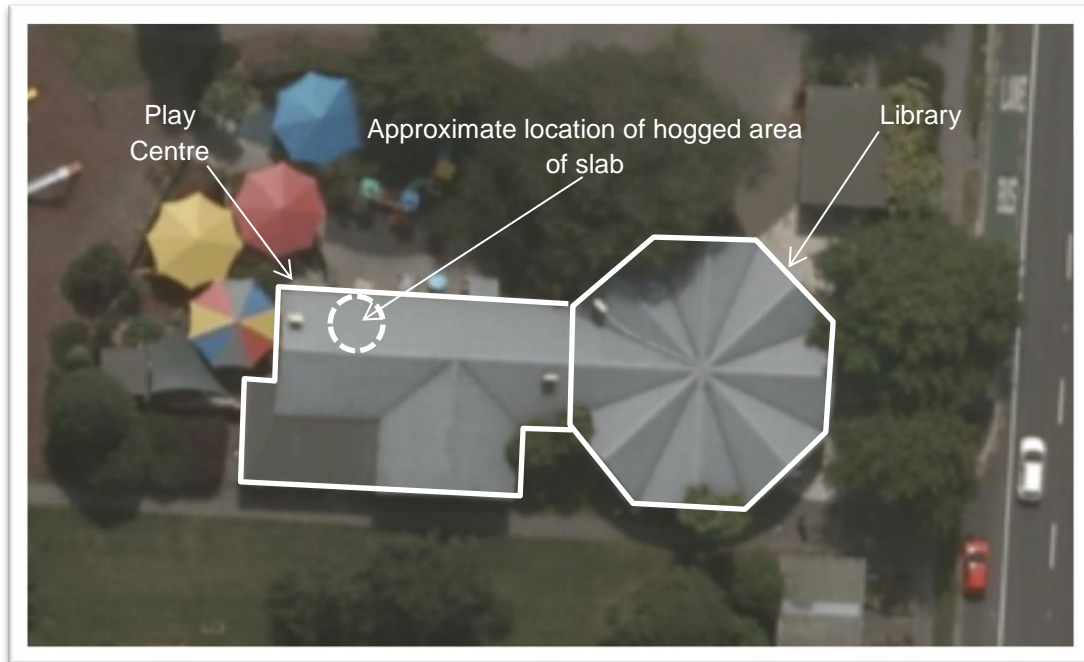
Aerial Photo Taken Post February 22

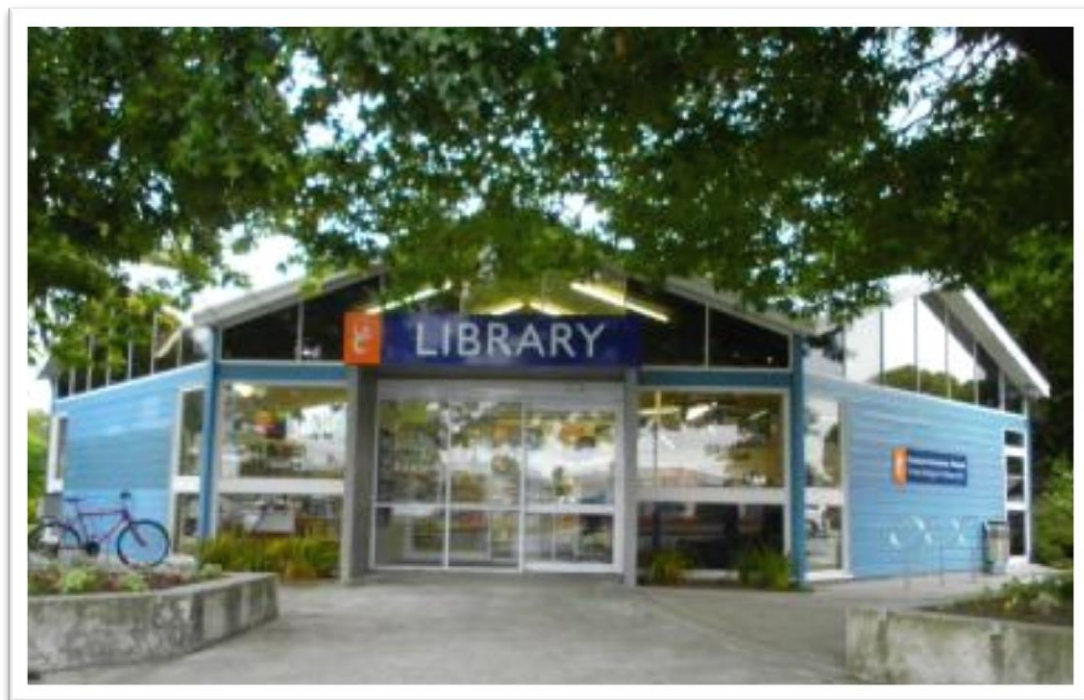
Library East Elevation

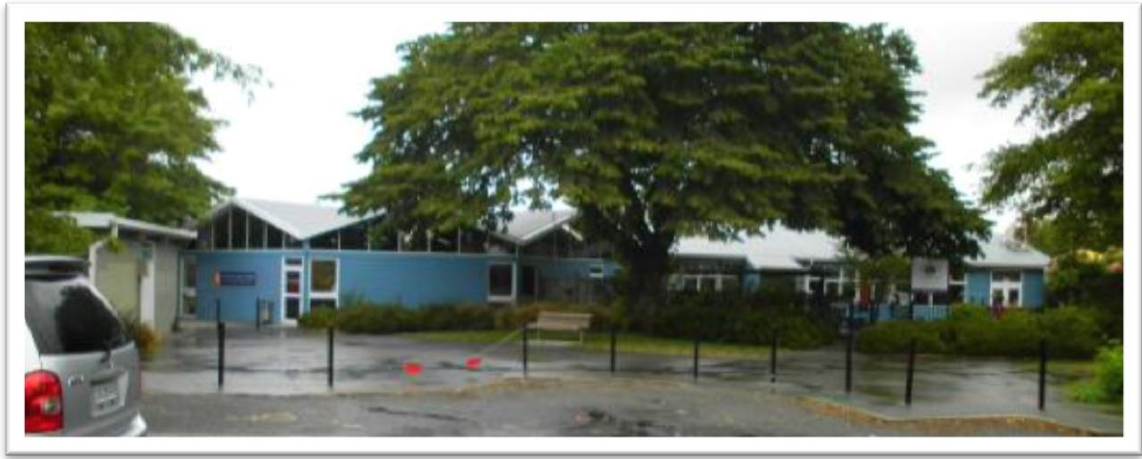
Building North Elevation

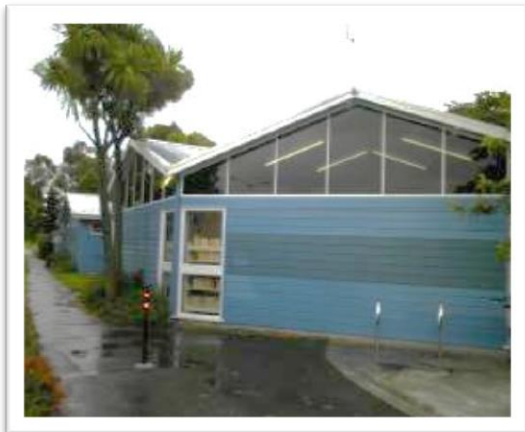
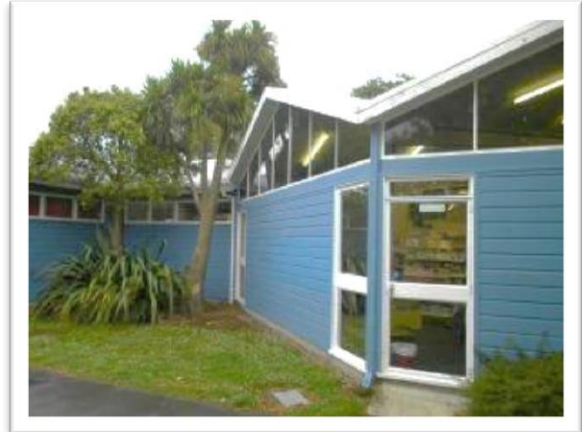
South/East Elevation

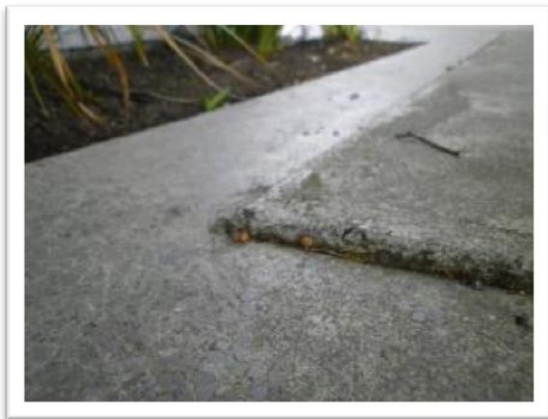
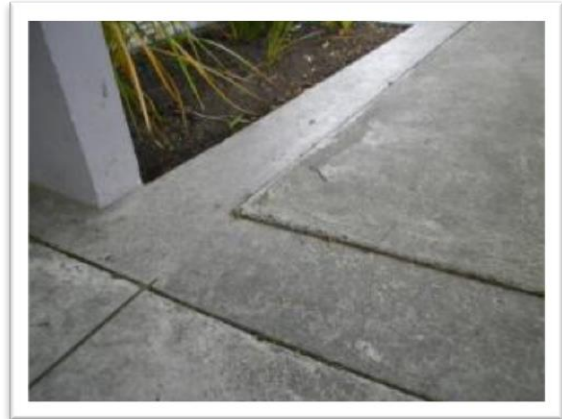
Uneven Concrete slab outside entrance to library

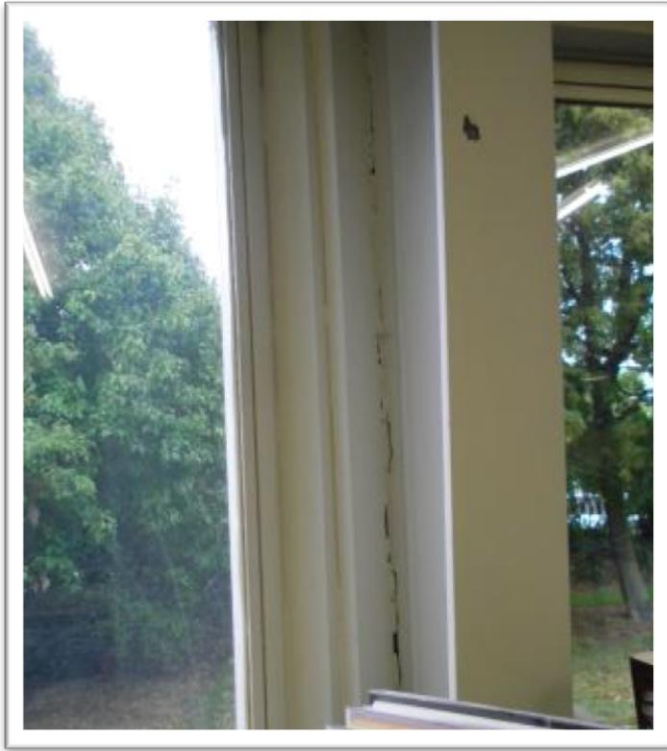
The exposed steel structure in the library allowed visual inspection without any intrusive investigation. Relatively minor cracks were identified in the joints between wall linings and the steel columns. The floors of the library were covered with carpet; however no evidence of distortion in the library floor was noted.

Cracking between window frame and steel column

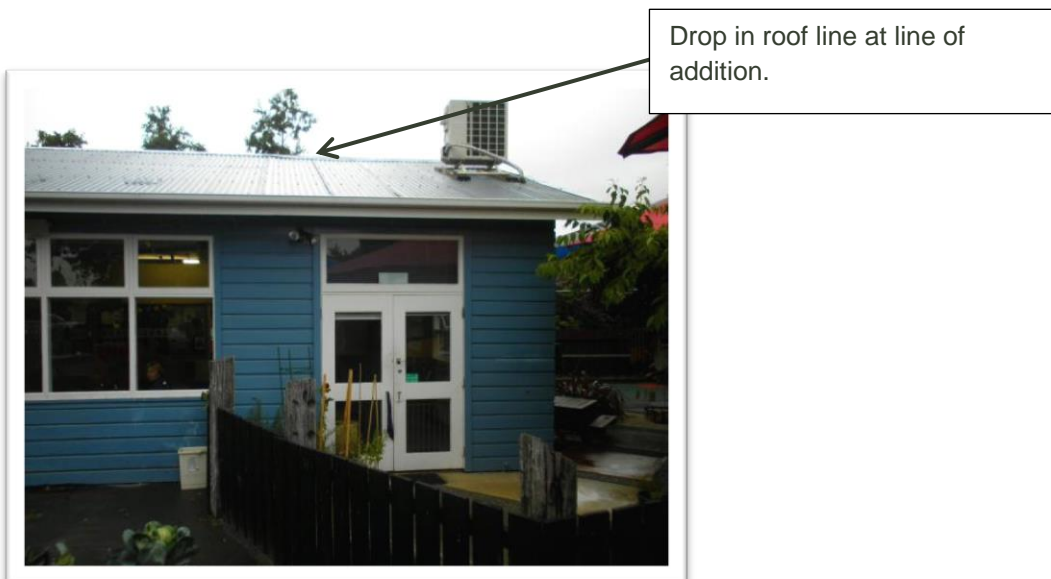
Play Centre North elevation – Note drop in roof line where new section added (this is in line with the distortion in the floor of the play centre)

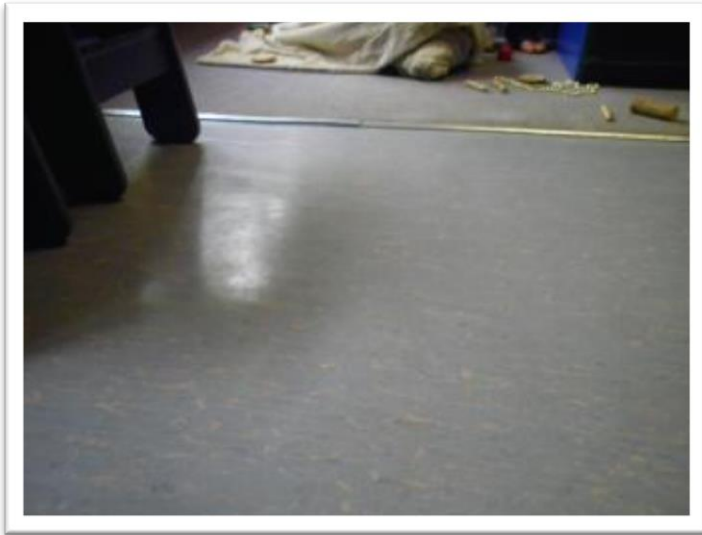
The structural members in the play centre were also covered by linings. The inspection of the linings covering the walls and ceilings showed little evidence of damage. At the west end of the Early Childhood Centre there is evidence of minor internal slab hogging. There is also evidence of ground movement on the exterior playground. The centre manager noted that play-ground coverings had been replaced due to the extent of the ground movement in that area.

Very little significant damage was observed in the Redwood Library. In the Early Childhood Centre slight hogging to a small area of internal floor slab was noted. A levels survey was done to investigate local movement in this area and to survey for possible evidence of other local movement or any possible global level differences. The level survey showed that level variation was within acceptable limits.

Nursery floor where distortion in lino is observed (appeared after earthquake)

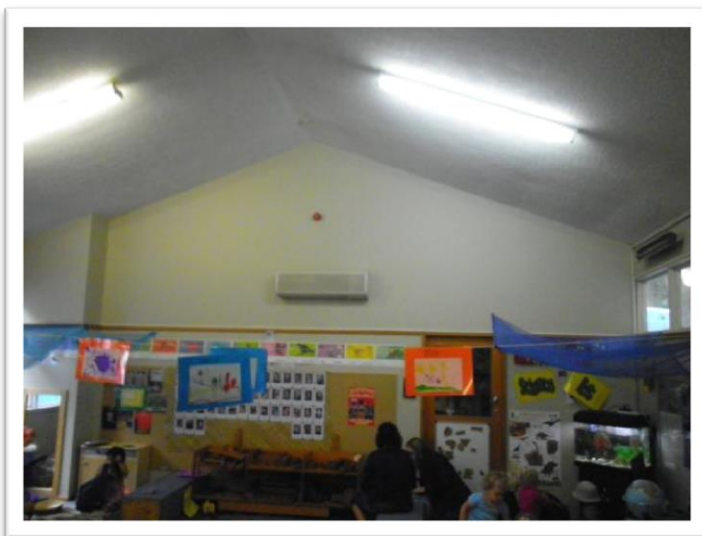
High ceiling in play centre (no visible damage)

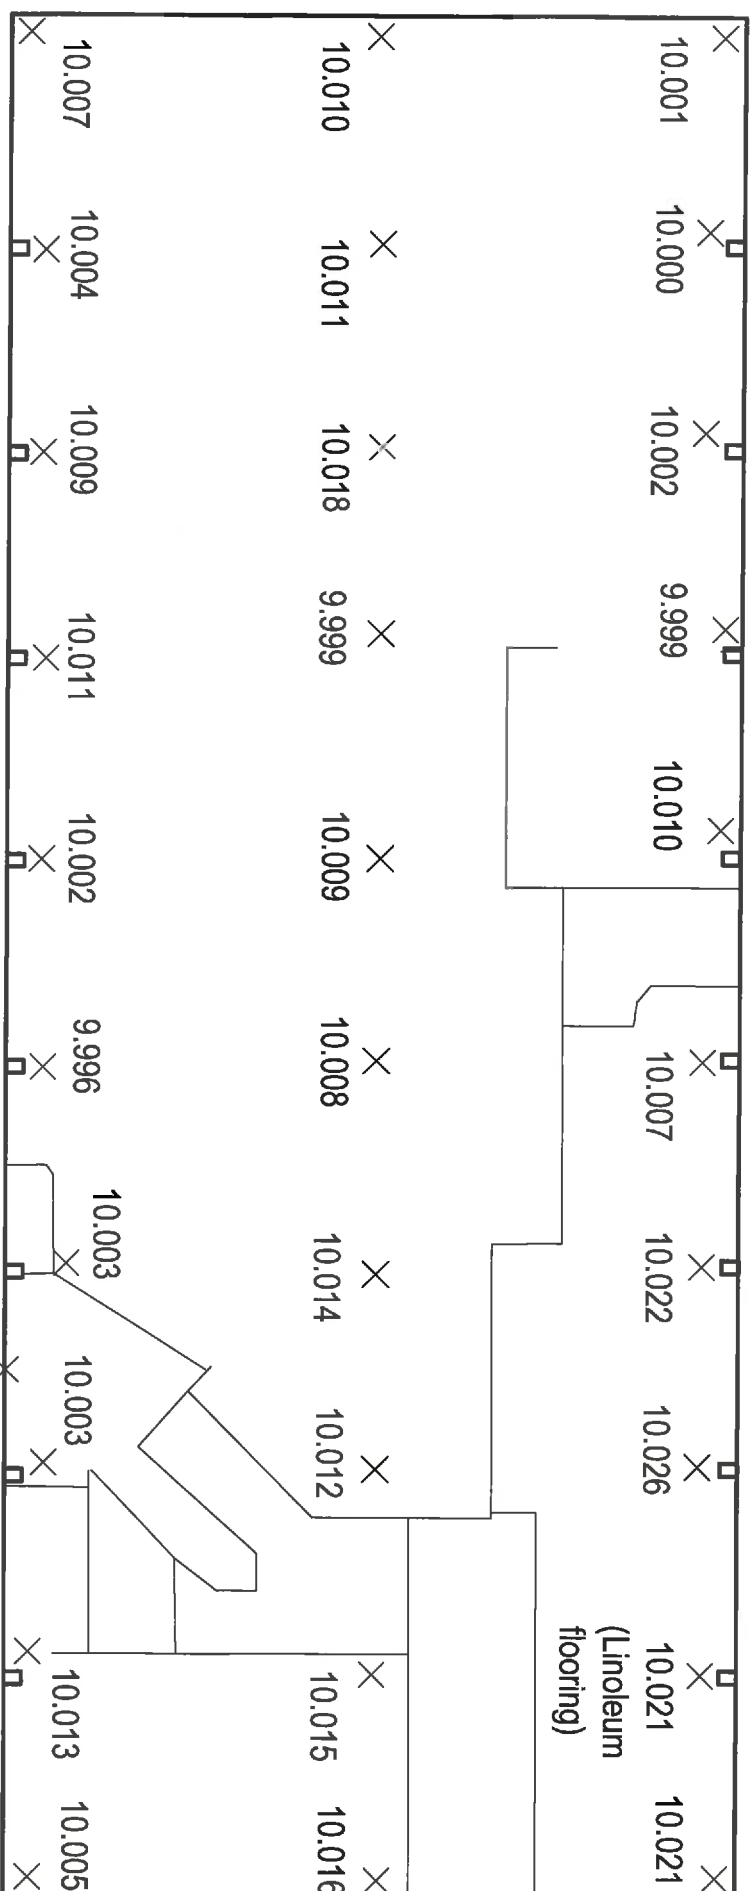
PROJECT	TITLE
Shirley Library Marshland Road	Floor Level Survey

The land below the Redwood Library is zoned TC2 yellow and as such has been identified as potentially subject to liquefaction and settlement. Additionally there is a small amount of local evidence of settlement and liquefaction in the surrounding land. A levels survey was carried out within Redwood Library to determine the extent of any differential settlement. The differential settlement was found to be within acceptable limits.
