Christchurch City Council

Reg Stillwell Place PRO 1320

**Detailed Engineering Evaluation
Quantitative Assessment Report**

189 Palmers Road, New Brighton

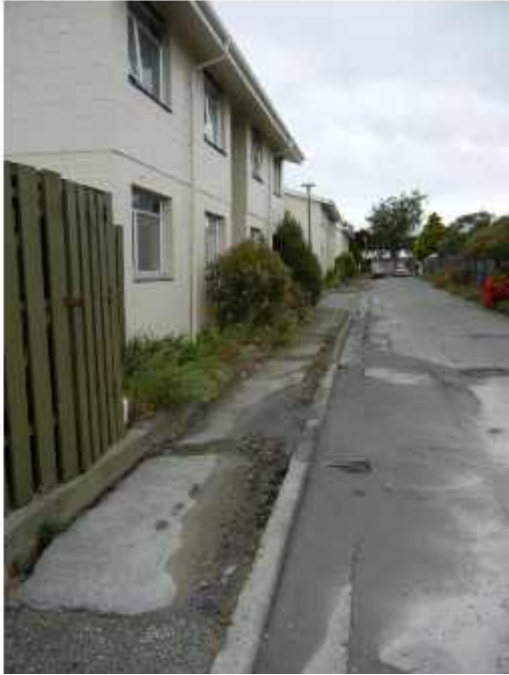
2.	South elevation of Block A. Note the ejecta due to liquefaction at the pavement

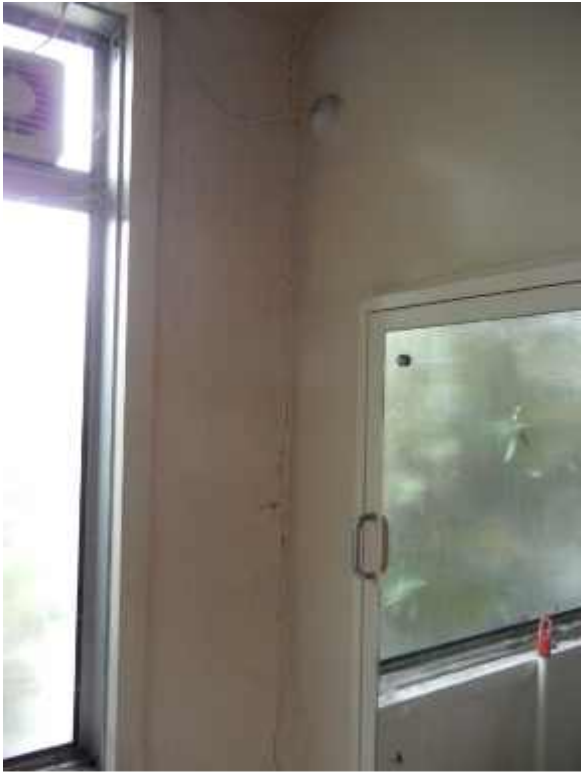
3.	Crack in gib board wall at unit 3

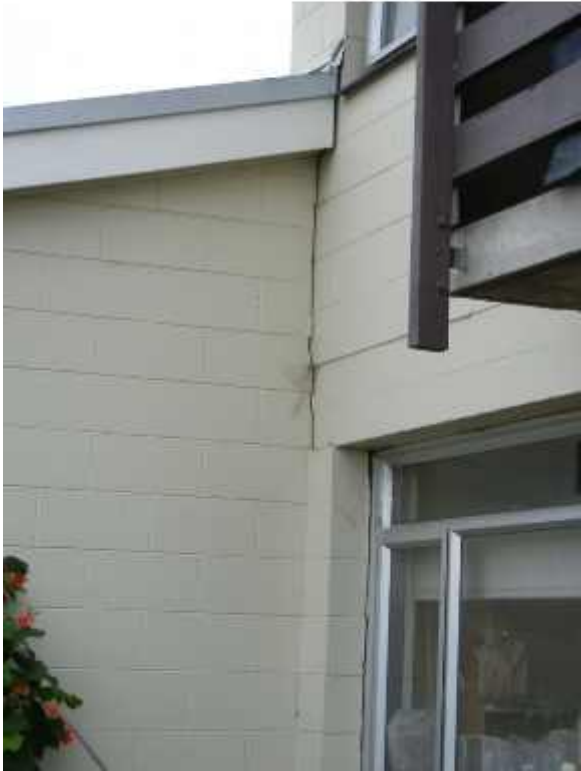
4.	Separation between the 2-storey portion and the 1-storey portion

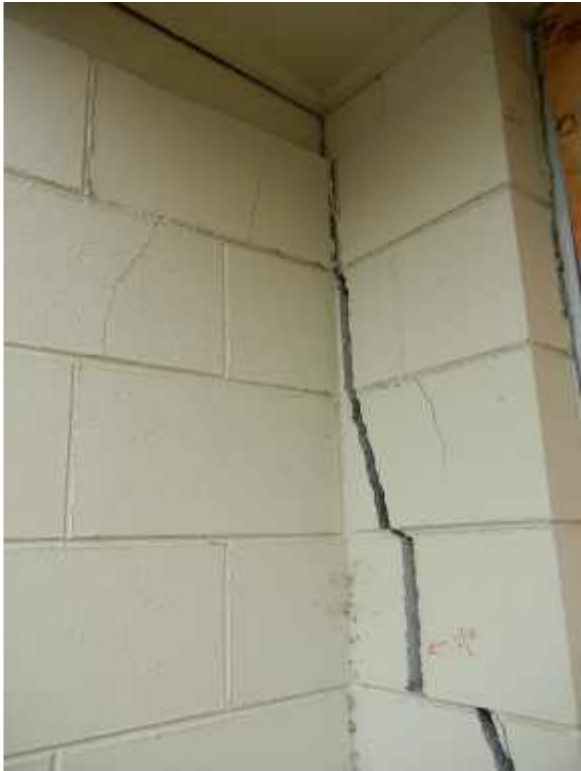
- a) Severe cracking of exterior concrete block veneer. Damage is most severe outside of unit 5.
- b) Cracking of interior lining.
- c) Noticeable settlement and rotation of the building.
- d) Cracking of the sides of concrete ground beam.

5.	Severe cracking in block veneer outside of Unit 5

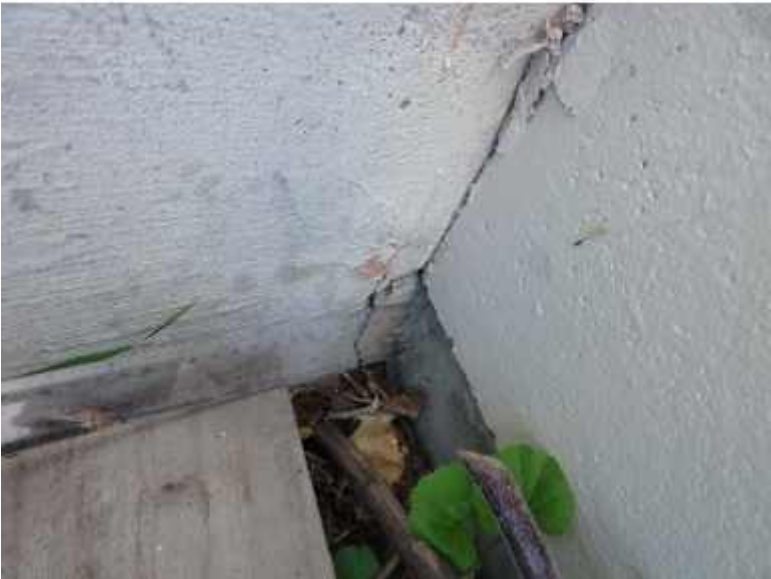
6.	Vertical crack at sides of concrete ground beam

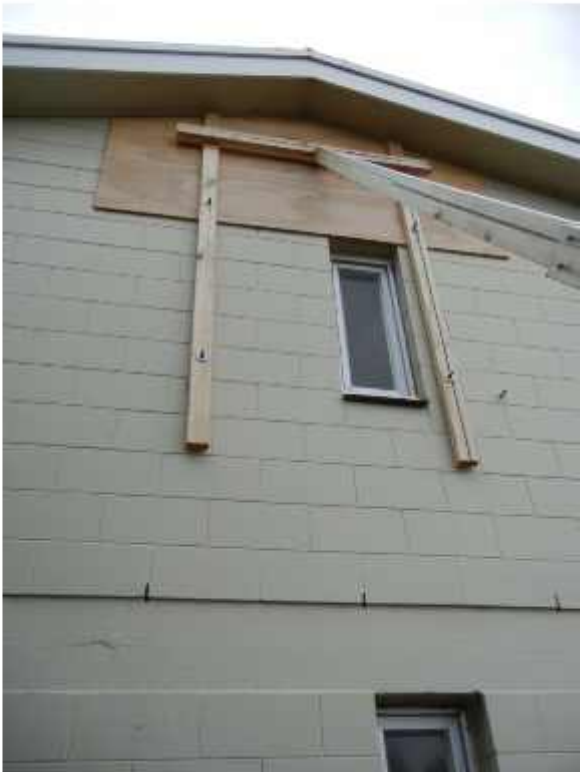
8.	Temporary bracing for exterior block veneer at gables

We recommended barricades to be set up or veneer be braced to protect pedestrians from falling hazards.

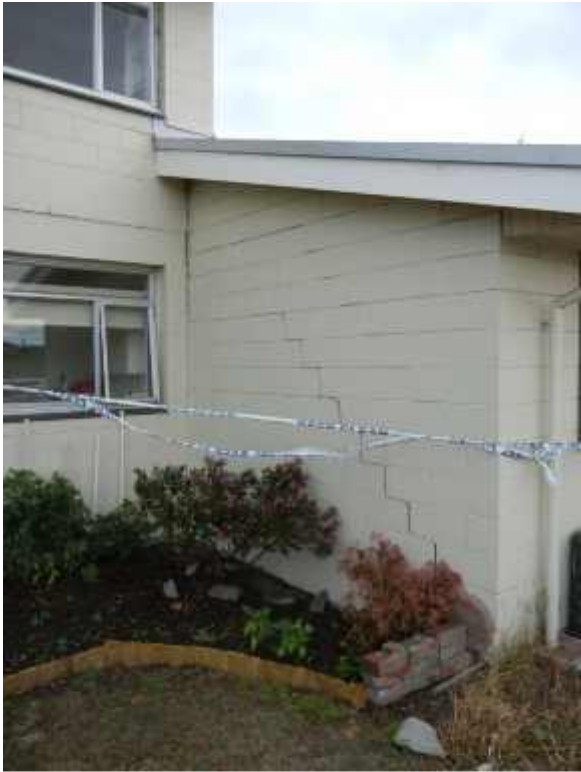
9.	Step cracking at veneer of single-storey portion. Veneer is leaning toward the interior of the unit

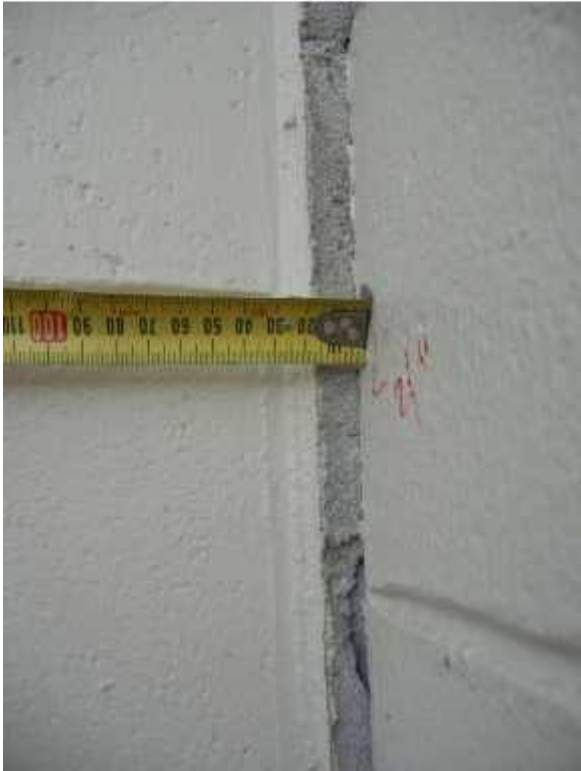
10.	Vertical crack and out-of-plane offset in block veneer

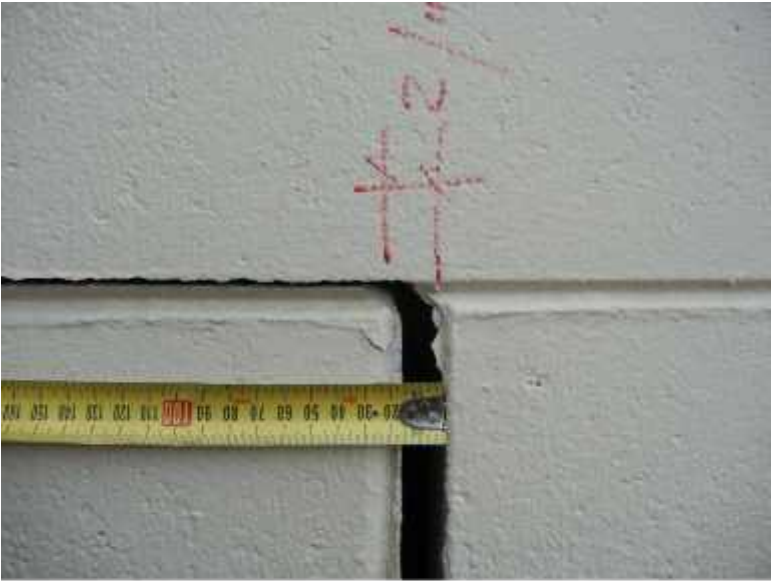
11.	15mm crack at veneer joints

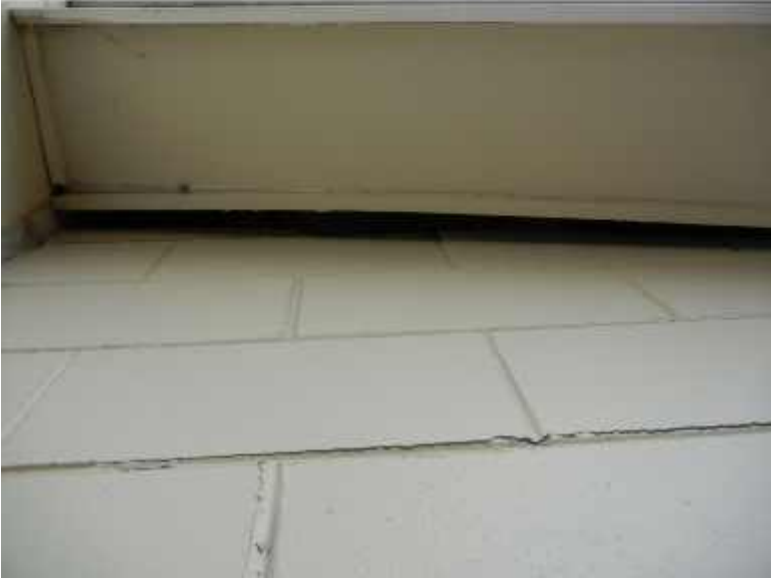
12.	Veneer leaning toward the interior of single story unit as evident in gap between soffit and face of veneer

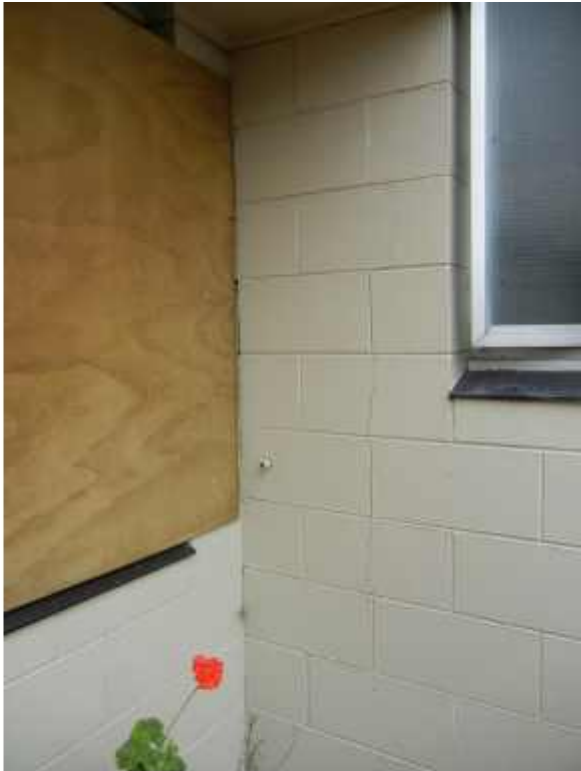
13.	Vertical crack of block veneer

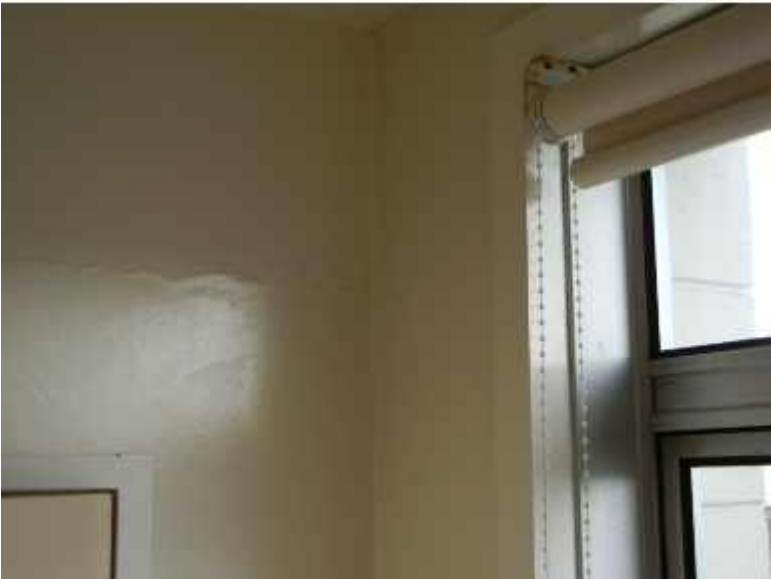
14.	Horizontal cracking in exterior blockwall propagates through into interior lining

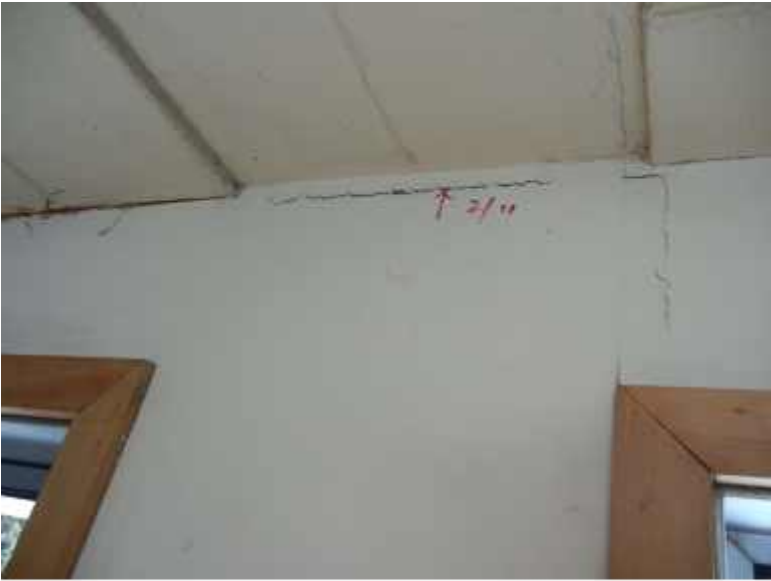
15.	Horizontal crack at top of lining

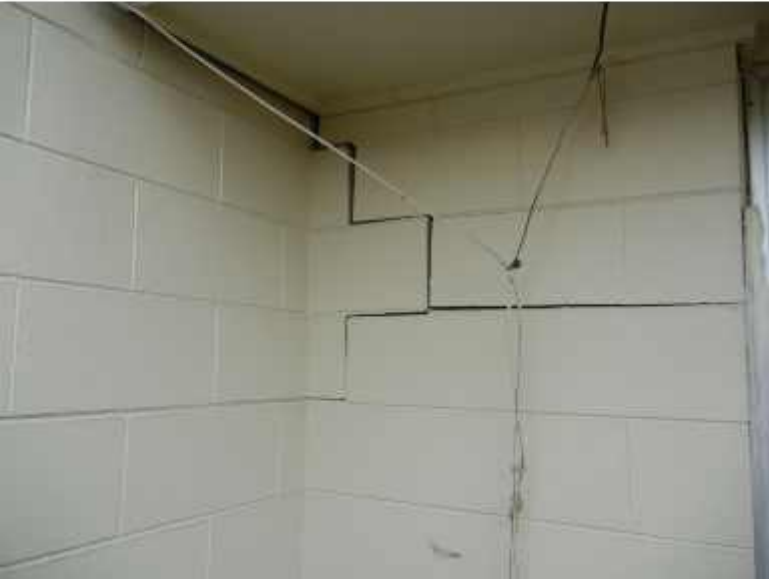
18.	Severe step cracking of block veneer at Unit 18

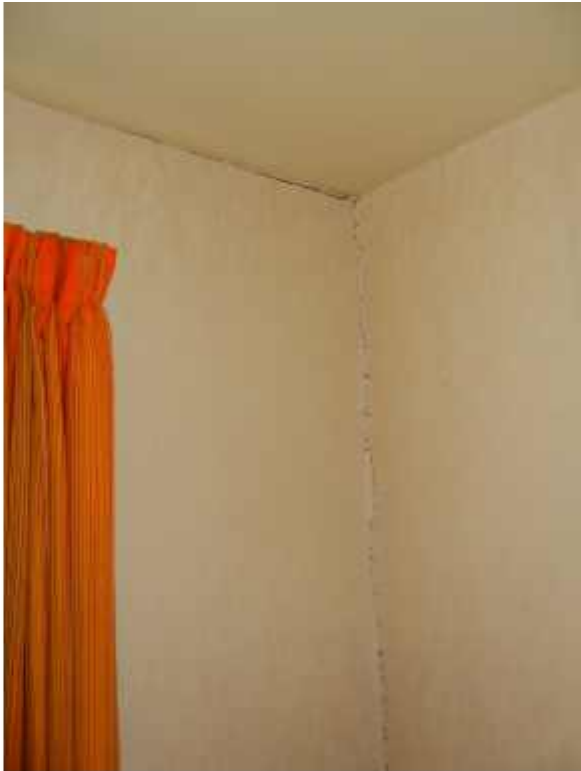
19.	Cracking of interior lining at Unit 18

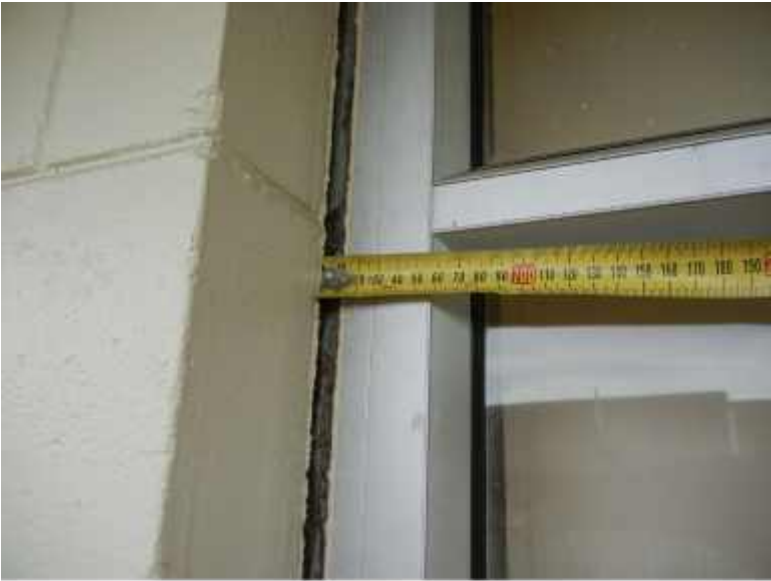
23.	Separation of block veneer around window at Unit 20

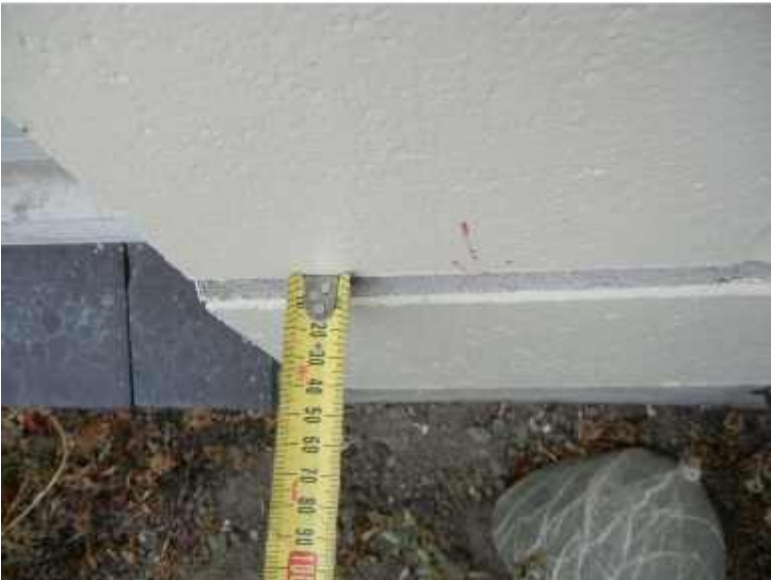
24.	Horizontal offset of exterior block veneer at Unit 20

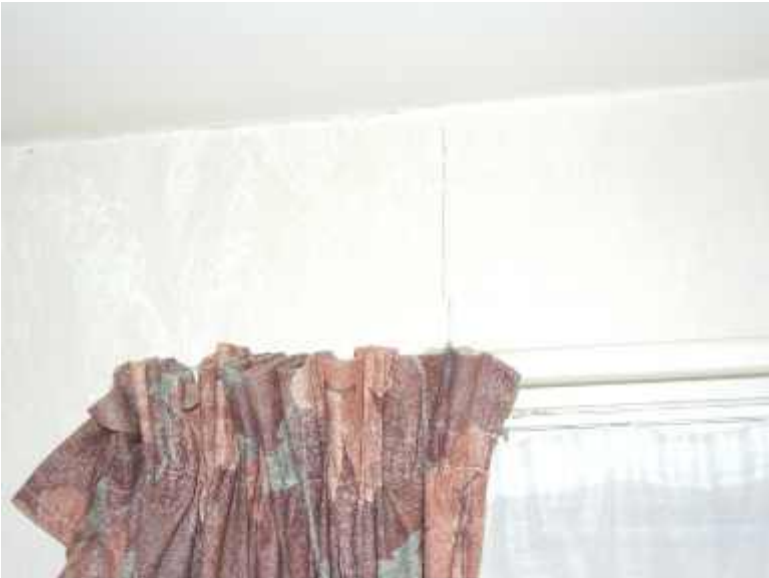
Block D		
25.	Minor cracking of interior linings at Unit 21

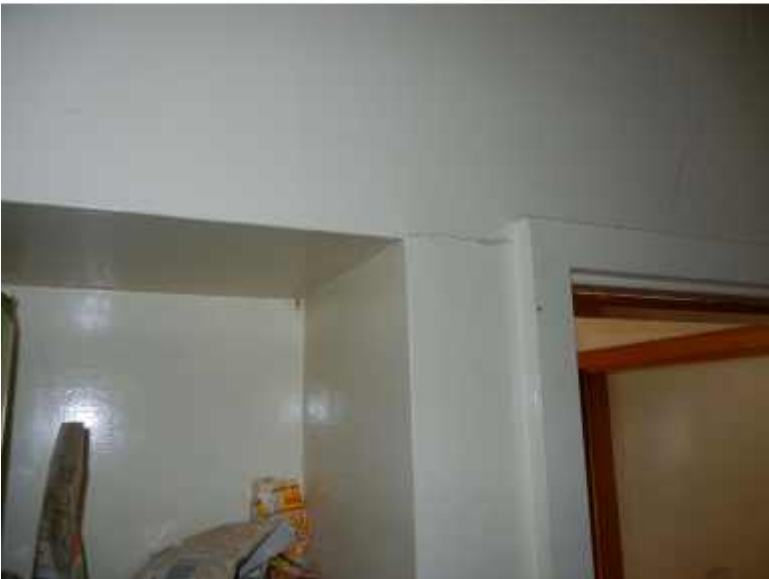
26.	Minor cracking of interior linings at Unit 22

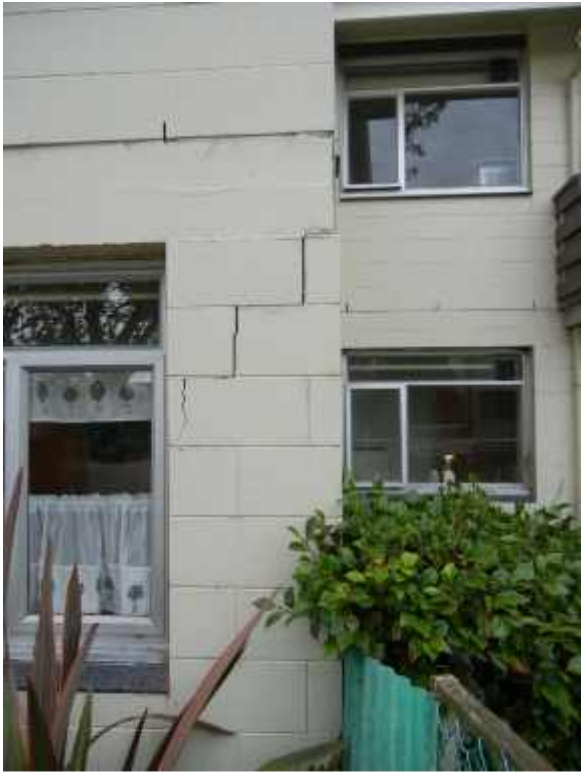
29.	Step cracking at exterior block veneer ground floor pier

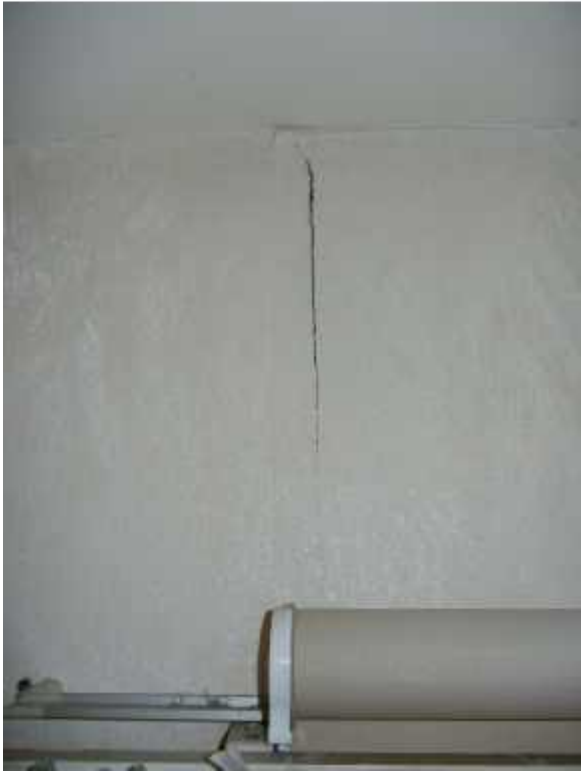
30.	Cracking of interior lining

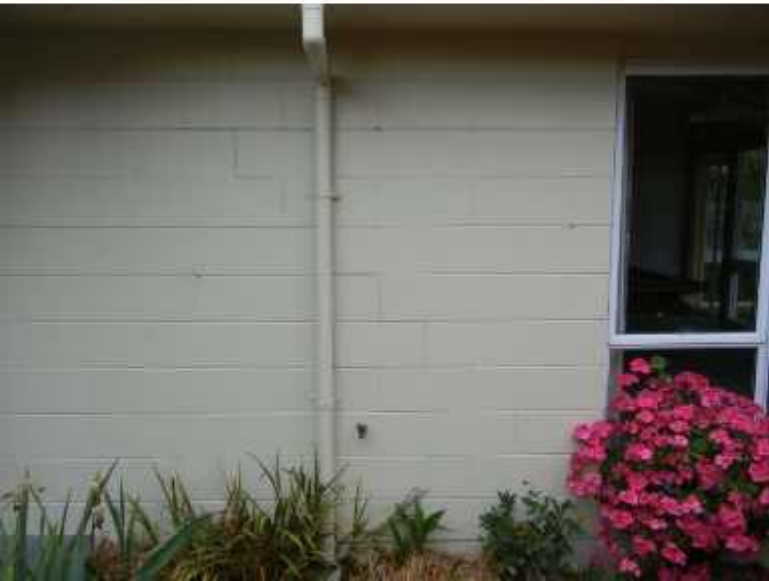
34.	Step cracking at exterior block work
