Resolution Courts Retirement Village BE 0578 EQ2

**Detailed Engineering Evaluation
Quantitative Assessment Report**

5 Resolution Place, Bryndwr, Christchurch

Date: April 2013

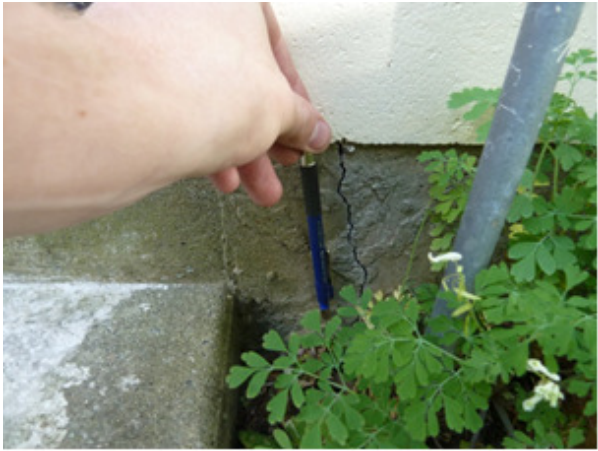
Small cracks were observed in the concrete foundations at Units 1-5 (refer to photos 2 and 13, Appendix A).

2.	Typical Cracking at Units 1-5

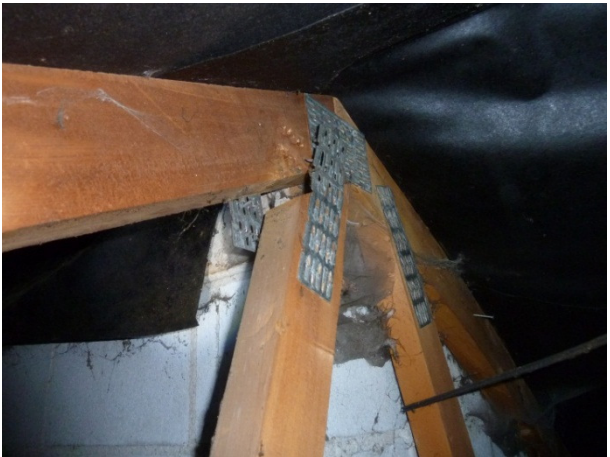
Some trusses throughout the 2 storey blocks had broken connections, the damage appeared to be in the vicinity of the stairwell between each of the upper storey units, however the damage was limited to 1 broken connection per lot, this being 2 units (refer to photos 3, 14 and 15, Appendix A).

3.	Broken Connection in Roof Truss Member above Unit 2/4

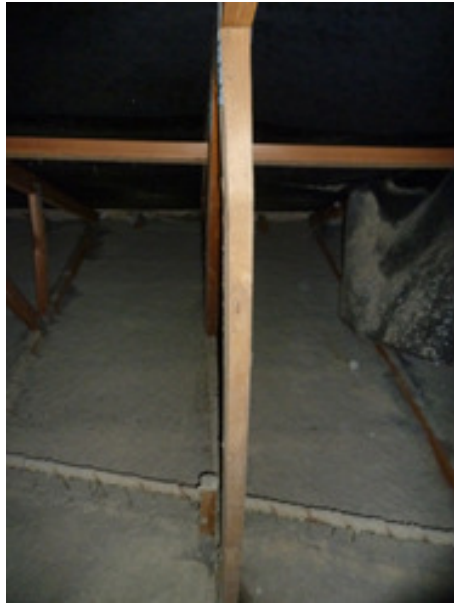
Several bows and buckles were observed in the roof trusses and some members were split parallel to the grain (often due to a knot or other defect exacerbated by loading).

4.	Bowing, Twisting and Cracking of Roof Truss Members above Unit 2/4

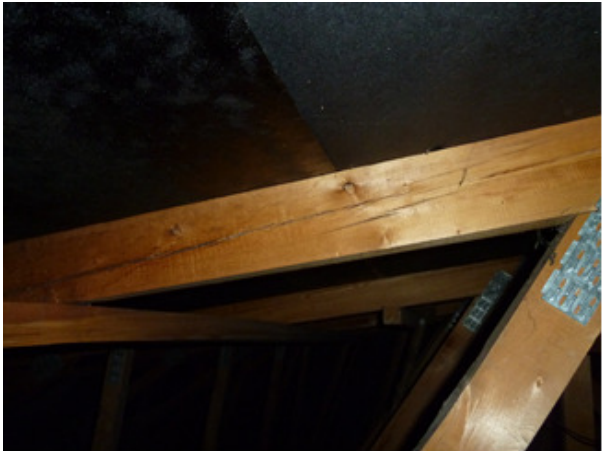
5.	Bowing, Twisting and Cracking of Roof Truss Members above Unit 2/4

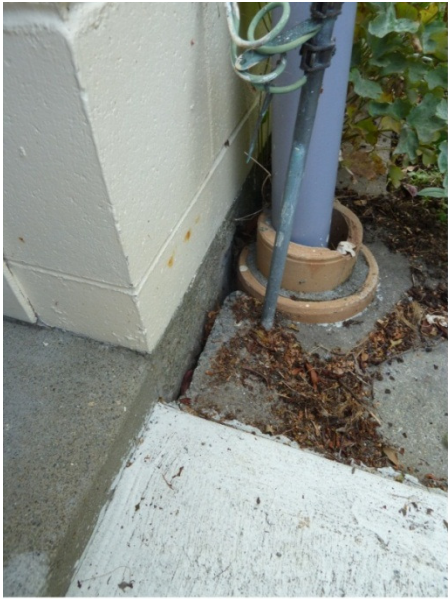
Minor permanent ground damage was observed; this appeared to be less than 10mm vertically as identified between the building foundation and concrete entranceways. There was also some evidence of ground movement as some downpipes had pulled away from the walls (refer to photos in Appendix A).

13.	Evidence of Ground Movement

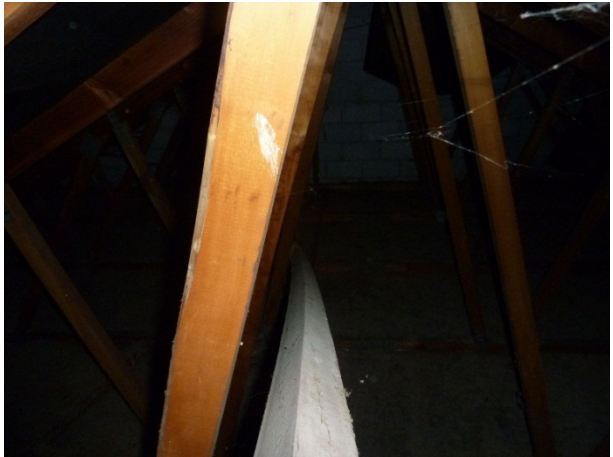
16.	Buckling of Brace above Unit 12

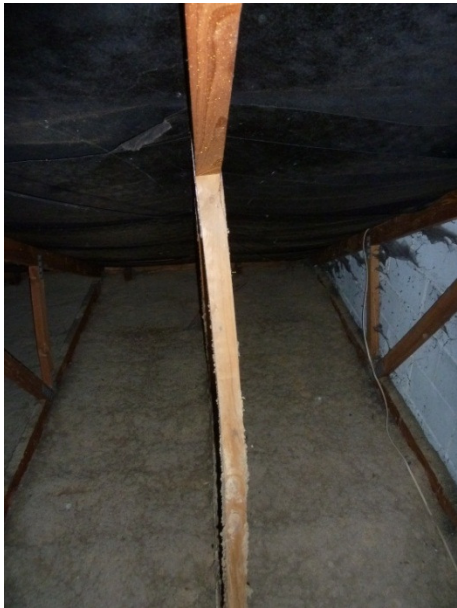
17.	Buckling in Truss Member above Unit 12

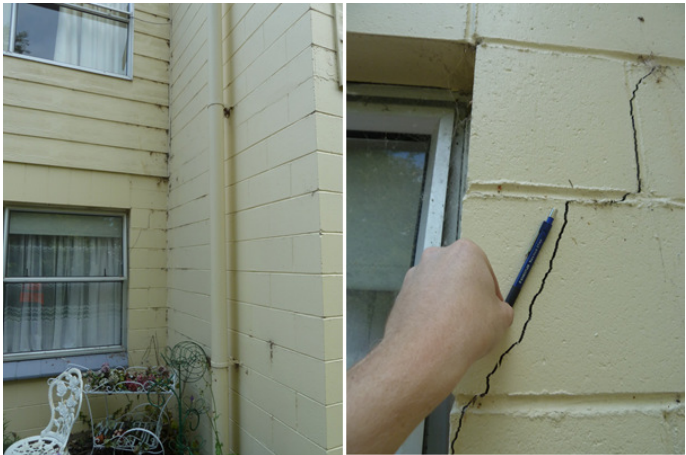
Staircase cracking was identified in the reinforced concrete block walls along the south east elevation of Block 2; this was located at the join between each of the lots. Some cracking included breaks through the concrete block; the cracks appeared to be up to 3-5mm wide in some locations (refer to photos 18, 19 and 20, Appendix A).

18.	Cracking on South Side of Units 11/13

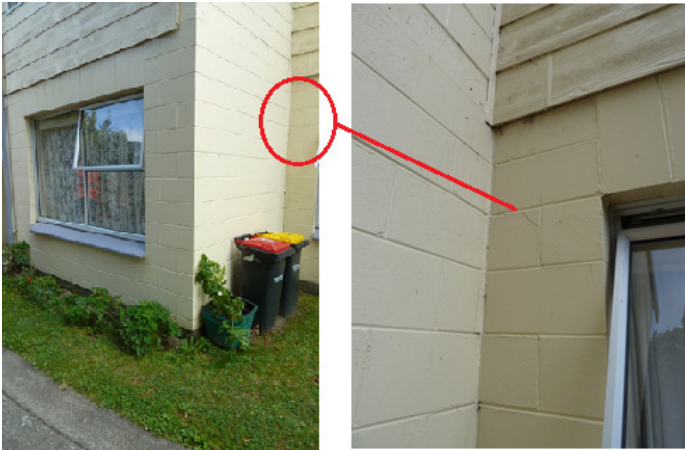
19.	Cracking on South Side of Units 11/13

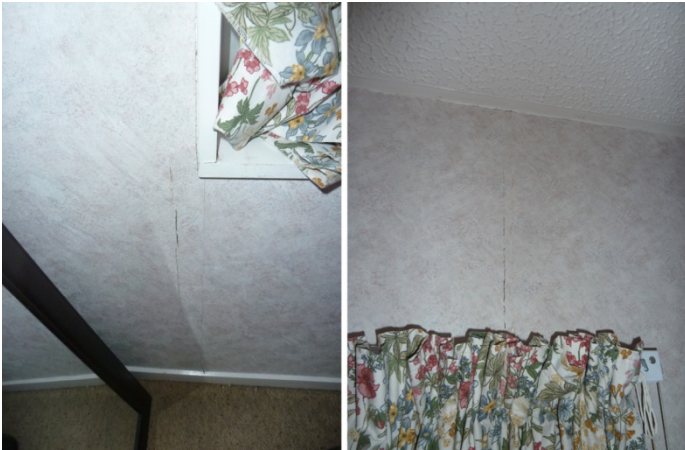
Several units suffered cracking damage to window and door frames both externally and internally. Cracks of up to 5mm were observed in the exterior block work veneer.

20.	Interior Damage to Unit 15

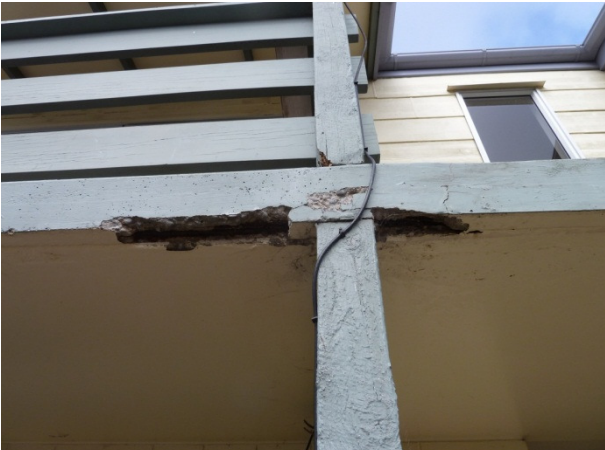
In addition, corrosion of reinforcing has forced cover concrete to come free from the slab on the balcony of Unit 10/12 leaving the reinforcing steel fully exposed.

21.	Corrosion of Steel Reinforcing outside Units 10/12
