Toilet – Rimu Park
PRK 1645 BLDG 001
Detailed Engineering Evaluation
Qualitative Report
Version Final

Christchurch City Council

Date
17th May 2013

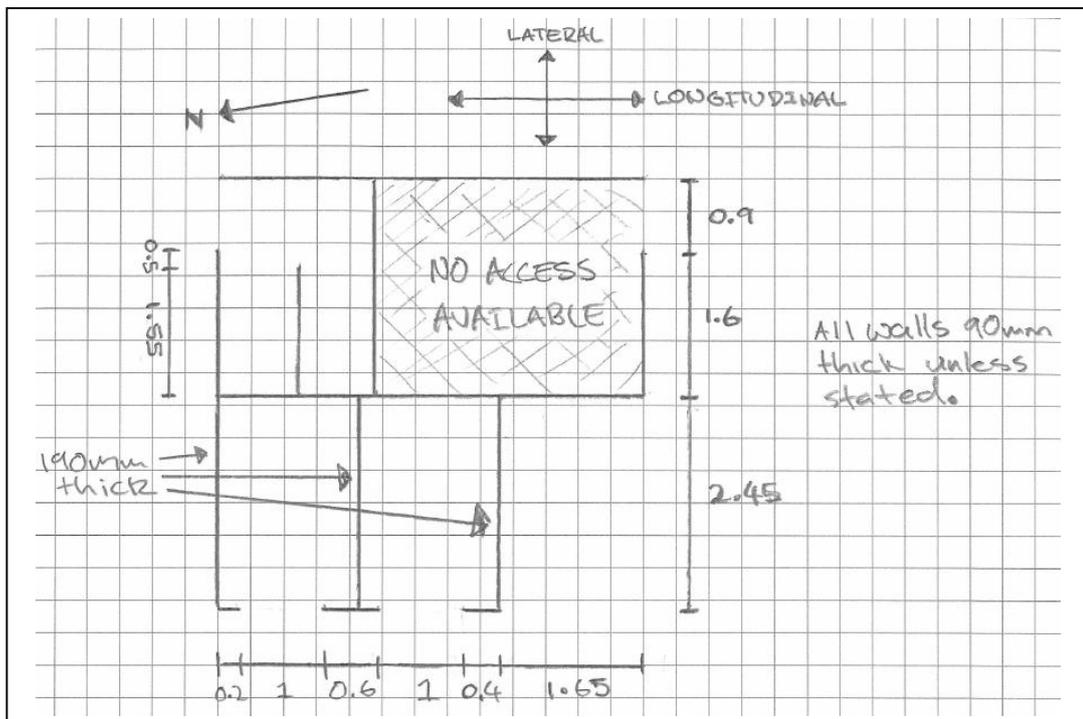
Figure 2 Plan Sketch Showing Key Structural Elements

The partial filled concrete masonry walls form the perimeter of the building and also provide the internal partitions; the layout can be seen in Figure 2. The walls are assumed to be partially filled and reinforced.

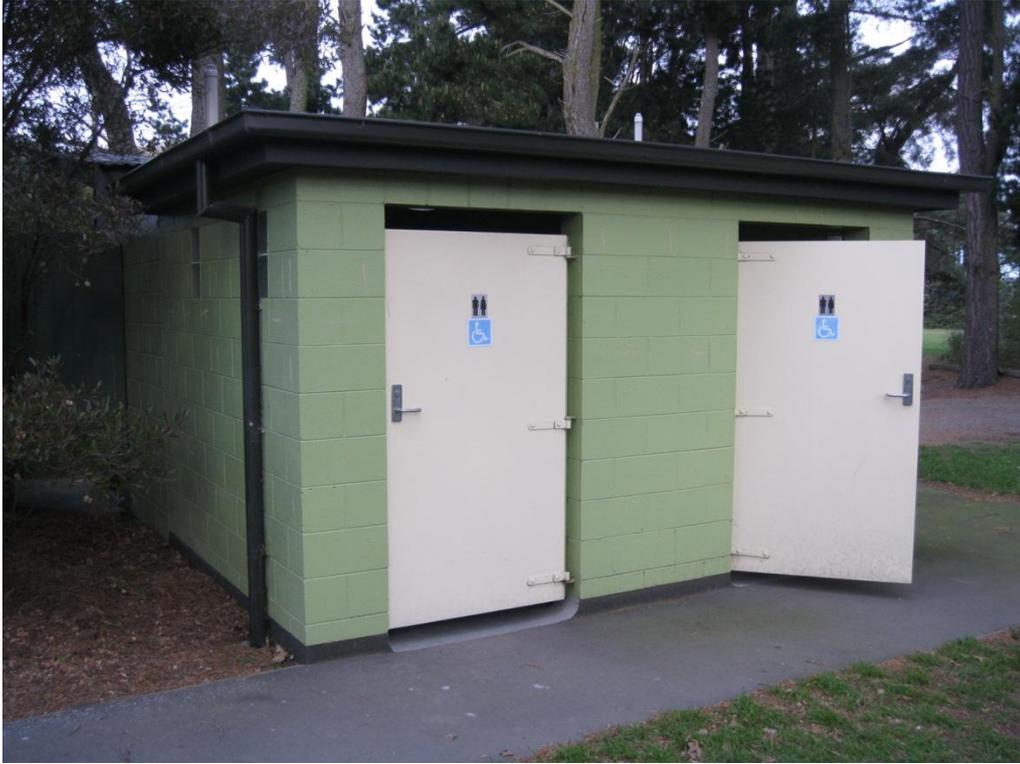
Photograph 1 Western elevation.

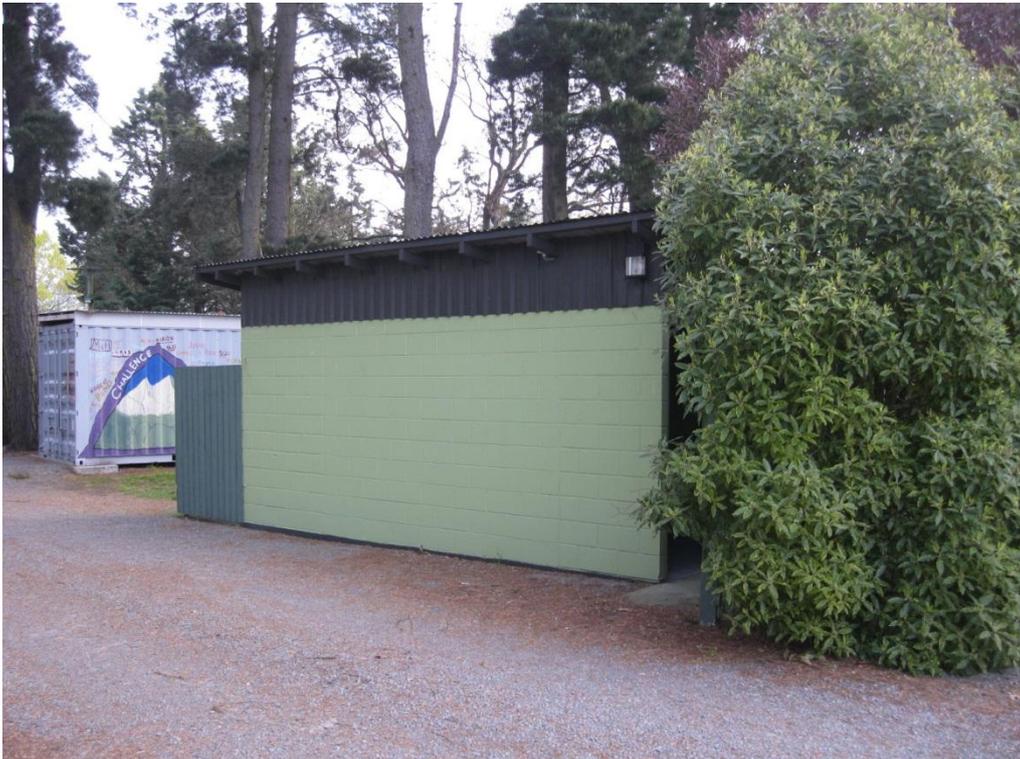
The timber studs above the concrete masonry wall in the buildings eastern face will provide no lateral restraint out of plane. This results in the roof providing no restraint to the top edge of the wall and the wall not being adequately braced out of plane. This problem has been considered as a 'significant' vertical irregularity.

Photograph 2 Eastern elevation showing timber stud over concrete masonry wall.

CCC are not required to undertake a detailed seismic assessment, however due to the relatively low score, GHD recommend a detailed seismic assessment is carried out.

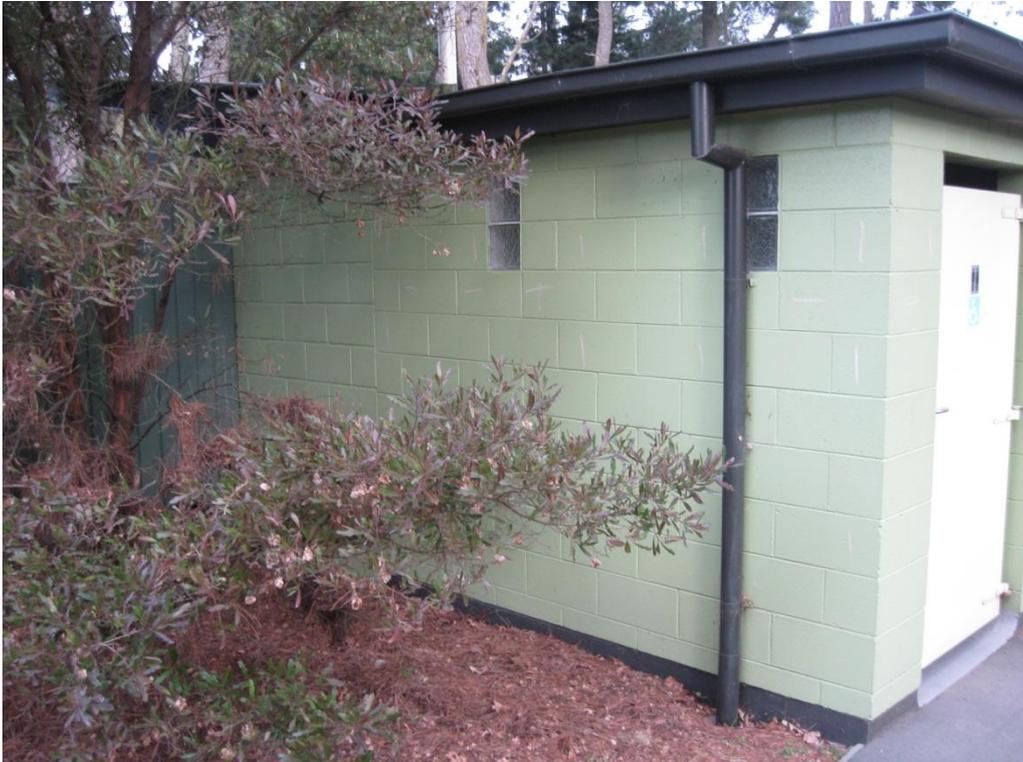
Photograph 3 View of the toilet block from the north.

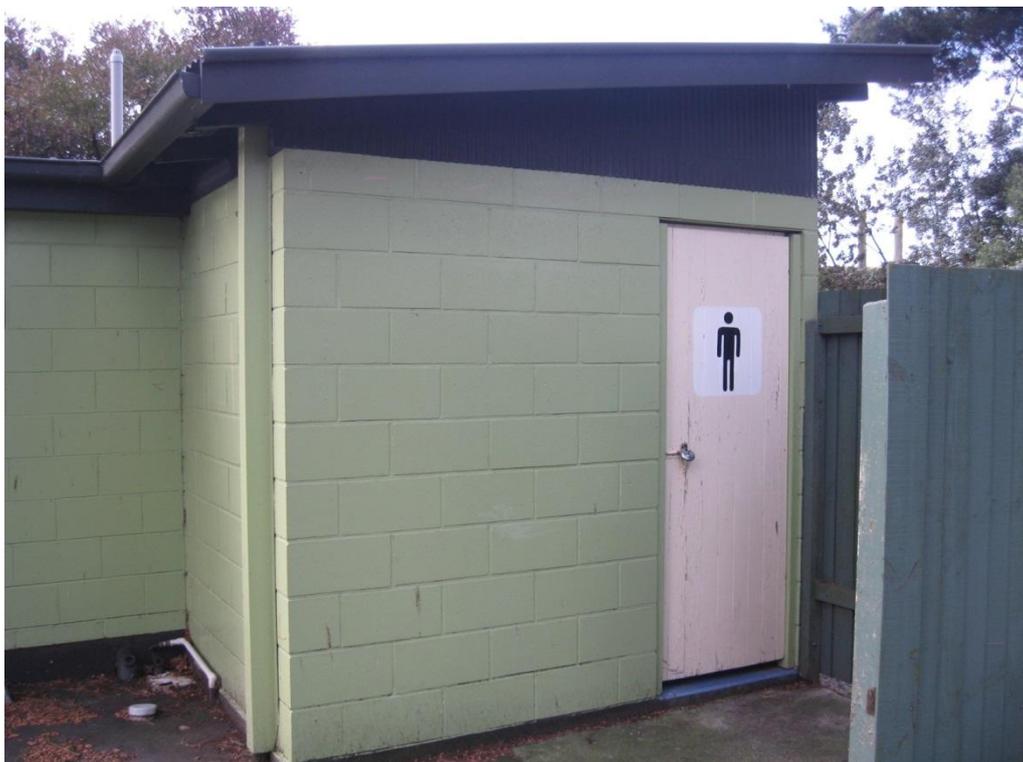
Photograph 4 Southern elevation

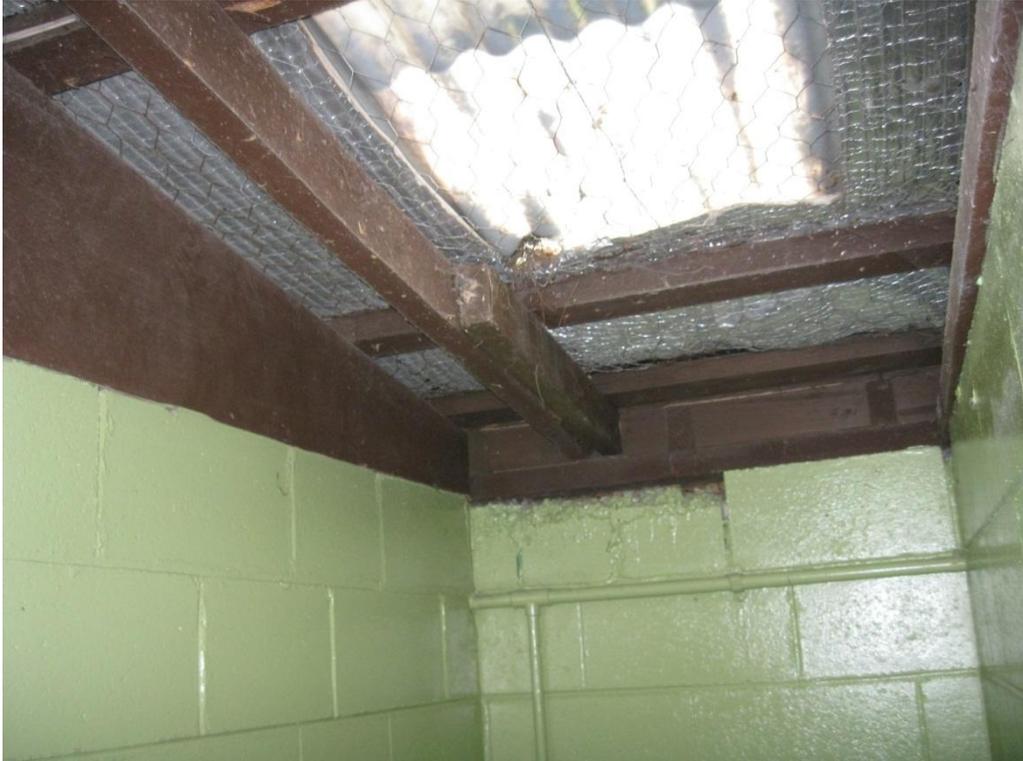
The sloping roof section will provide little diaphragm action as the roof structure requires the need for timber studs to connect the roof to the top of the concrete masonry walls. This effectively acts as an unrestrained edge.

Photograph 5 Mono-pitch roof structure.

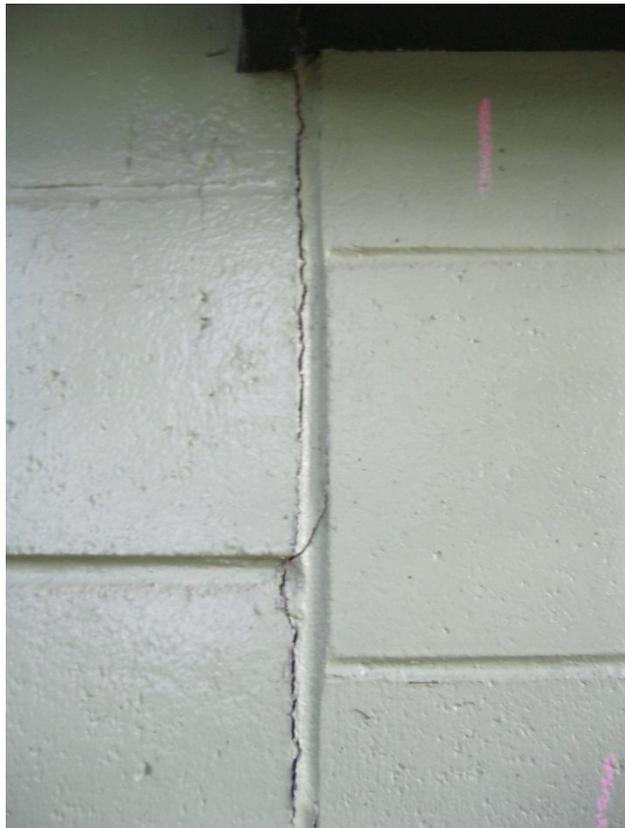
Cracking was noted at construction joints in the concrete masonry walls.

The only damage noted in the building was cracking between construction joints in the walls. This is damage that would not compromise the load resisting capacity of the existing structural systems. Because the building has achieved between 33% and 67% NBS following an initial IEP assessment, no further assessment is required by Christchurch City Council to comply with the building act. However, due to the relatively low score, GHD recommend a detailed seismic assessment is carried out.

Photograph 6 Cracking at construction joint.

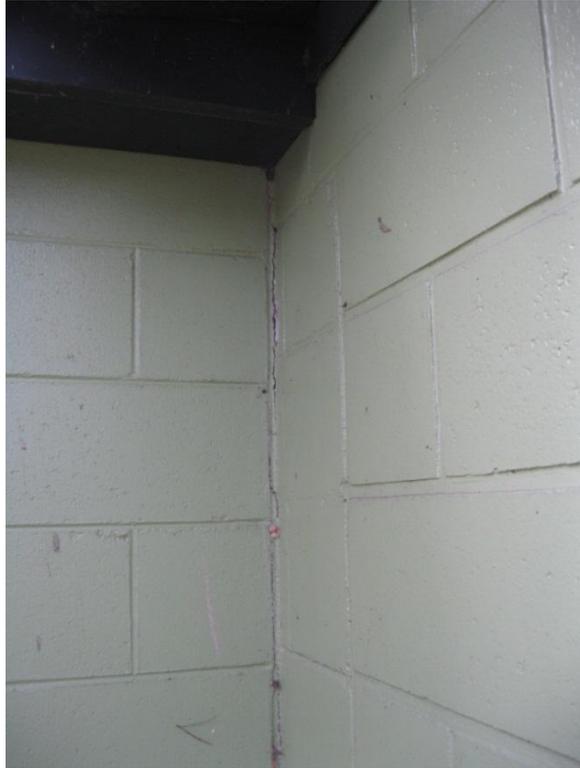
Photograph 7 Cracking at construction joint 2.

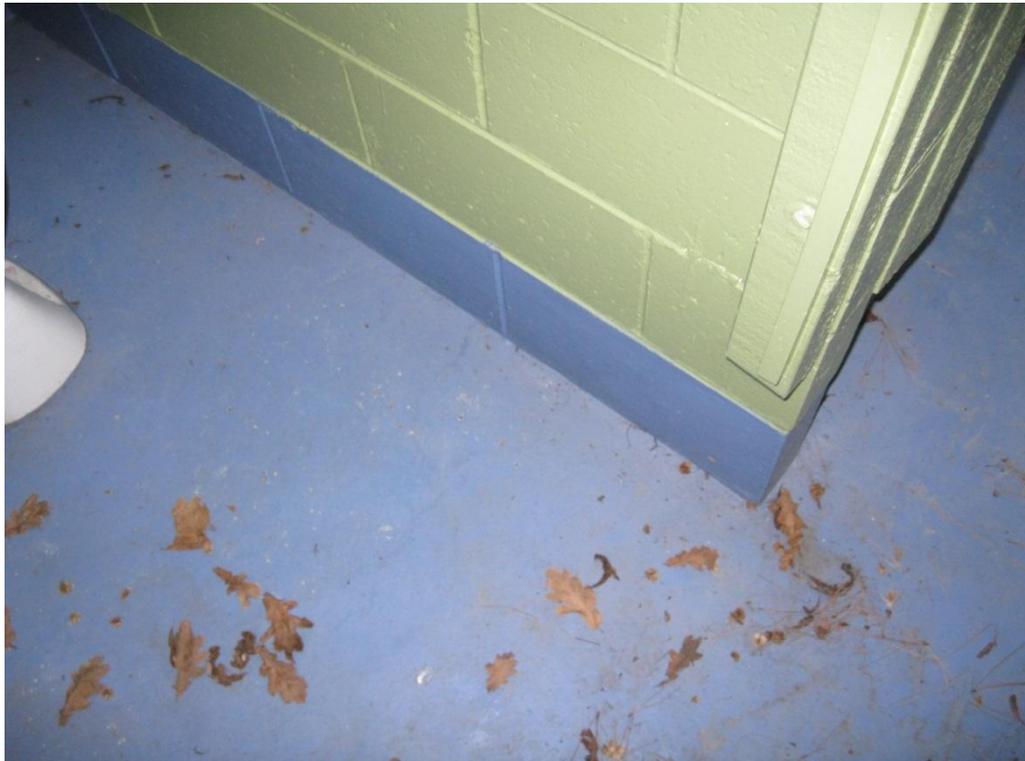
Photograph 8 Concrete floor slab.
