# Roimata Place Housing Complex PRO 0917

Detailed Engineering Evaluation Quantitative Assessment Report

Roimata Place, Woolston, Christchurch

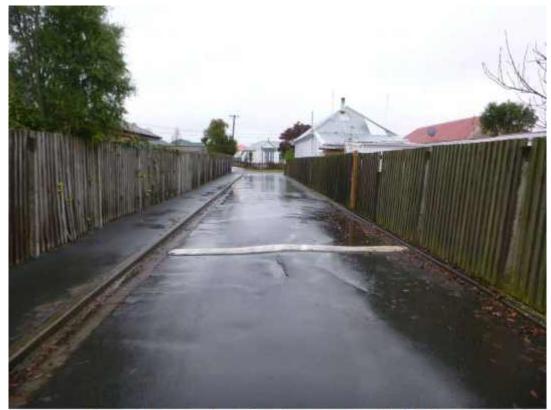
- Pavement damage (depressions and heave) and evidence of sand boils observed at the southern corner of Roimata Place access road, refer to photos 1 and 2.

Photo 1: Pavement depression damage and sand boil evidence

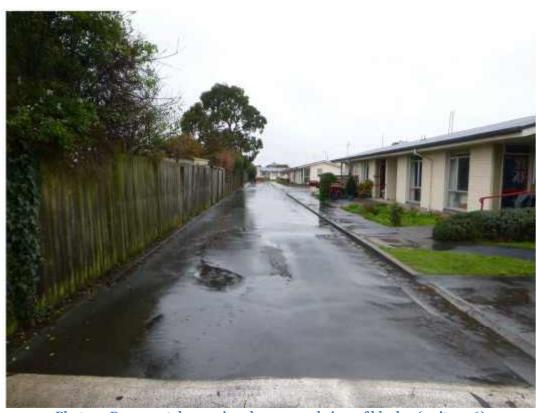
Photo 2: Pavement depression damage and view of block 2 (unit 5 – 6)

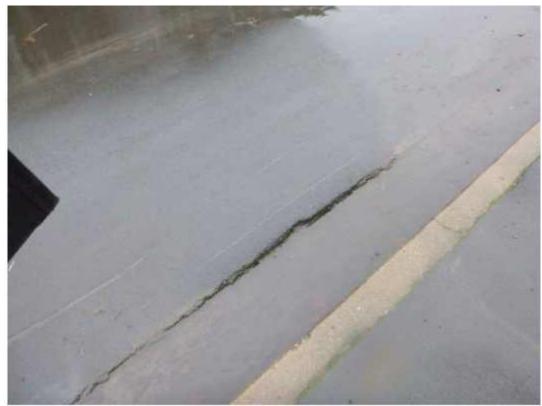
- Uplift of pavement observed at curb edge, refer to photo 3.
- Cracking of concrete porches, typically 4mm crack width throughout site, refer to photos 4, 6, 7, 10, 14, 17, and 18.

Photo 3: Pavement up lift, up to 30mm

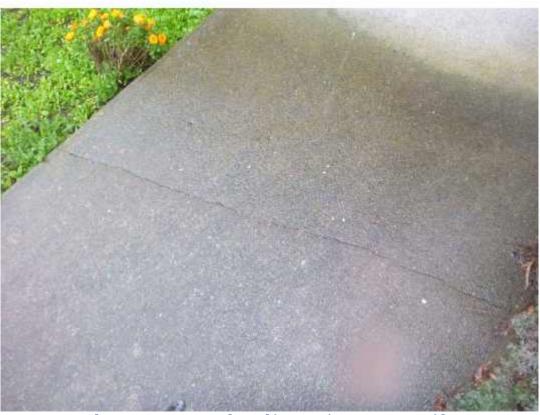
Photo 4: Concrete porch cracking at unit 5, up to 3mm wide

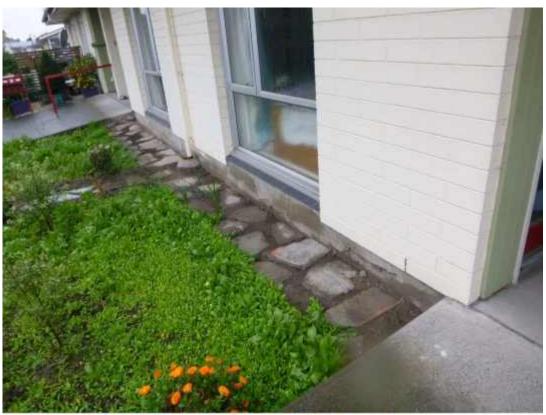
- Foundation sprawling damage, refer to photo 5,
- Exposed concrete around drain, indicates possible settlement of the garden areas, refer to photos 8 and 23.

Photo 5: Foundation damage of unit 5

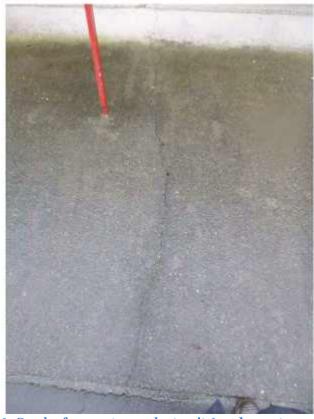
Photo 6: Crack of concrete porch at unit 6 and 7, up to 4mm wide

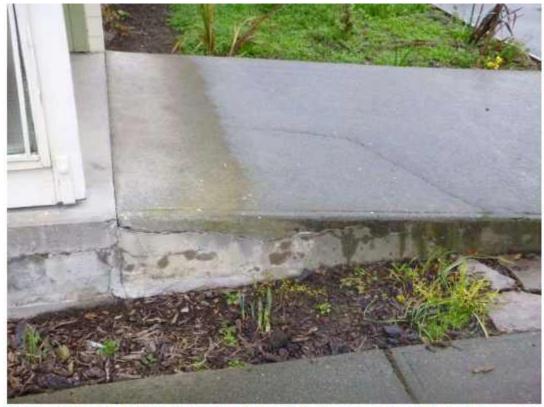
Photo 7: Cracking of concrete porch and building foundation at unit 8, up to 3mm wide

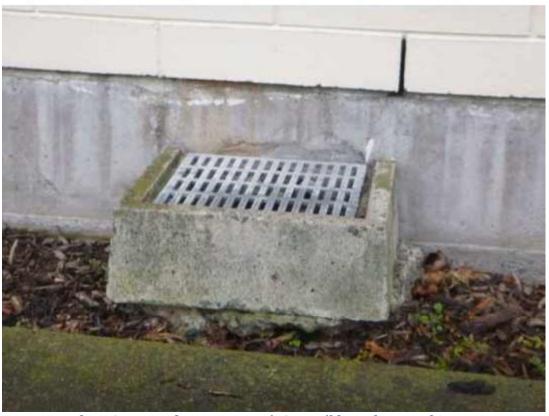
Photo 8: Exposed concrete at unit 8, possible settlement of 60mm

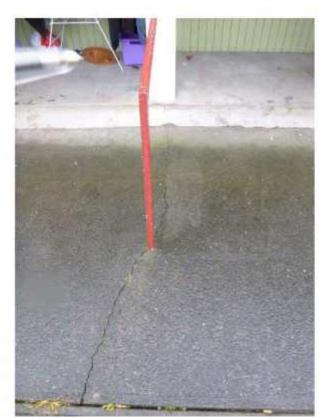
Photo 10: Crack of concrete porch at unit 6 and 7, up to 5mm wide and 2mm vertical

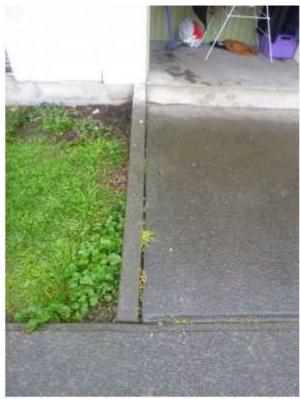
Photo 11: Separation of concrete porch at unit 11, up to 10mm wide

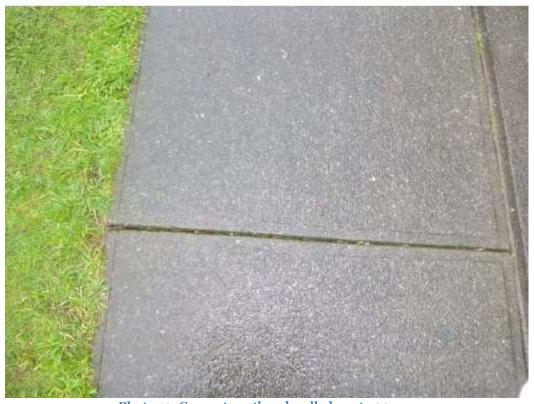
Photo 12: Concrete path unlevelled, up to 20mm

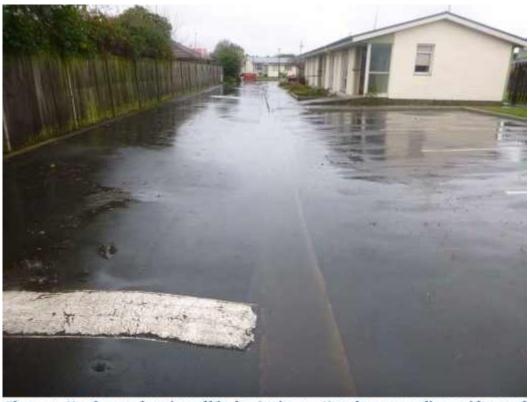
Photo 13: North east elevation of block 4 (unit 13 - 16) and water pooling, evidence of pavement and drainage level change

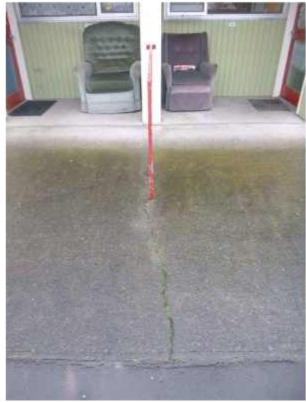
Photo 14: Cracking of concrete porch at unit 14 and 15, up to 5mm wide

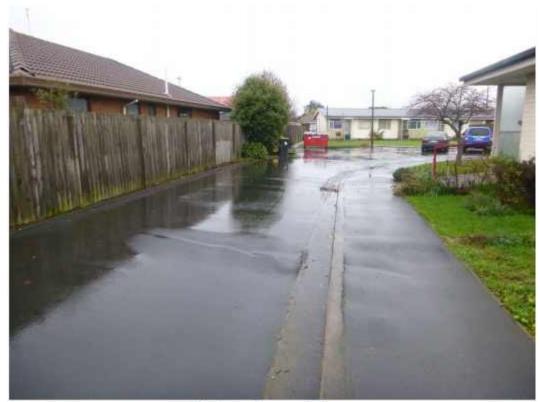
Photo 15: Pavement heave

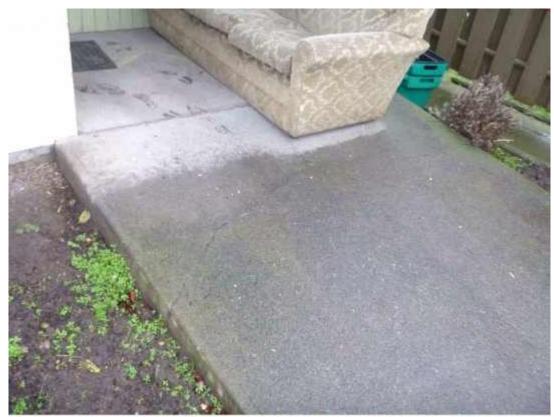
Photo 17: Cracking of concrete porch at unit 17, up to 2mm wide

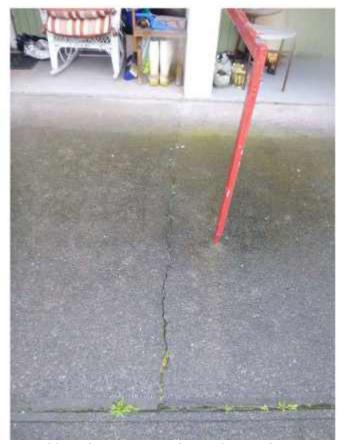
Photo 18: Cracking of concrete porch at unit 18 and 19, up to 4mm wide

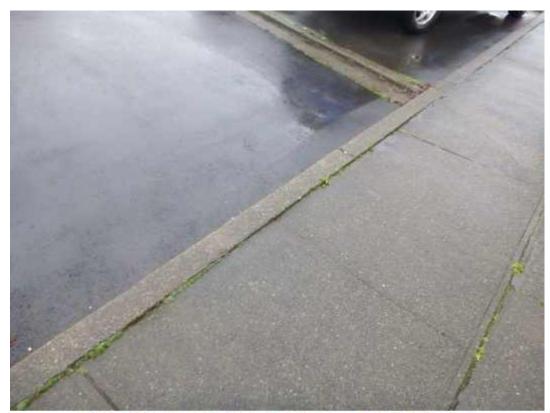
Photo 19: Differential settlement of concrete path, up to 15mm

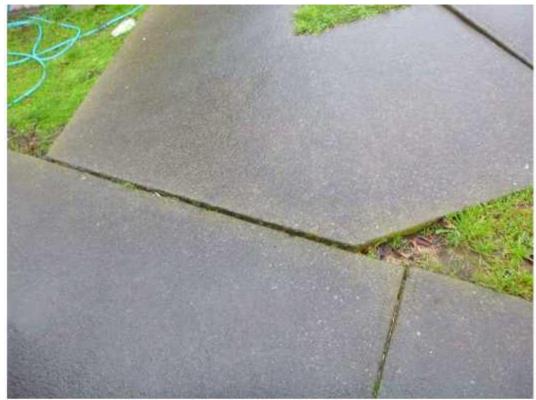
Photo 21: Unlevelled concrete path, up to 3mm

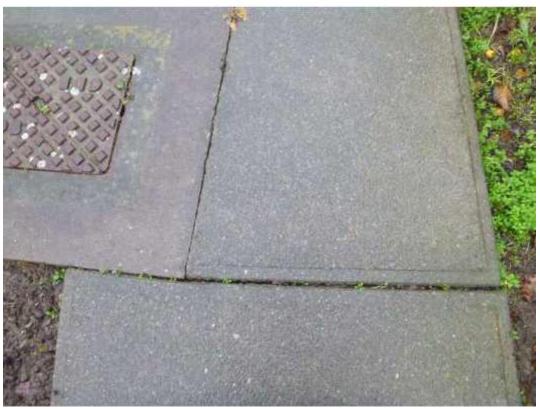
Photo 22: Separation of concrete path near unit 24, up to 10mm

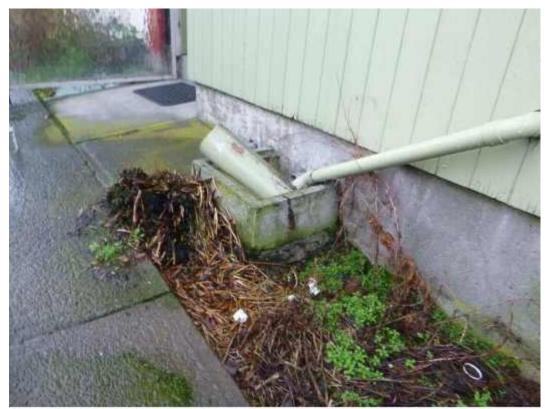
Photo 23: Exposed concrete at unit 21, evidence of settlement, up to 70mm

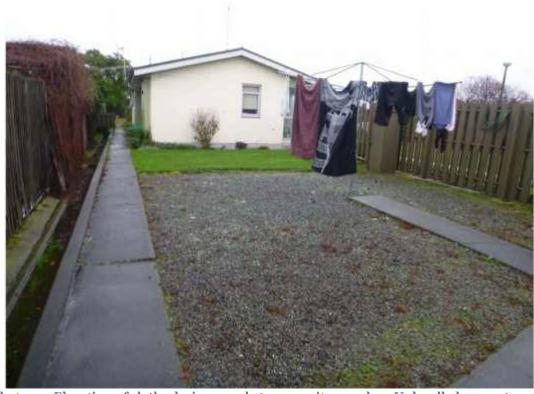
Photo 24: Elevation of cloths drying area between unit 20 and 21. Unlevelled concrete path and path settlement of up to 40mm

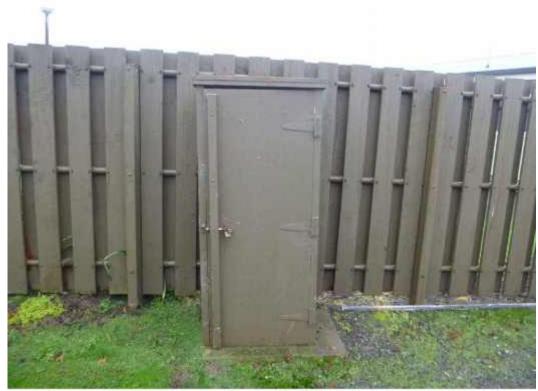
Photo 25: Tilting of fence, evidence of differential settlement up to 100mm

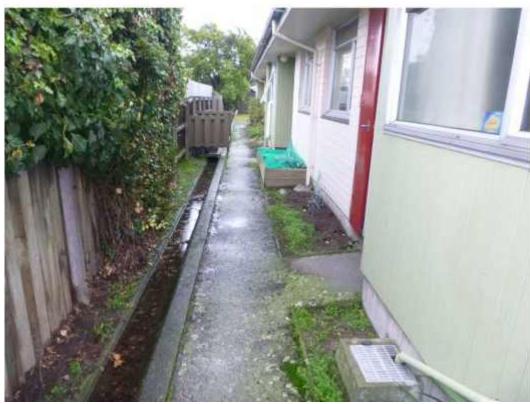
Photo 26: South west elevation behind unit 5, evidence of concrete path settlement of up to 30mm

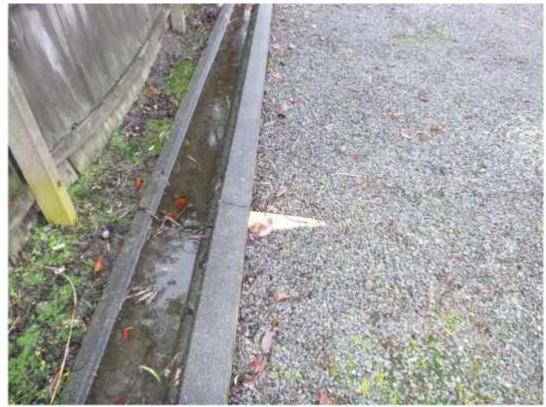
Photo 29: Differential settlement causing pipe change of grade towards Block 2

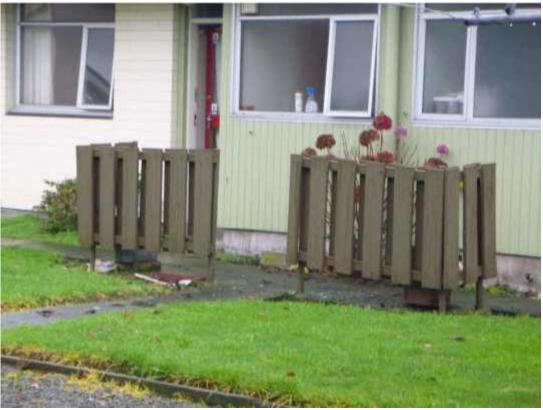
Photo 30: Tilting of fence, possible differential settlement of fence foundations of up to 50mm

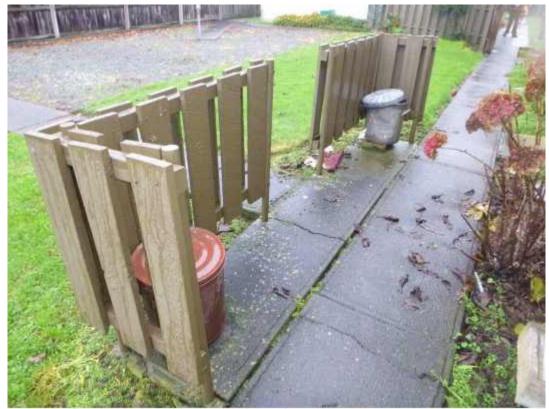
Photo 31: Concrete path uplift, separation and cracking, up to 25mm separation and 5mm wide cracks

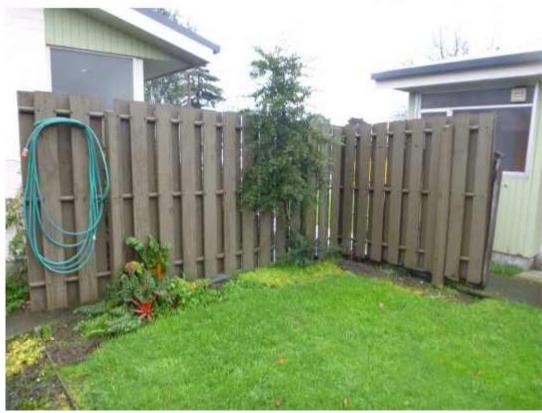
Photo 32: Tilting of fence, possible differential settlement of fence foundations of up to 100mm

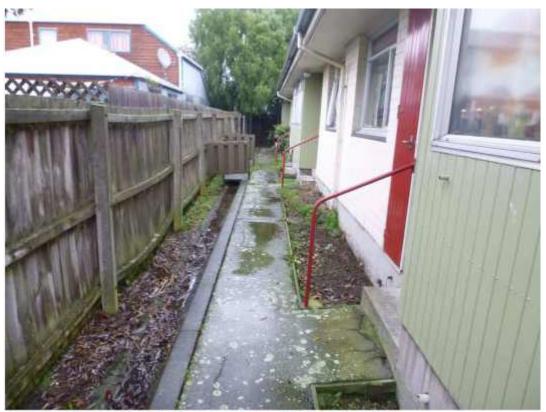
Photo 33: Settlement of concrete path, up to 40mm

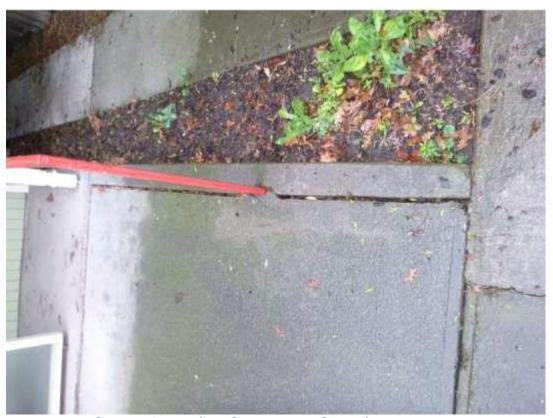
Photo 34: Separation of concrete porch at unit 1, up to 10mm
