CHRISTCHURCH CITY COUNCIL
PRK_0895_BLDG_001 EQ2
Ruru Lawn Cemetery – Toilets
Raymond Road, Bromley

QUALITATIVE ASSESSMENT REPORT

- Rev B
- 23 May 2013

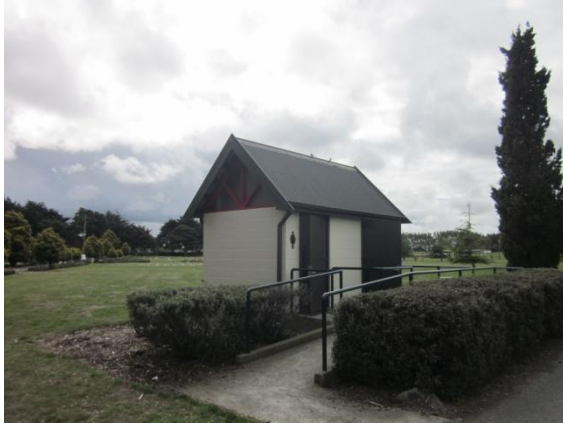
No external or internal damage was observed during our site inspection.

Photo 1: Overall View of Building

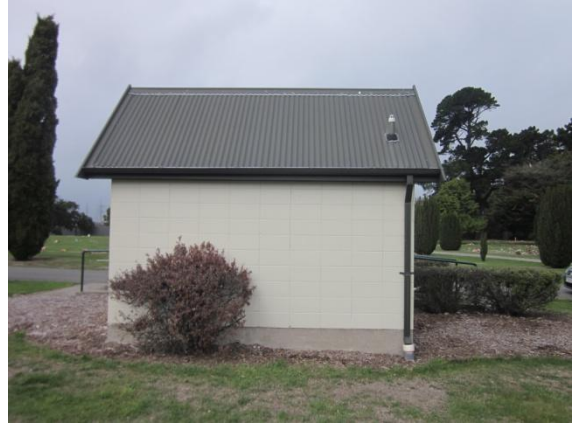
Photo 2: South Elevation

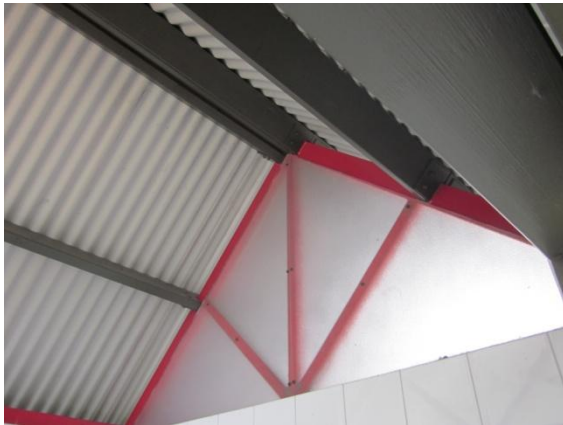
Photo 3: Roof Structure

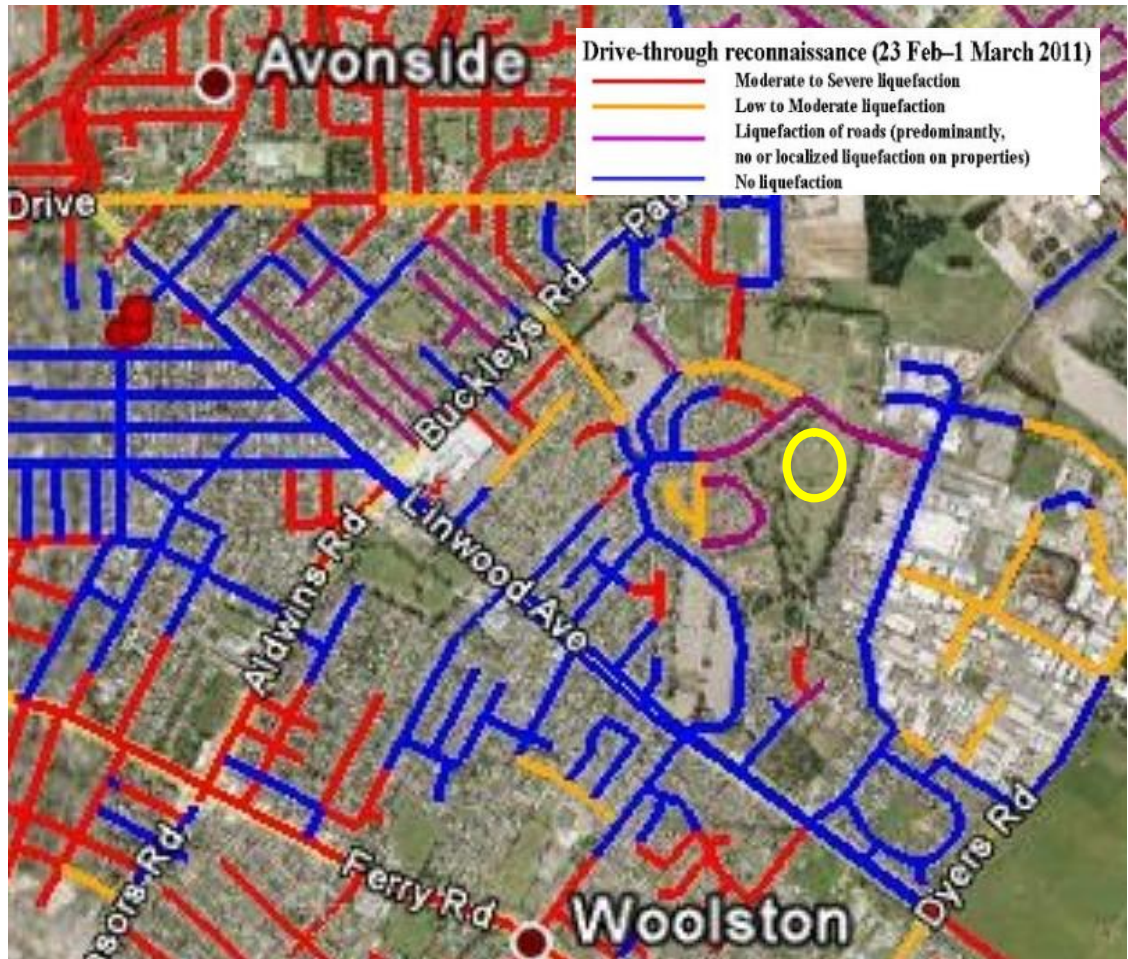
■ **Figure 4 – Liquefaction map (Cubrinovski & Taylor, 2011). Site marked in red.**

Following the 22 February 2011 event drive through reconnaissance was undertaken from 23 February until 1 March by M Cubrinovski and M Taylor of Canterbury University. Their findings show predominantly liquefaction of roads with no or localised liquefaction in the areas near the site. In parts of the area immediately west of the site low to moderate and moderate and severe liquefaction had been noted.

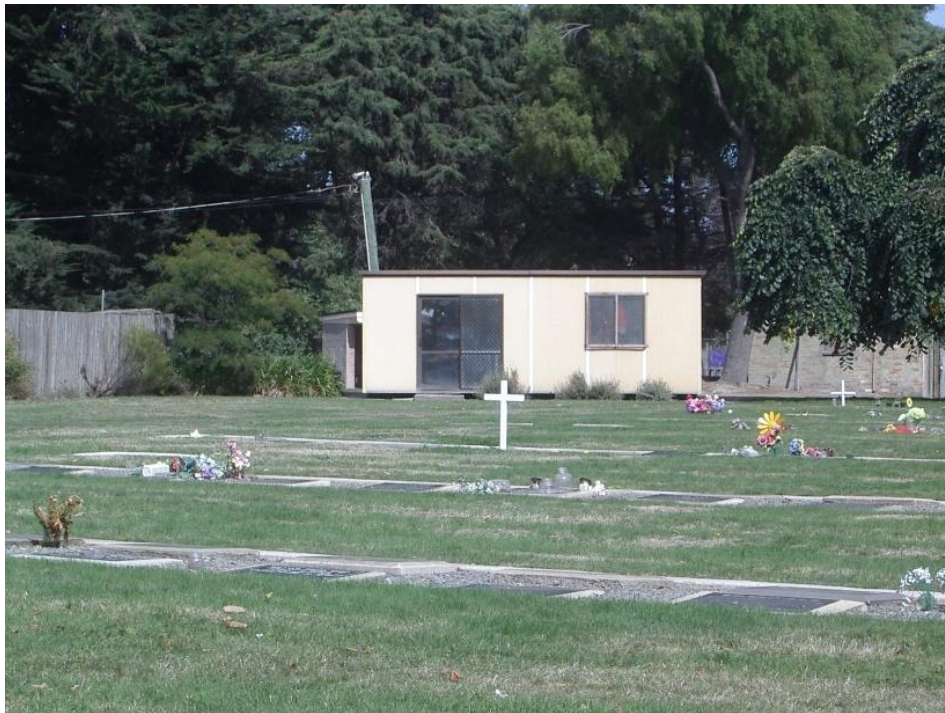
■ **Figure 9 No visible damage to land or the building**

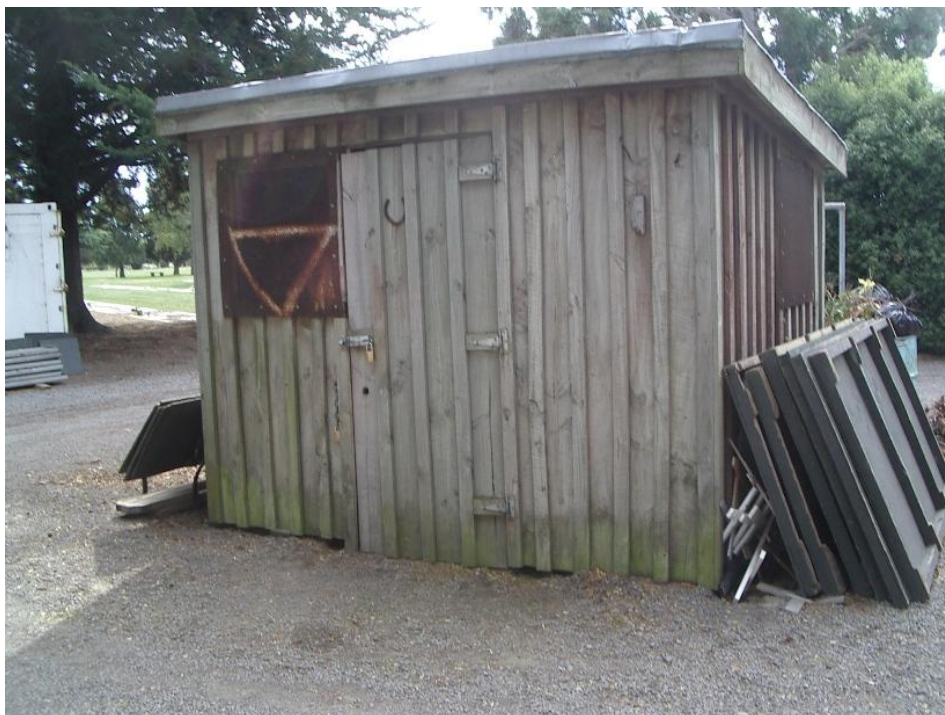
■ **Figure 10 No visible damage to the pump house**
