CHRISTCHURCH CITY COUNCIL
PRK_0895_BLDG_004 EQ2
Ruru Lawn Cemetery – Pumphouse
Raymond Road, Bromley

QUALITATIVE ASSESSMENT REPORT
FINAL

- Rev B
- 24 September 2013

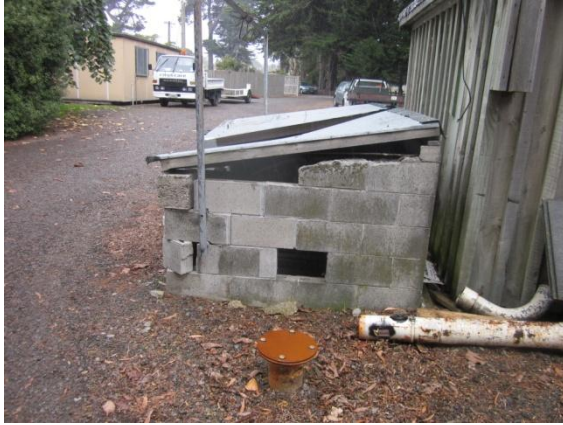
Photo 1: Western elevation

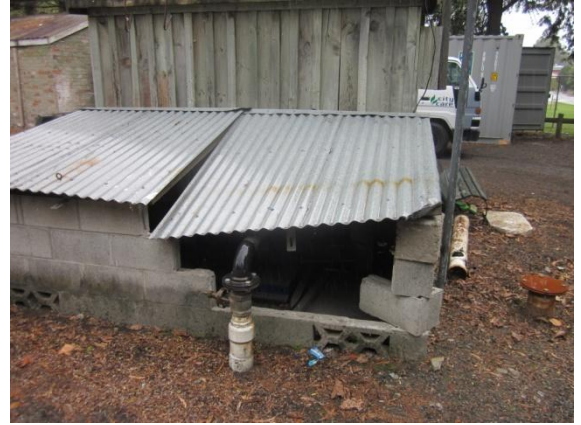
- 1) No visual evidence of settlement was noted at this site. Therefore a level survey is not required at this stage of assessment.
- 2) Blocks have moved out of alignment in the north-west corner. Significant cracking to the mortar in this area (PHOTO 2 & 3).
- 3) Cracking to mortar in the north-east corner (PHOTO 4).
- 4) Blocks have possibly collapsed and been removed along the northern face. This has caused the roof/cover in this area to partially collapse (PHOTO 2).

Photo 2: Northern Elevation – Damage to NW Corner

Due to the size of this structure it is not cost effective to carry out a quantitative assessment or strengthen the structure to current code requirements. We recommend that this structure is demolished and replaced with either a steel cage, timber framed enclosure or a reinforced concrete block enclosure that meets current code requirements for masonry construction. The replacement structure could be designed by a qualified tradesman and should not require specific engineering design or building consent.

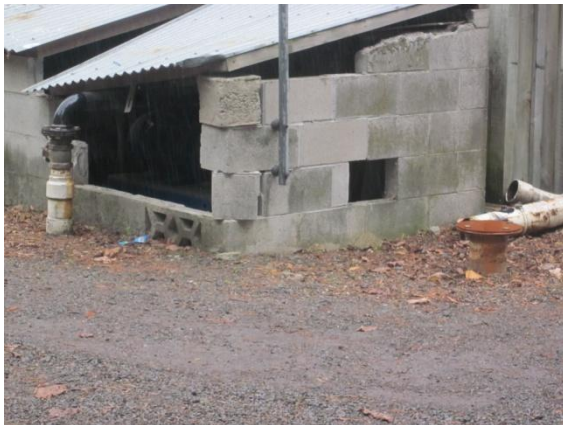
Photo 3: Damage to NW Corner

Damage in NW corner - western wall unsupported on one side. Block walls are unreinforced and unfilled - need to cantilever vertically.

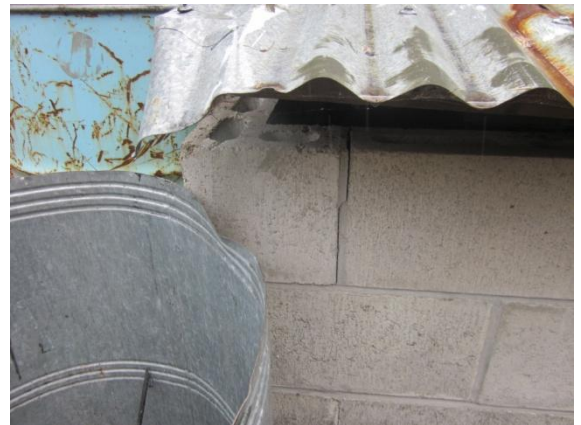
Photo 4: Cracking to Mortar in the NE Corner

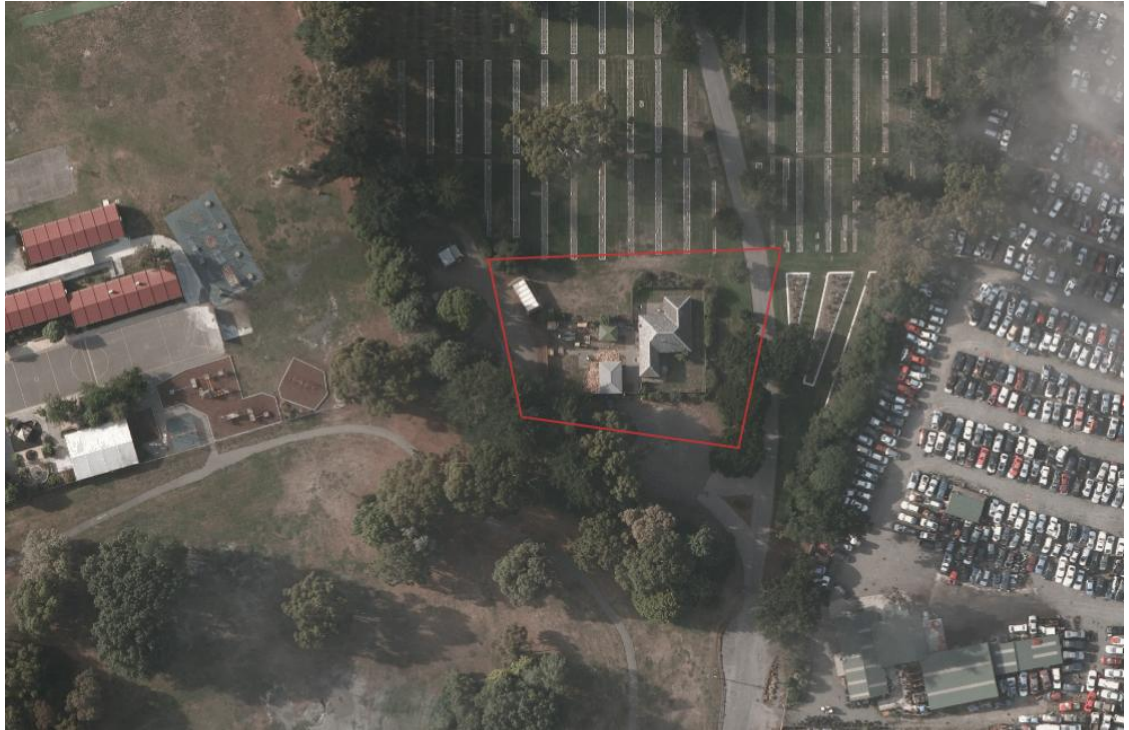
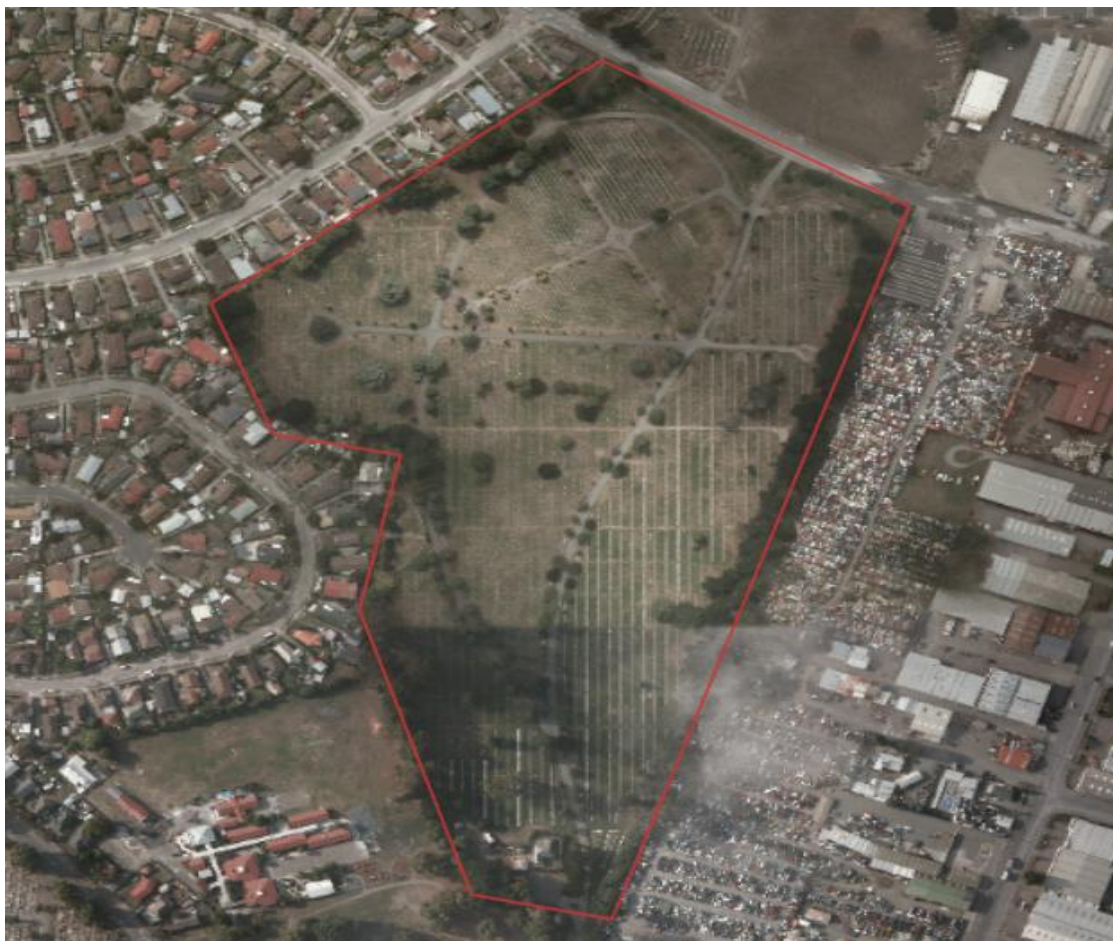
Significant amount of liquefied material can be seen on Ruru road, running down the northern section of the site, from the aerial photographs. Additionally, localised liquefaction and evidence of sand boils could be seen on adjacent properties.

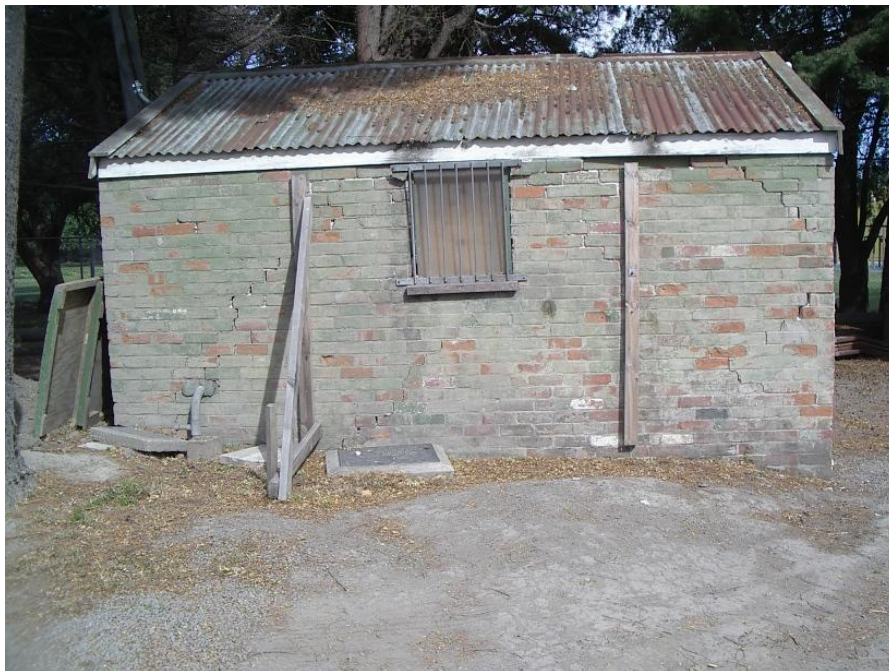
The toolshed was the only building on the site with any noticeable structural damage. The main damage observed was the cracking of the bricks.

■ **Figure 8 Visible damage to the tool shed**

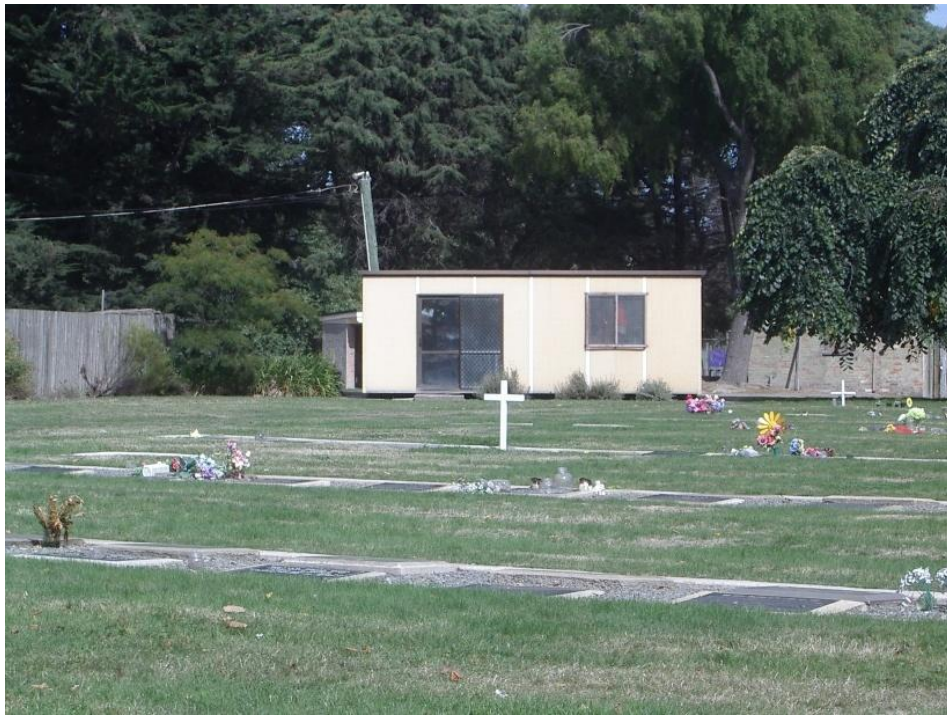
■ **Figure 9 No visible damage to land or the building**

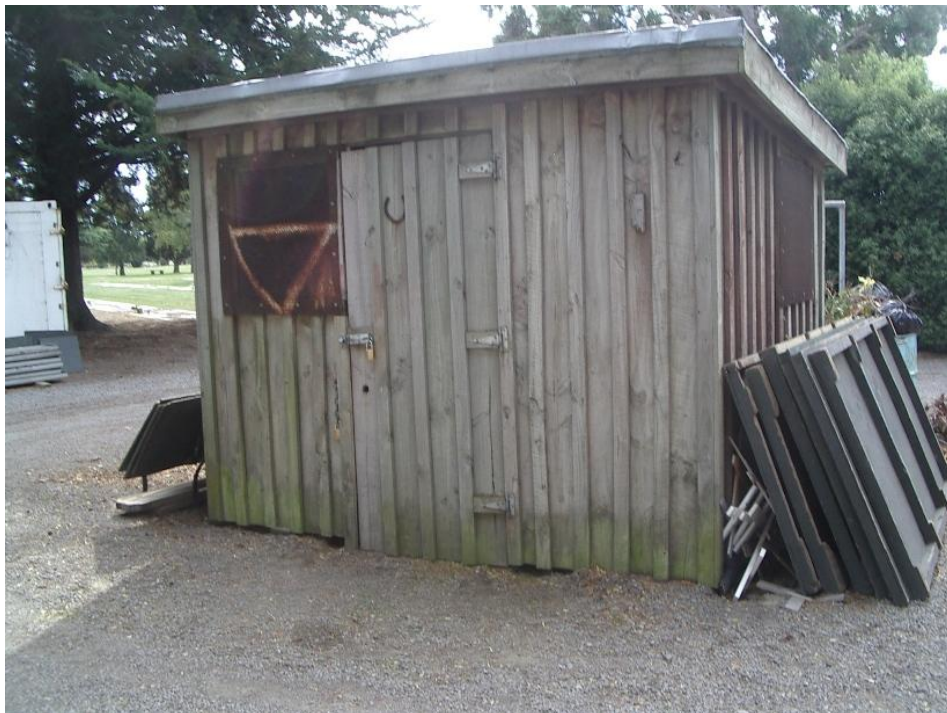
■ **Figure 10 No visible damage to the pump house**
