**Sandilands
Housing Complex
PRO 0755**

**Detailed Engineering Evaluation
Quantitative Assessment Report**

Sandilands Housing Complex

Date: March 2014
Reference: 6-QC400.00
Status: Final

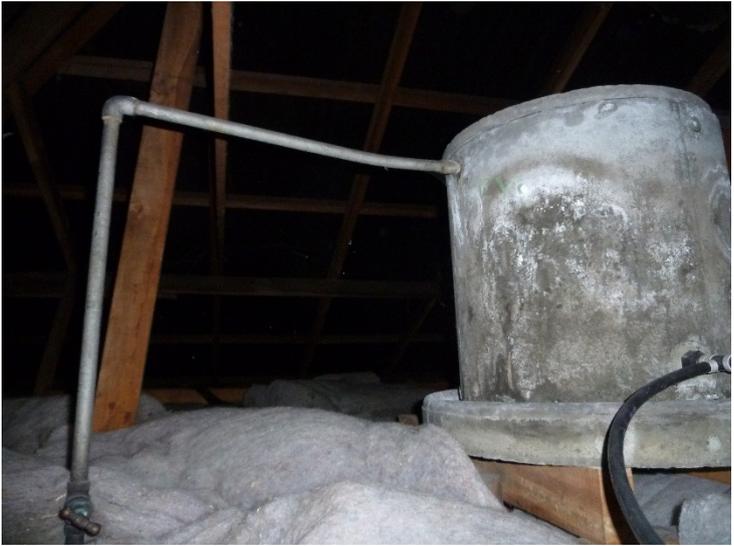
<p>10.</p>	<p>Concrete header tank in roof space</p>

A concrete header tank was observed in the roof space of all units.

- The timber garages at 12 Nicholas Drive and 18 Griffiths Avenue be strengthened to support gravity loads and to at least 67%NBS.
- Strengthening schemes be developed to bring the capacities of the garages at 9-11 and 17-19 Coulter Ave to at least 67%NBS.
- Concrete header tanks be removed.
- Cosmetic repairs be undertaken as required.

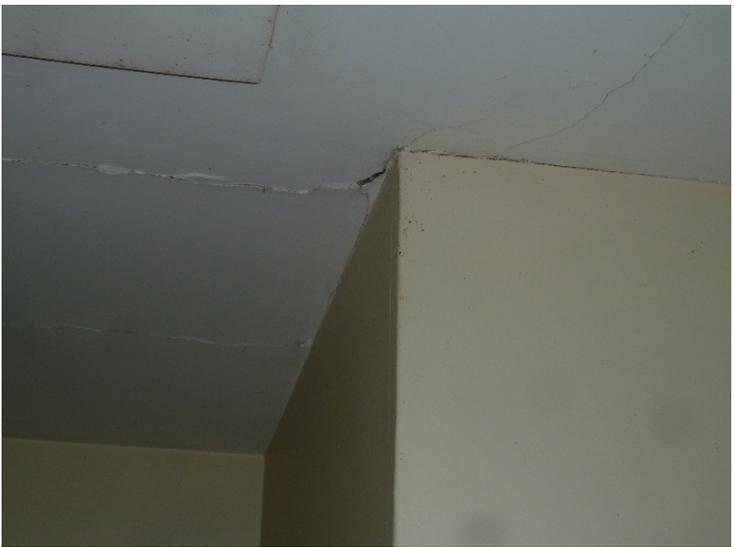
<p>11.</p>	<p>Typical cracking of the roof diaphragm</p>

Cracking of ceiling diaphragms was observed in many of the units, typically at the joint between panels. Cracking of the lathe and plaster wall linings was observed in most units, typically around windows and above doorways. While this was consistent throughout all the units visited, this damage was more significant in the units at 11, 15, 17, 23, 25 Griffiths Ave, 17 Coulter St and 4 Nicholas Drive. This damage however is deemed minor and does not affect the lateral resistance structure.

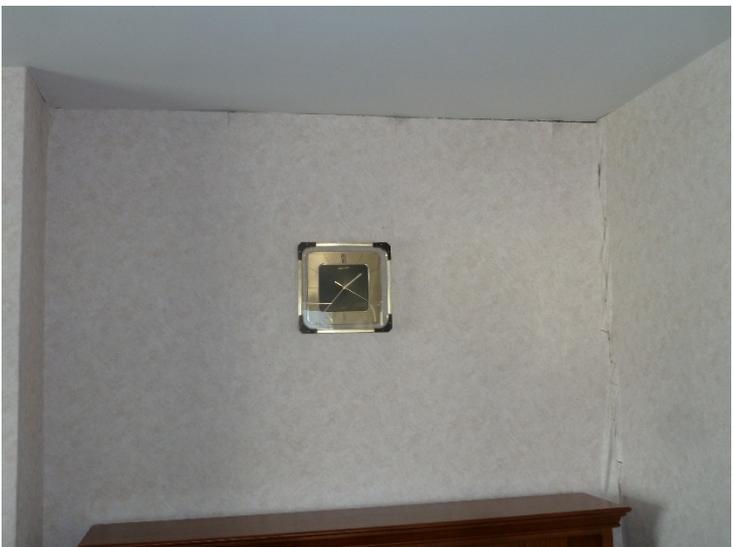
<p>14.</p>	<p>Splitting between interior walls and the firewall</p>

Splitting between internal wall linings and the firewall was observed in all units. Cracking of the weatherboard veneer was observed between the board joints. Cracking of the plaster veneers was also observed, typically above or below window frames. Cracking of the concrete entrance stairs was observed across the majority of units.

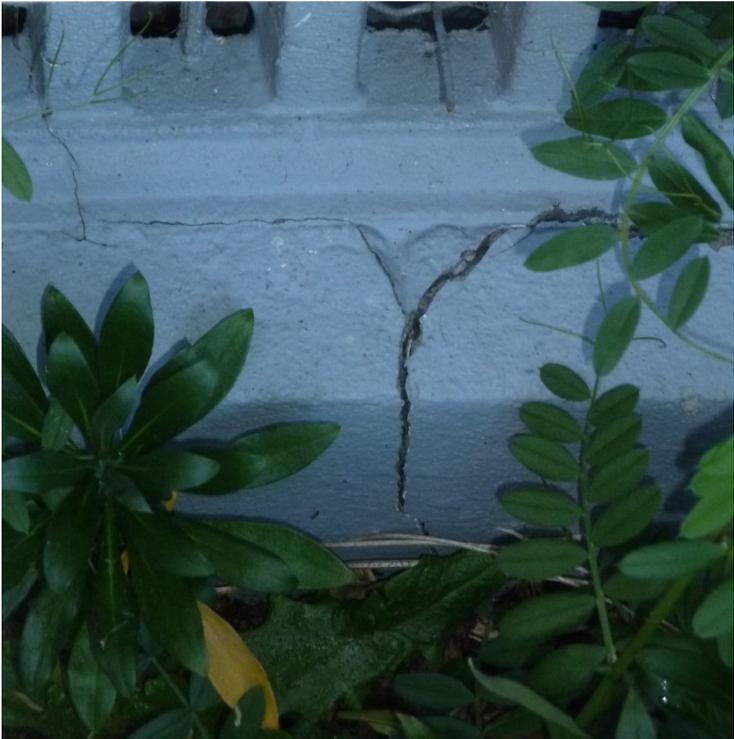
<p>16.</p>	<p>Typical cracking in concrete perimeter foundation footing</p>

The residential units have suffered minor to moderate damage to non-structural elements. This included cracking of the weatherboard and plaster veneer. Moderate cracking was noted to the concrete foundation perimeter footing in some residential unit blocks. Cracking to the wall linings was observed in all units, typically above doorways and around windows. This damage was deemed low enough to not affect the capacities of the buildings.

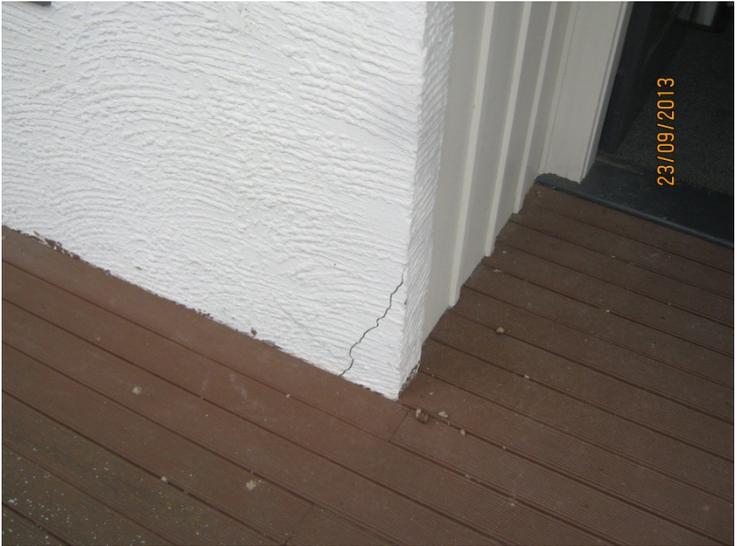
<p>18.</p>	<p>22 Griffiths Ave – Cracking to exterior plaster cladding</p>

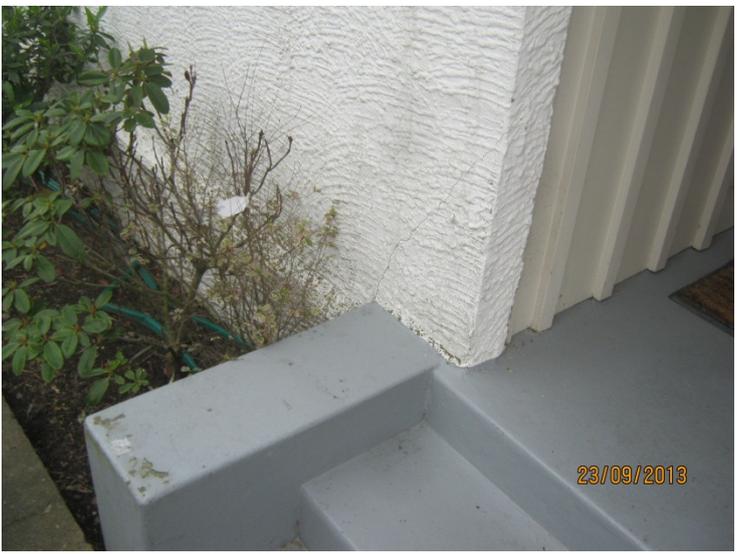
<p>19.</p>	<p>Cracking to exterior plaster cladding</p>

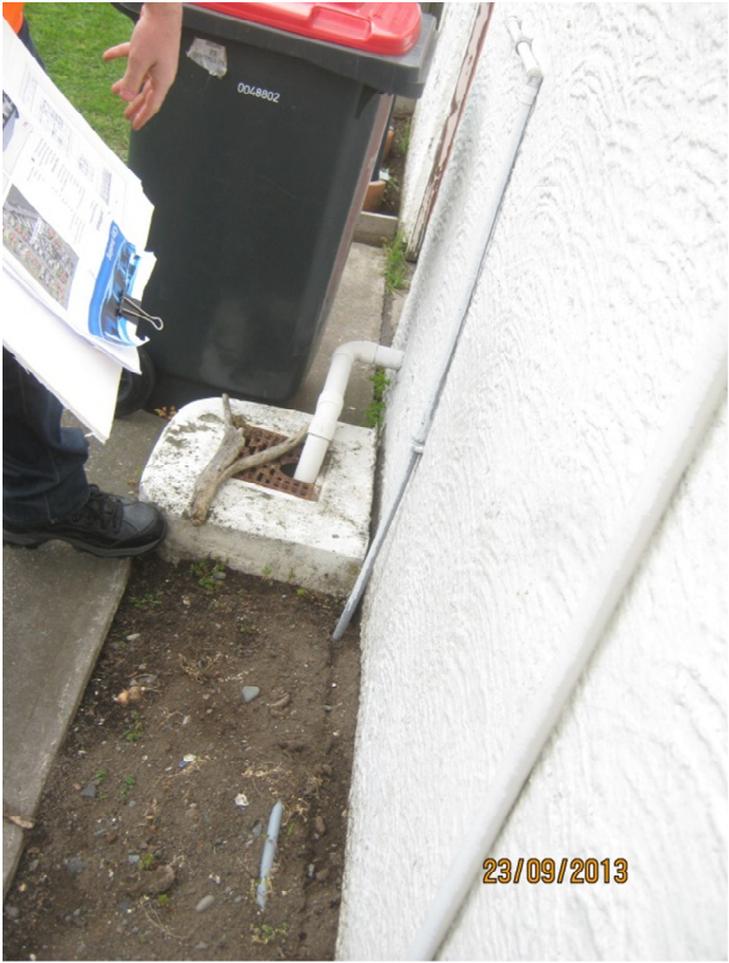
<p>20.</p>	<p>Concrete gully trap surround separated from building</p>

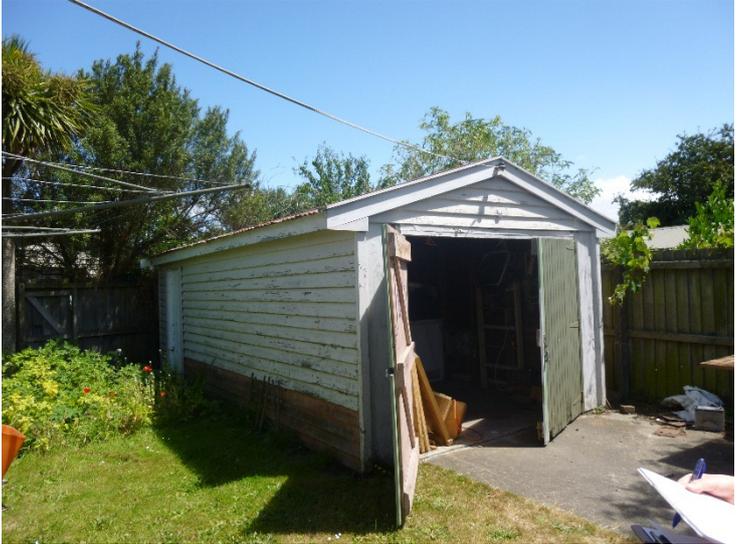
- The garages at 12 Nicholas Drive and 18 Griffiths Avenue have capacities of more than 33%NBS, as limited by the in-plane capacity of the bracing walls. They are deemed to be a 'moderate risk' in a design seismic event according to NZSEE guidelines. Their level of risk is 5-10 times that of a 100% NBS building (Figure 1). These garages have inadequate connection of rafters at the apex affecting capacity to resist gravity loading.

- The timber garages at 12 Nicholas Drive and 18 Griffiths Avenue be strengthened to support gravity loads and to at least 67%NBS.
- Strengthening schemes be developed to bring the capacities of the garages at 9-11 and 17-19 Coulter Ave to at least 67%NBS.
- Concrete header tanks be removed.
- Cosmetic repairs be undertaken as required.

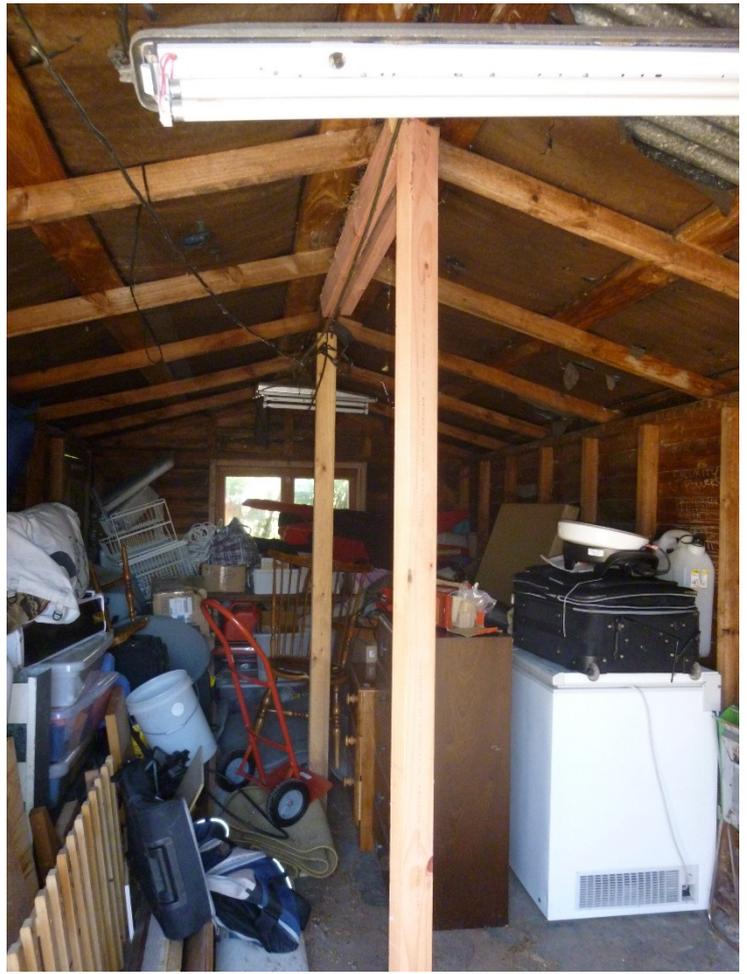
*Gravity load path inadequate due to apex connection of rafters, permanent strengthening recommended.

30. Propped central beam in garage at 18 Griffiths Ave

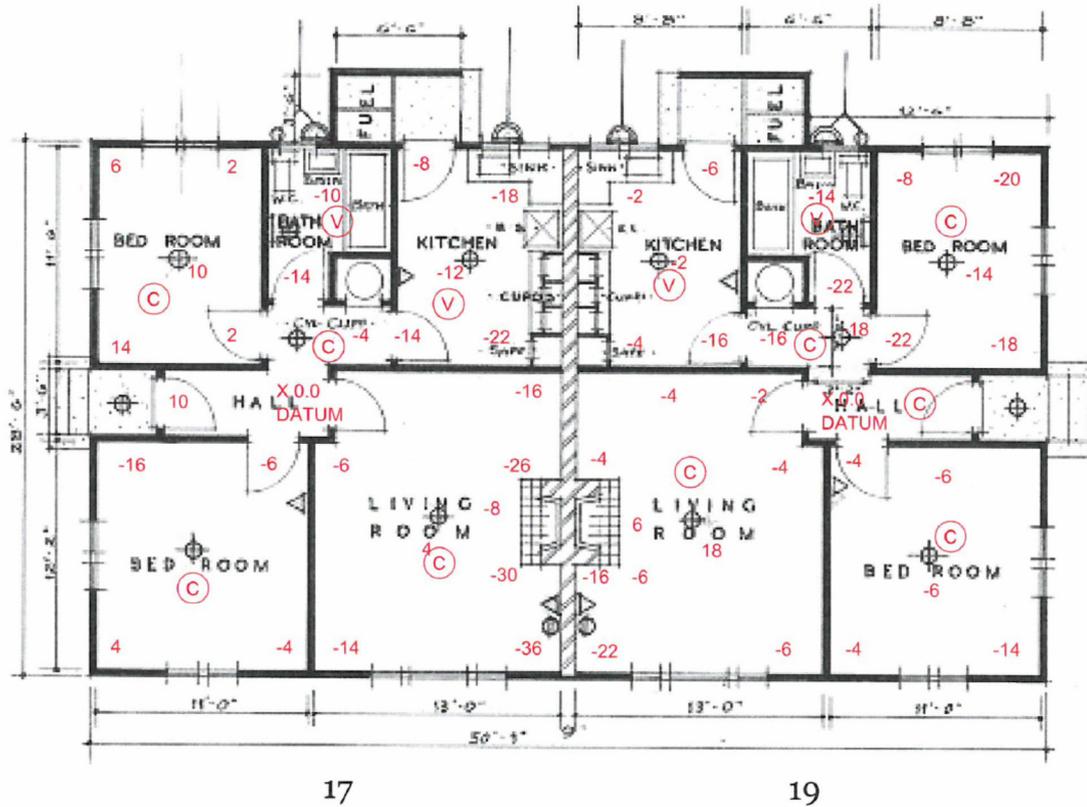
17-19 Coulter Street

Block	Unit No.	Comment	Maximum Fall*
Griffiths Avenue			
A	29	Pass	
	31	Pass	
B	23	Fail	15 mm/m
	25	Fail	16 mm/m
C	15	Fail	10 mm/m
	17	Fail	19 mm/m
D	11	Fail	14 mm/m
	13	Pass	
E	3	Pass	
	12	Pass	
H	18	Pass	
	20	Pass	
I	22	Pass	
	24	Pass	
Coulter Street			
J	17	Fail	14 mm/m
	19	Fail	11 mm/m
K	9	Pass	
	11	Pass	
Nicholas Drive			
F	14	Pass	
	14a	Pass	
G	2	Pass	
	4	Fail	13mm/m
L	6	Pass	
	8	Pass
