Scarborough Fare Tearooms BU 1471-001 EQ2

Detailed Engineering Evaluation
Quantitative Report
Version FINAL

147, Esplanade, Sumner

Date
2nd October 2012

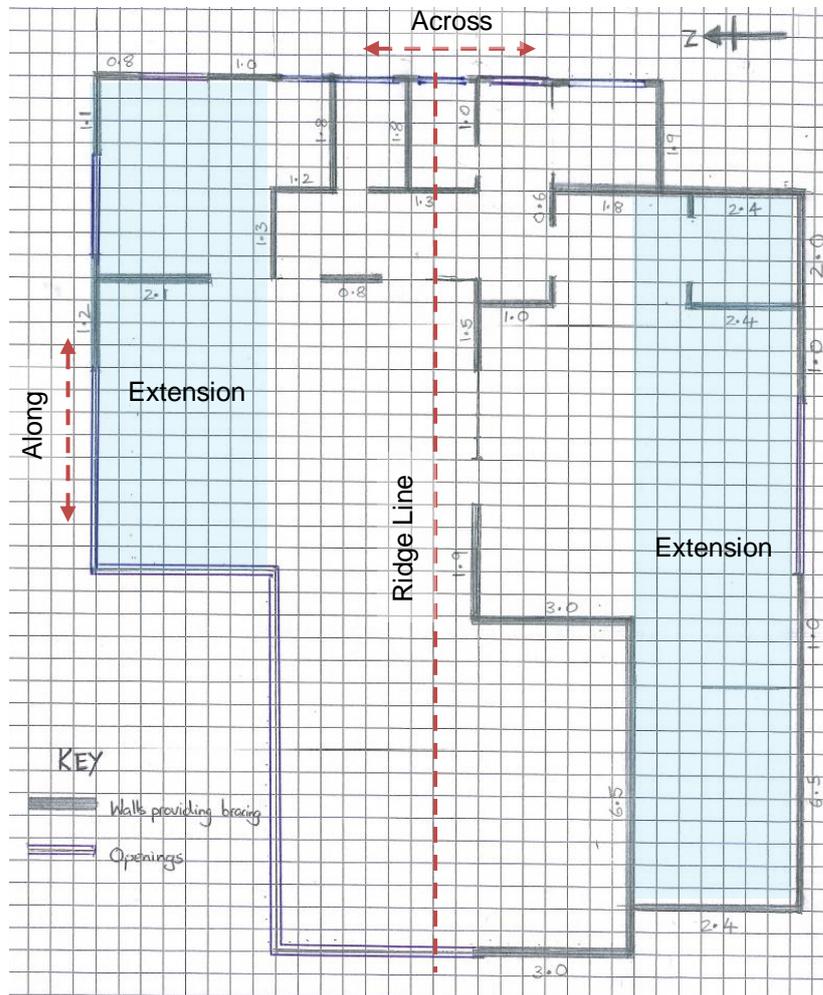
Figure 2 Plan Sketch of building showing bracing walls and openings

Lateral loads acting on the structure in both the long and short directions of the building are resisted by timber framed walls braced with plasterboard lining. The braced walls are distributed throughout the building in both the long and short directions. Seismic forces acting on the building during an earthquake are distributed to the braced walls through diaphragm action of the plasterboard lined ceiling.

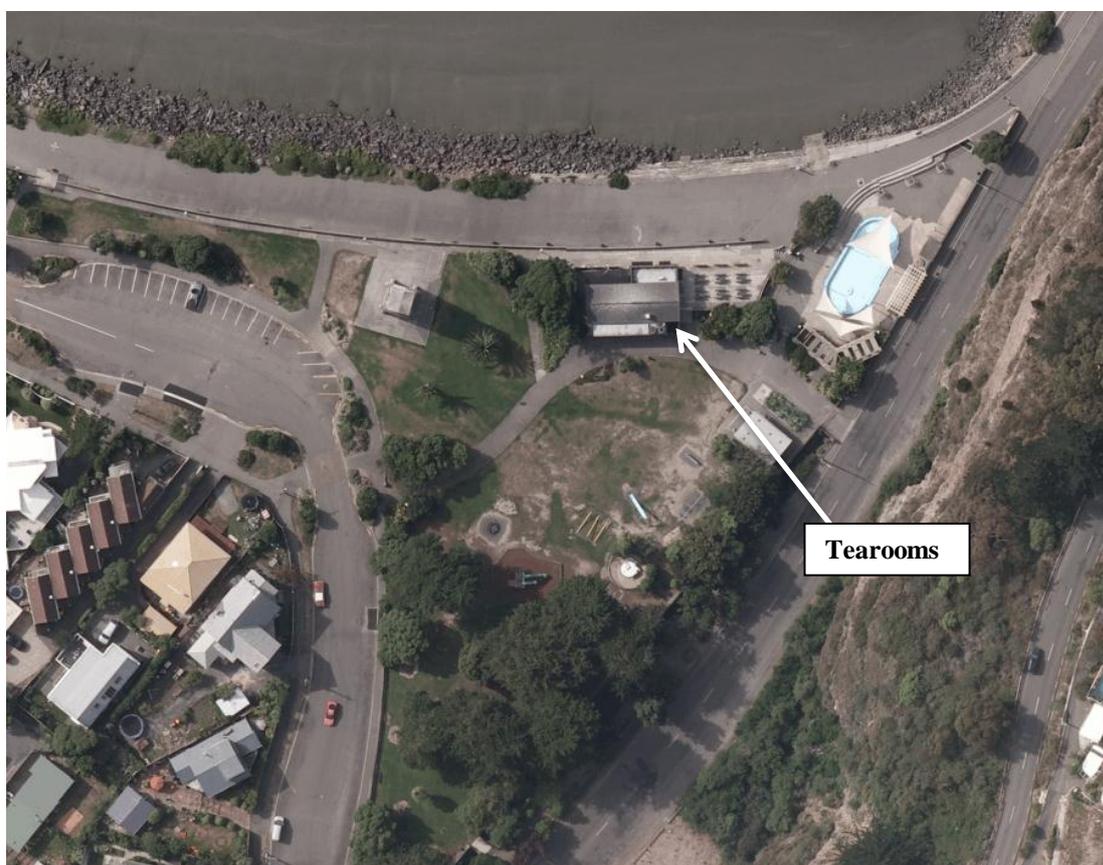
Figure 3 Post February 2011 Earthquake Aerial Photography²

Aerial photography taken following the 22 February 2011 earthquake (Figure 1) show signs of liquefaction with sand boils eminent near the site.

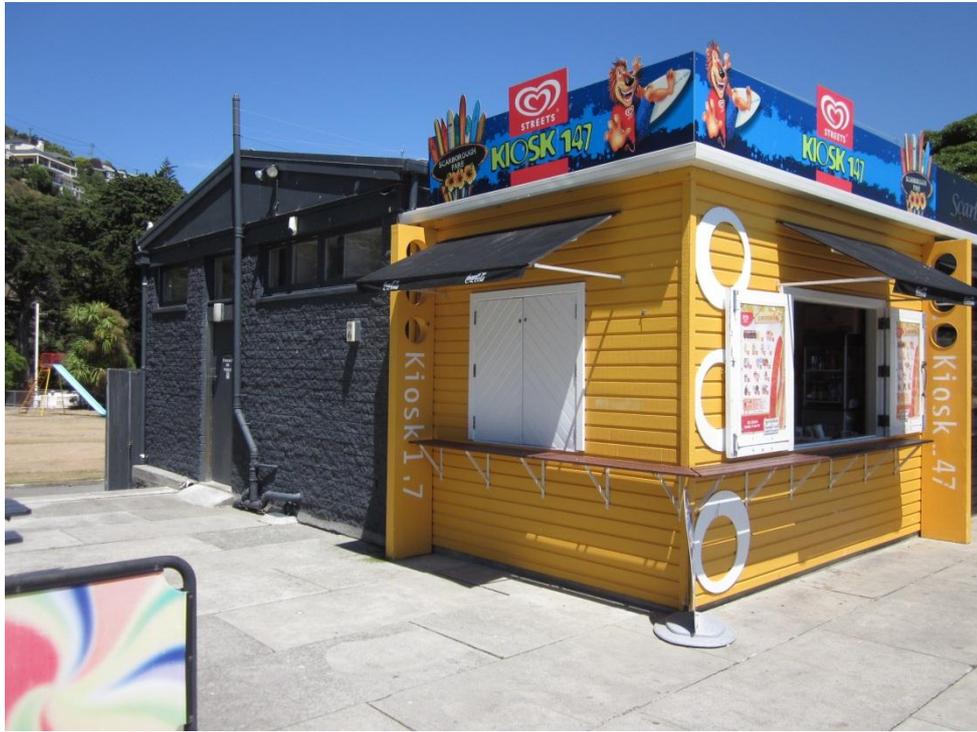
Photograph 1 View of extension (yellow section) to the northern side of the building.

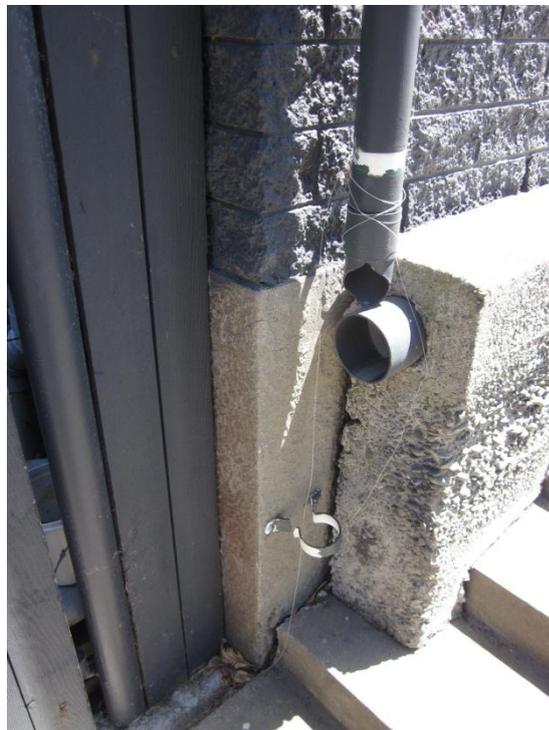
Photograph 2 View of minor cracking between the building foundations and external concrete steps.

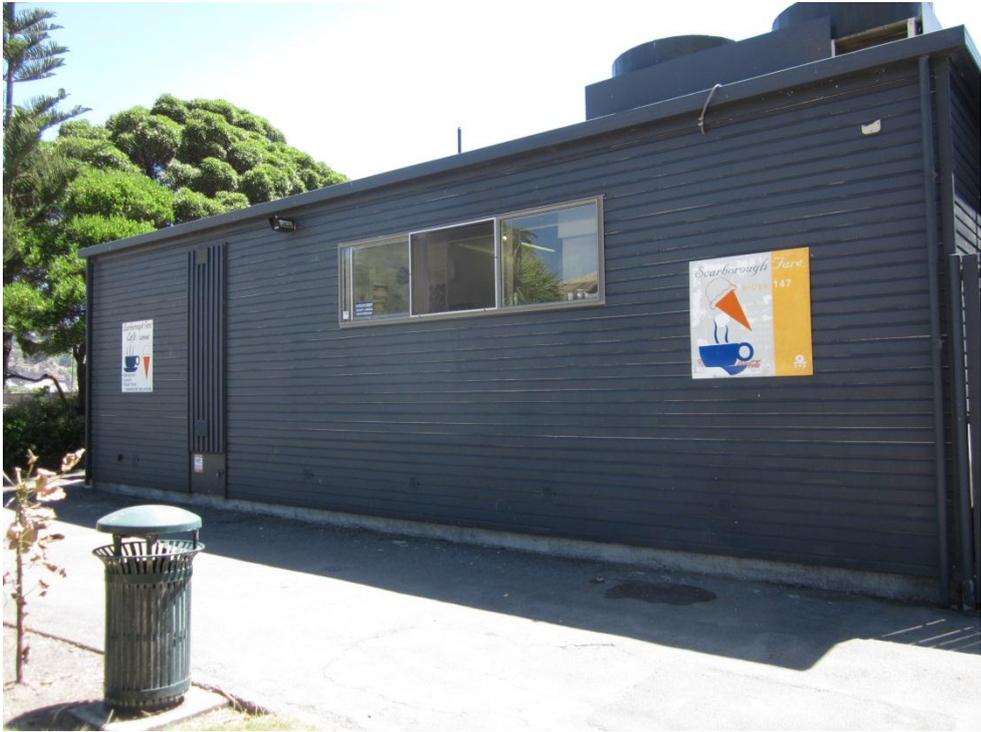
Photograph 3 View of extension to southern side of building.

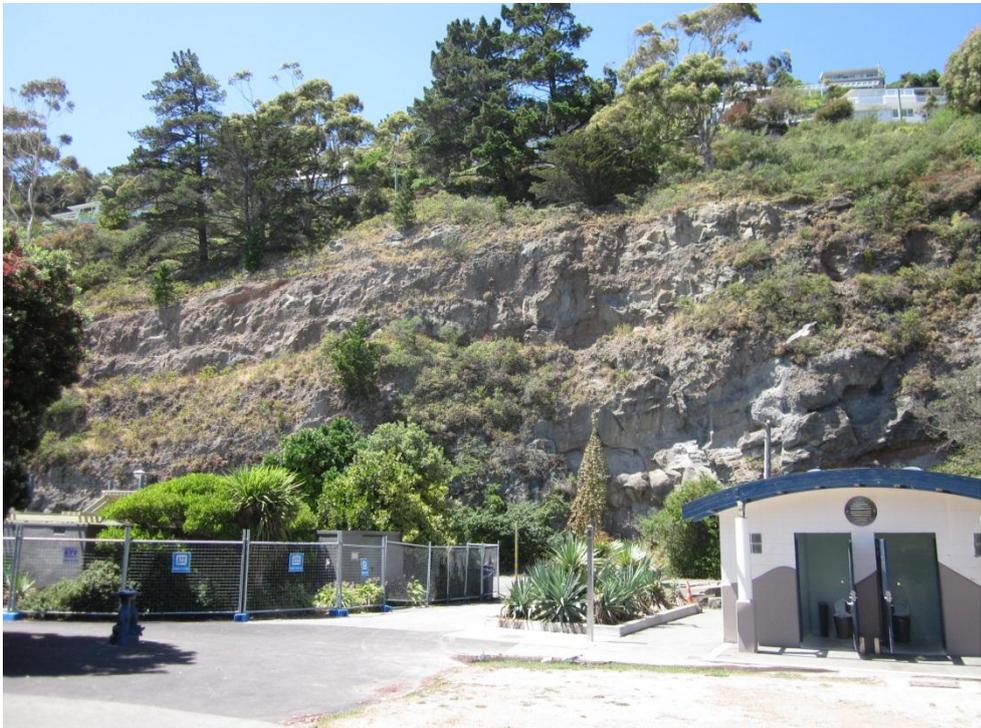
The site itself is located adjacent to the beach and within a predominantly flat section of Sumner. However, the site is approximately 50m from the cliffs. Evidence of rockfall was noted during the site inspection beneath these cliffs. However, minor rockfall is not anticipated to impact on the site. An analysis of the slope stability is beyond the scope of this report. Any localised retaining structures and/or embankments installed at or near the cliff should be investigated to determine the site-specific slope failure or rockfall potential.

Photograph 4 Cliffs to the south-east of the building.

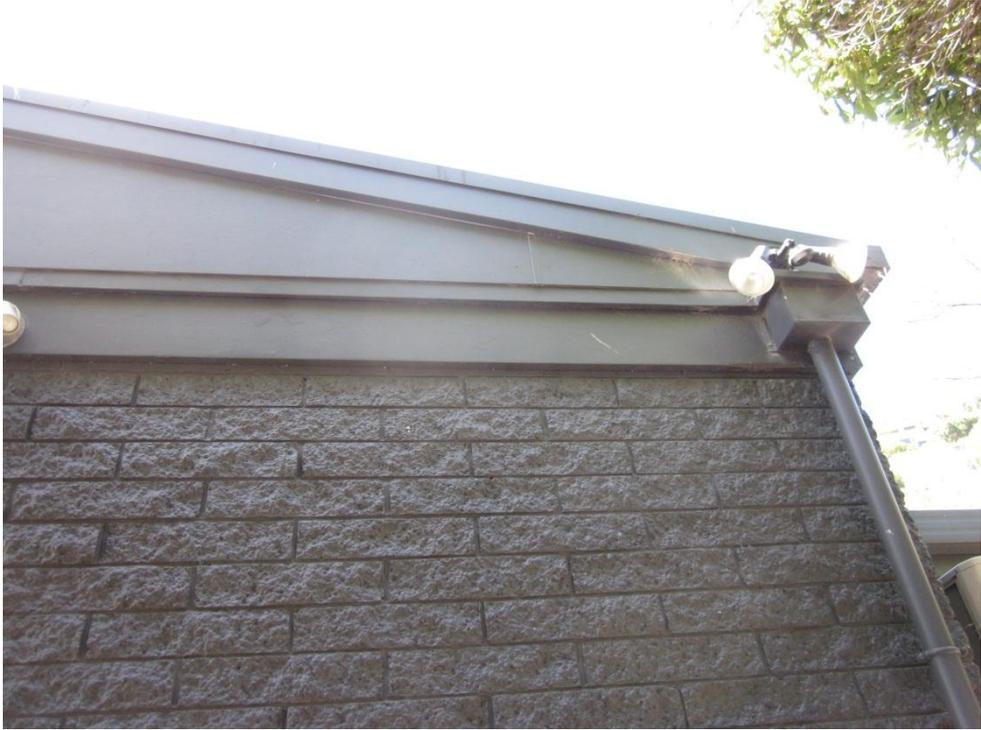
Photograph 5 Brick veneer cladding.

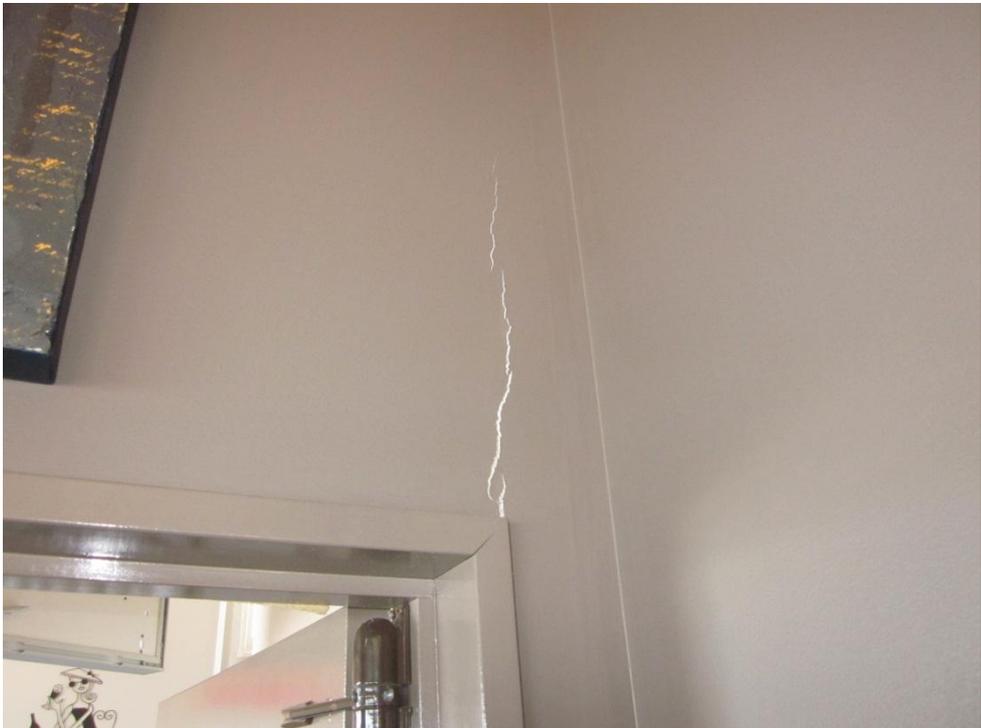
Minor cracking to the internal plasterboard lining above and around doorways was observed in several locations throughout the building. These are shown in Photograph 6 to Photograph 10. The damage to the plasterboard lining is due to movement of the structure during an earthquake. The ductile timber frame is able to accommodate movement during an earthquake; however the plasterboard lining has behaved in a more brittle manner and has cracked as a result of the movement.

Photograph 6 Cracking to plasterboard lining above internal doorway.

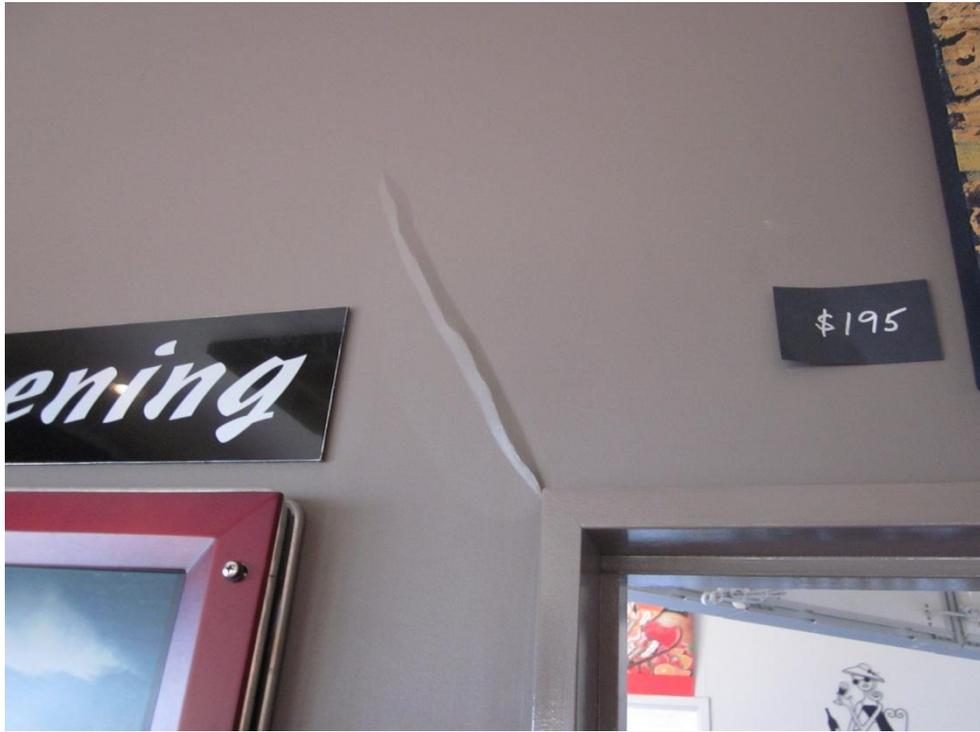
Photograph 7 Diagonal cracking to plasterboard lining above internal doorway.

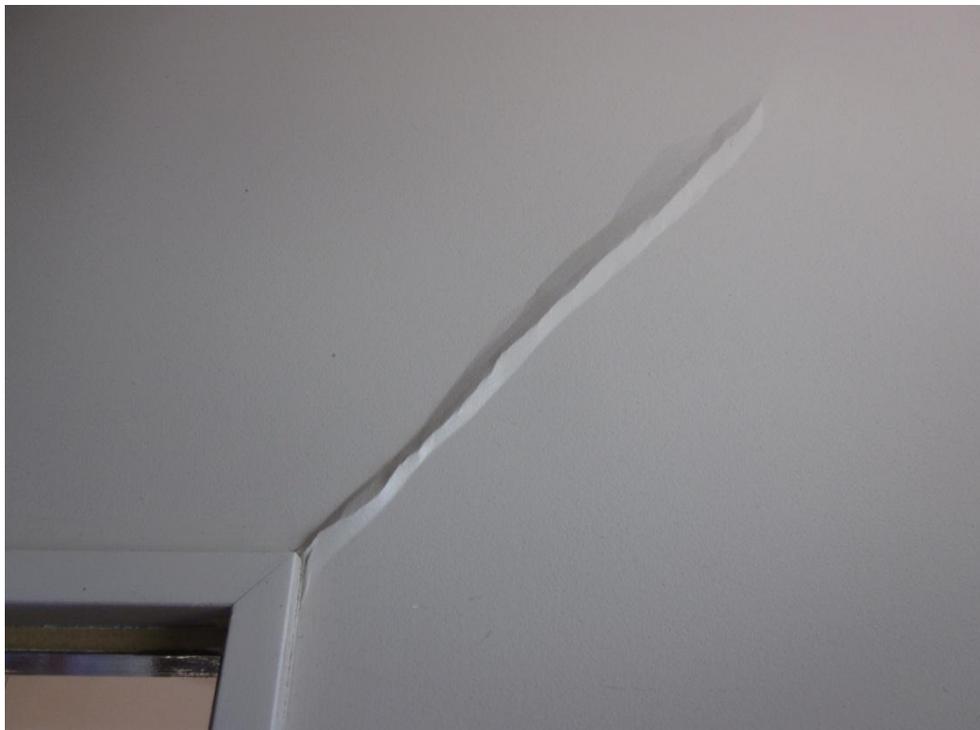
Photograph 8 Further cracking to plasterboard lining above internal doorway.

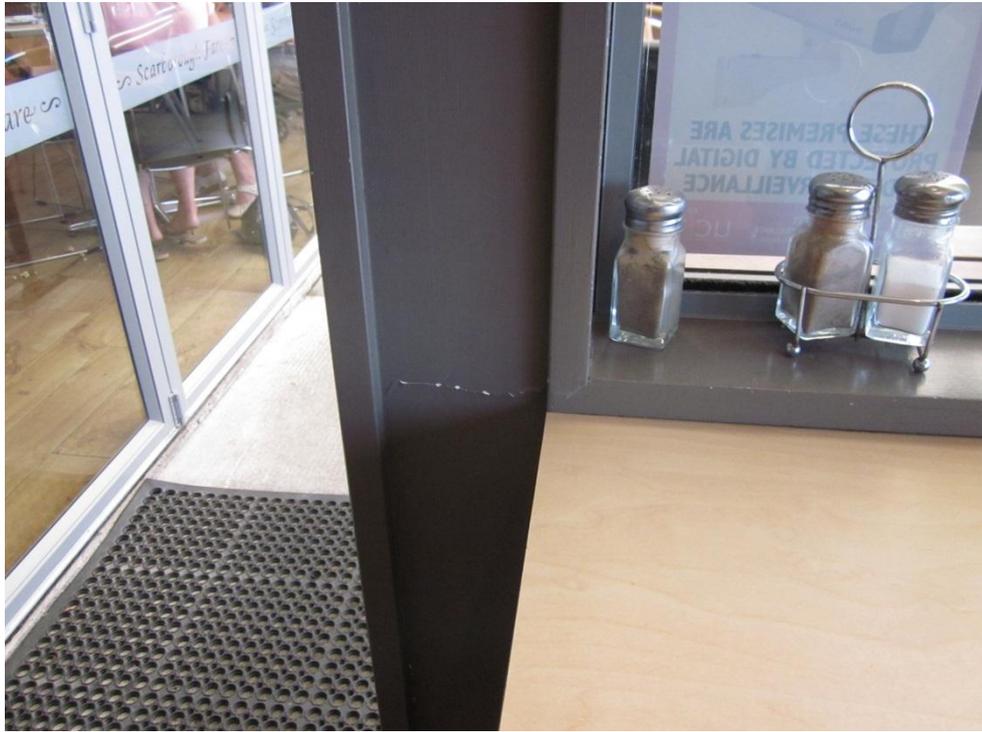
Photograph 9 Cracking to plasterboard lining between external door and window.

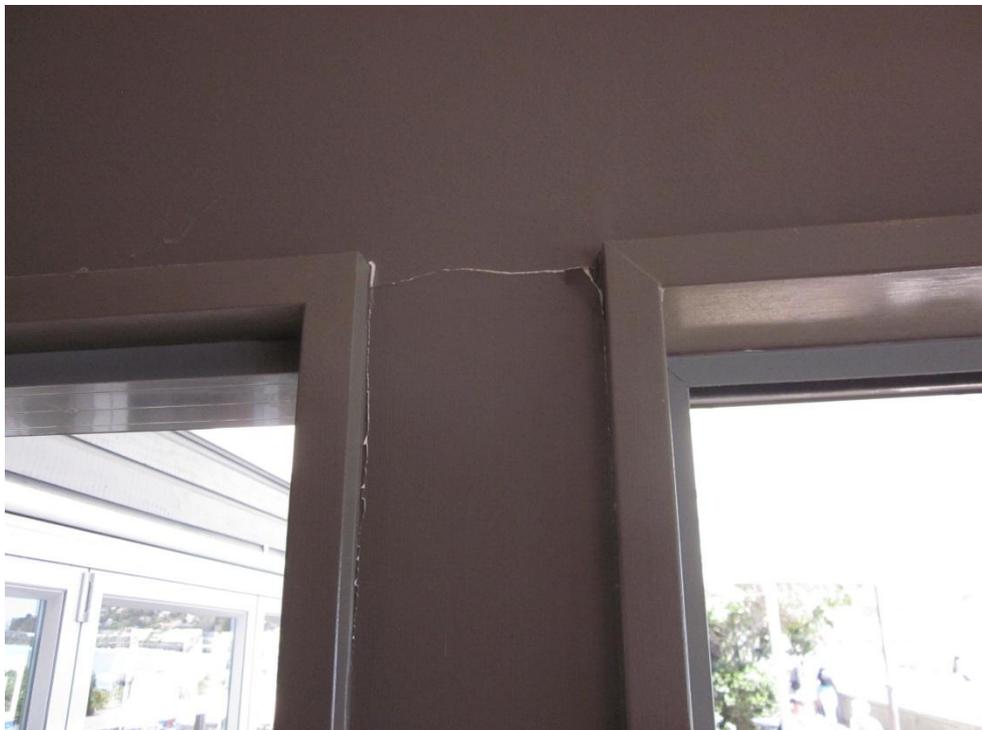
Photograph 10 Cracking to plasterboard lining between external door and window.

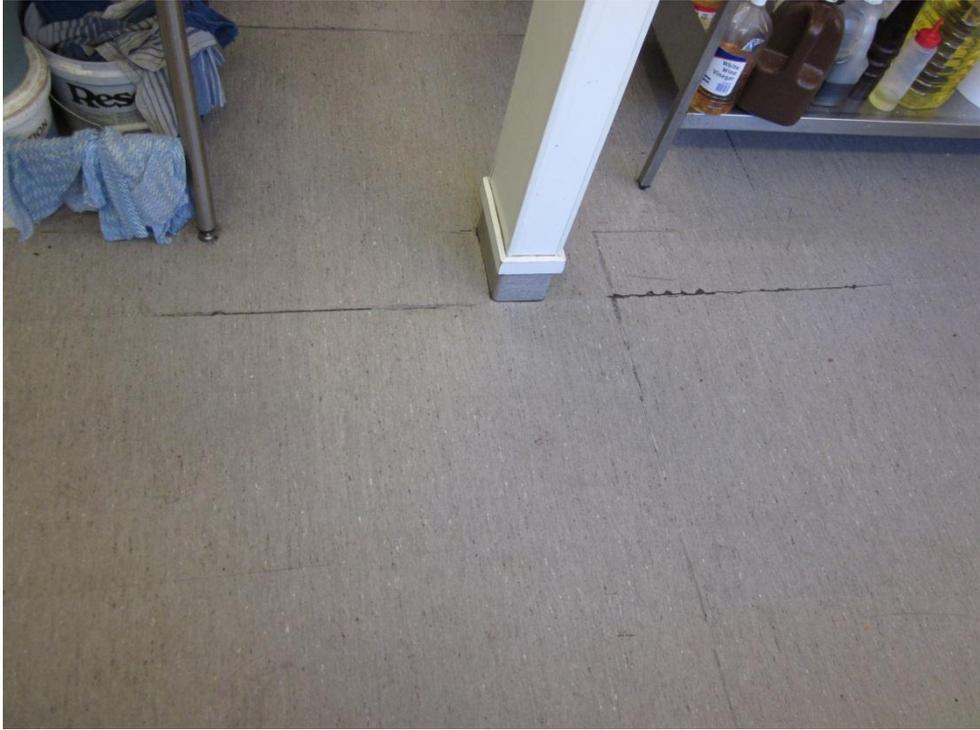
Minor residual displacement of the structure was noted during the inspection of the building. The floor in the kitchen area of the building appears to have undergone movement due to the carpet tiles in this area having separated as can be seen in Photograph 11. This is likely due to some minor settlement of the building foundations.

Photograph 11 Minor residual displacement of floor shown by displaced carpet floor tiles.

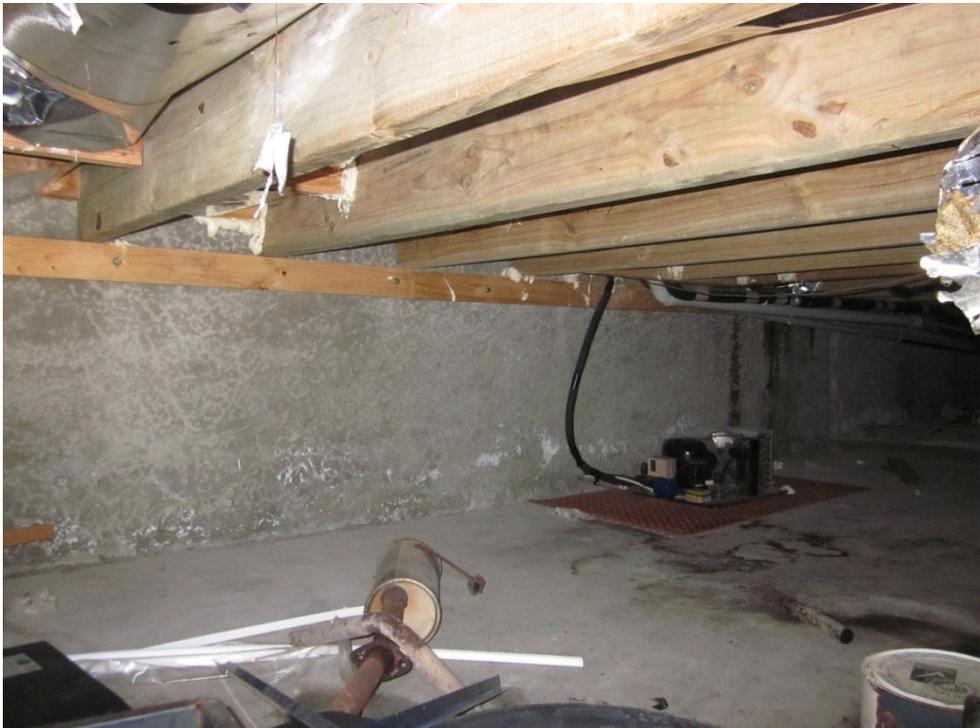
Photograph 12 Substructure and foundations of extension to southern side of original building.

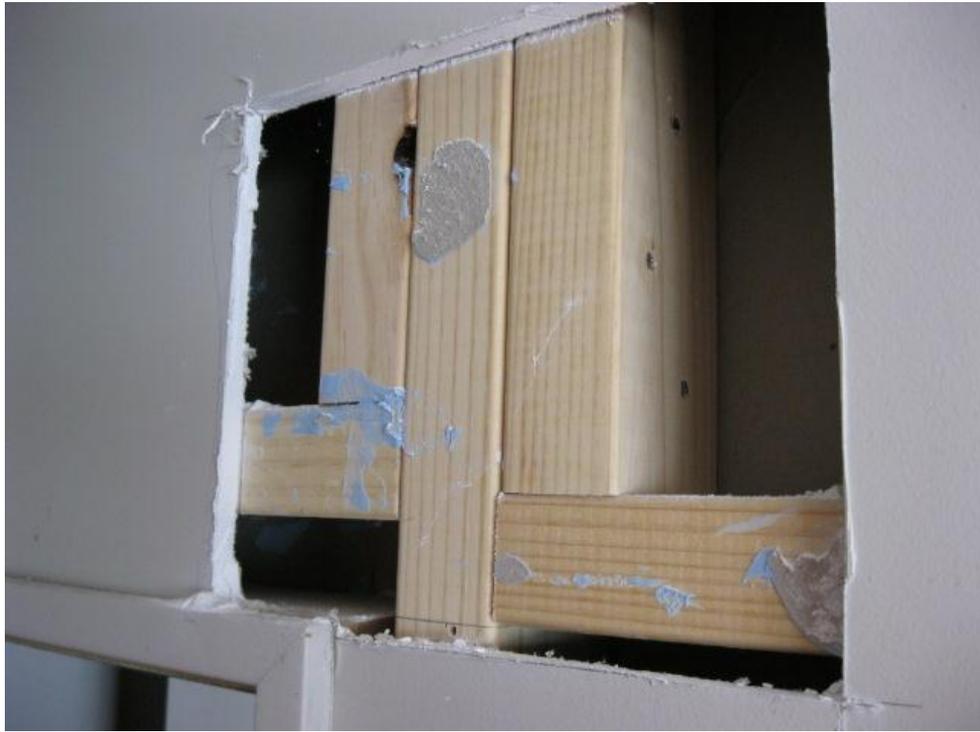
Opening up works were carried out on 13th of February 2012 to determine the extent of damage to the timber structure behind the plasterboard lining where cracking was visible. An area with diagonal cracking in the plasterboard lining above an internal doorway was opened up. The opening up work carried out can be seen in Photograph 13 and Photograph 14. The connection between the lintel and the timber post was checked to ensure load transfer could still be achieved through the connection. The opening up works performed did not reveal any damage to the timber framed structure behind the lining.

Photograph 13 Opening up works to determine extent of damage to timber structure.

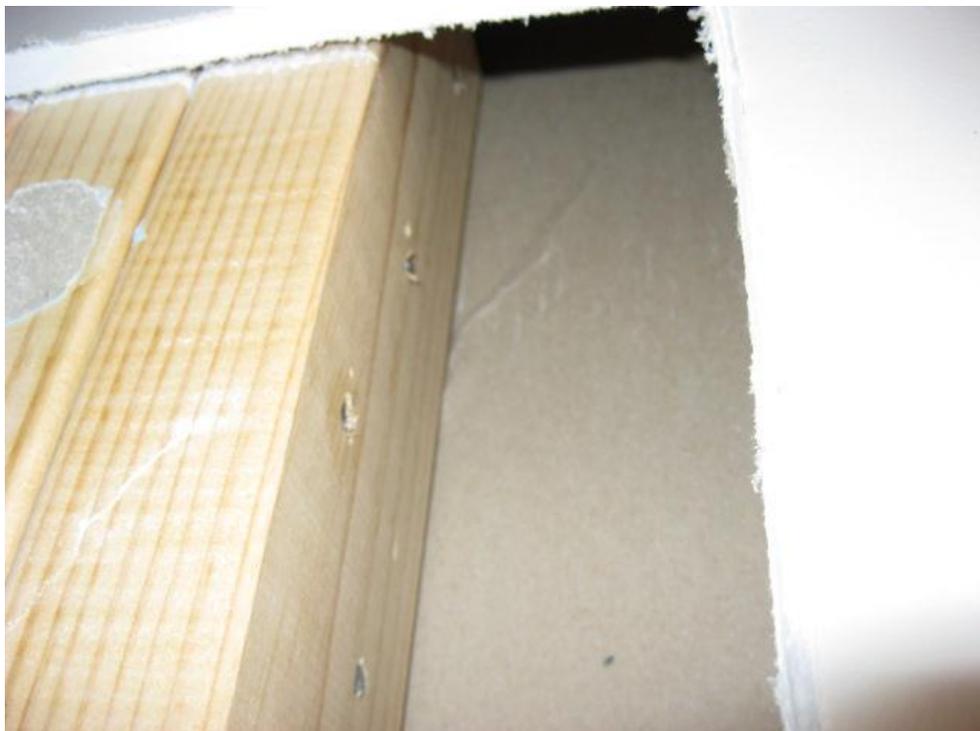
Photograph 14 Close up of opening up work to cracking above internal doorway.
