Christchurch City Council

PRK_1409_BLDG_008 EQ2
Scott Park Ferrymead - Double Garage
2 Main Road

QUALITATIVE ASSESSMENT REPORT FINAL

- Rev B
- 05 November 2012

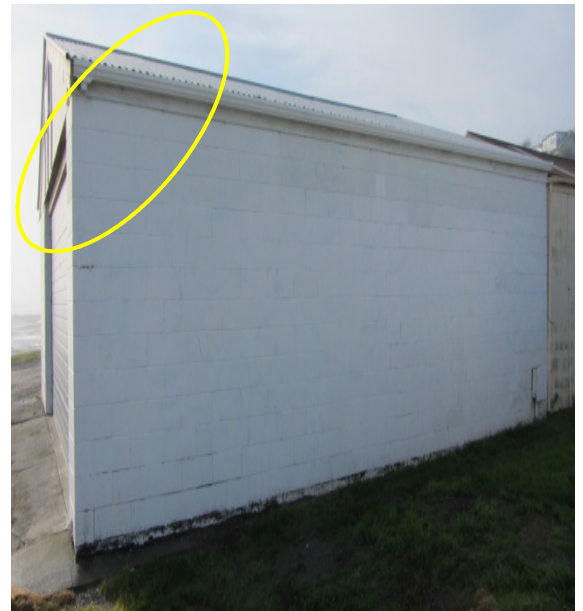
- 0.3mm step cracks in the masonry block joints on the west face of the building

- 1) 0.3mm step cracks in the masonry block joints on the west face of the building
- 2) Evidence of possible settlement was noted at this site, from the level of liquefaction that occurred. A level survey is not required at this stage of assessment due to the size of the structure.

Photo 4: West Elevation, showing the location of the step cracks through the mortar joints.

We do not believe that it will be cost effective to strengthen this building and hence we recommend that no further assessment or strengthening is carried out.

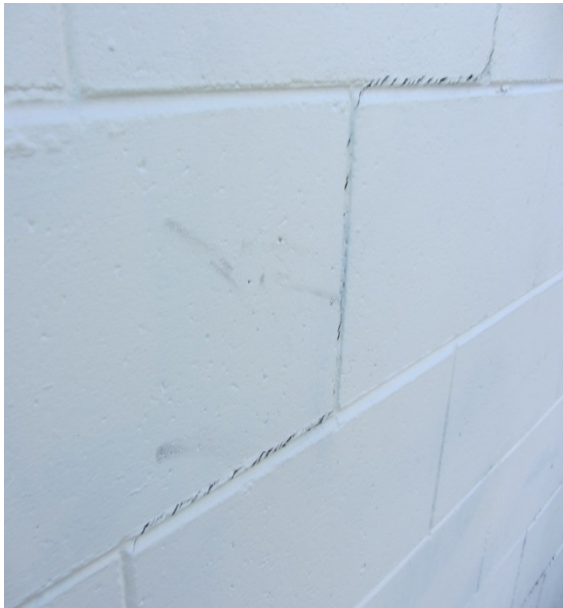
Photo 5: Close up view of steps cracks through mortar joints in photo 4

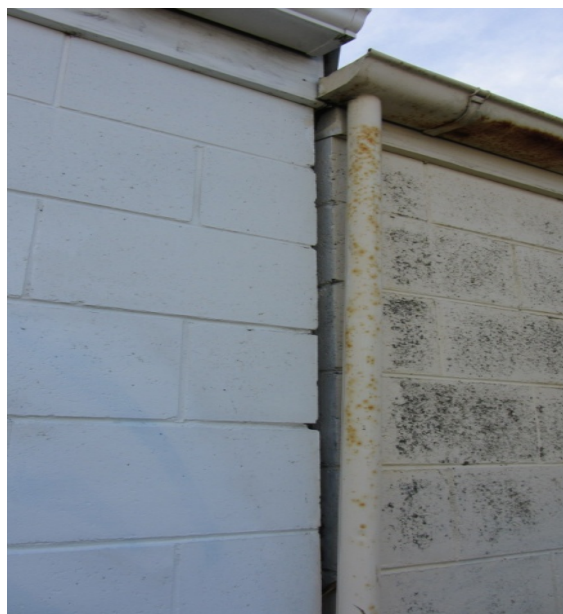
Photo 7: 25mm separation between the south elevation of the garage and the storage shed (1)

There was no significant structural damage noted on any of the buildings. The gap between the double garage and shed appeared slightly wider at the base of the building and narrowed with height; however, this is not believed to be as a result of earthquake damage.

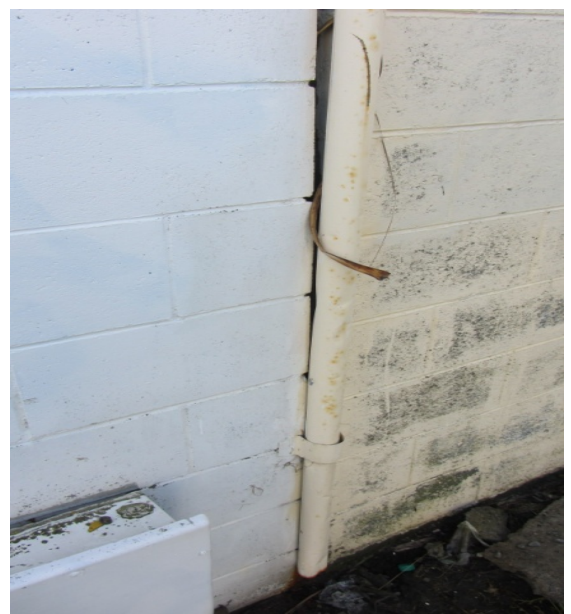
Photo 8: 25mm separation between the south elevation of the garage and the storage shed (2)

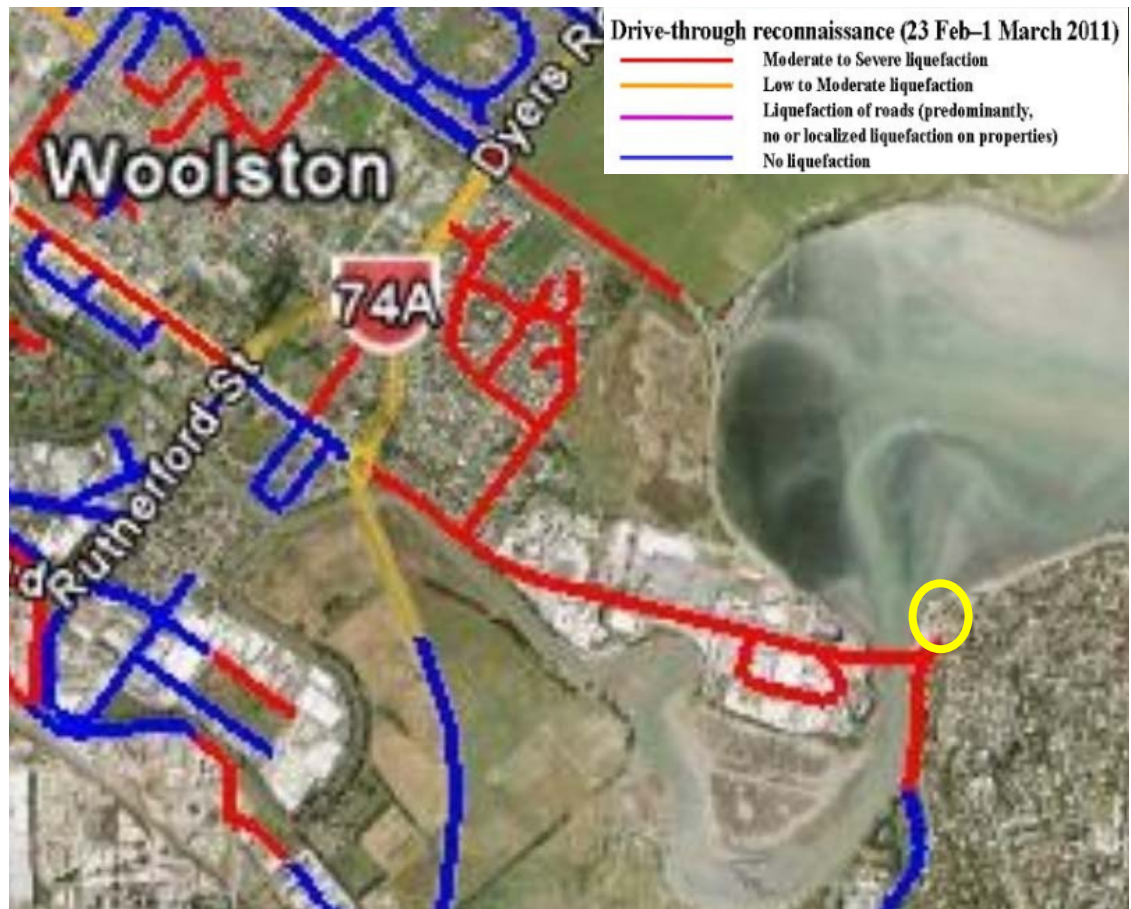
■ **Figure 4 – Liquefaction map (Cubrinovski & Taylor, 2011). Site marked in yellow.**

Following the 22 February 2011 event drive through reconnaissance was undertaken from 23 February until 1 March by M Cubrinovski and M Taylor of Canterbury University. The site is located near the edge of the drive through reconnaissance. However, moderate to severe liquefaction was noted in the area immediately west of the site.

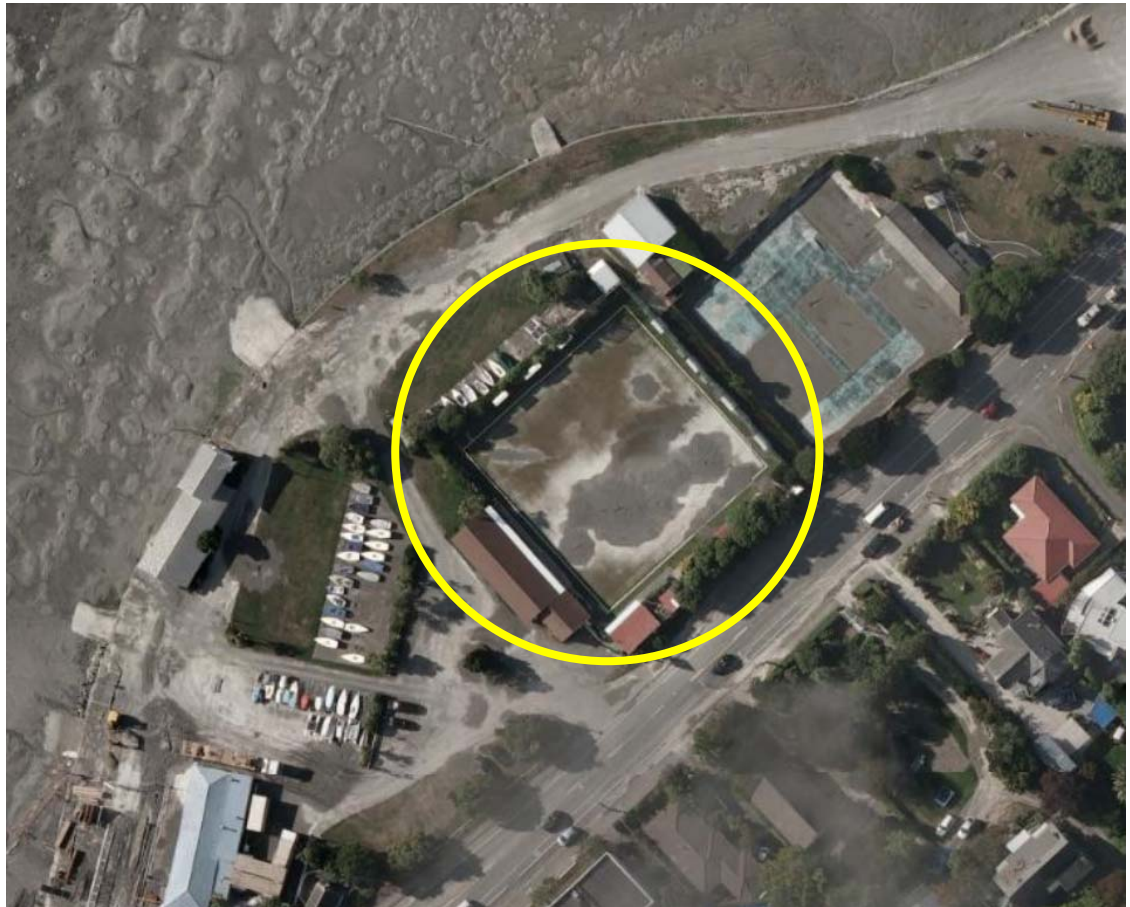
- **Figure 5 – Aerial photography from 24 Feb 2011 (<http://viewers.geospatial.govt.nz/>)**

Severe liquefaction on site and in the surrounding areas could be seen from the aerial photograph. Although there appears to be no significant evidence of lateral spreading, due to scale of liquefaction on site it is expected that some lateral spreading towards the estuary is likely to have occurred.

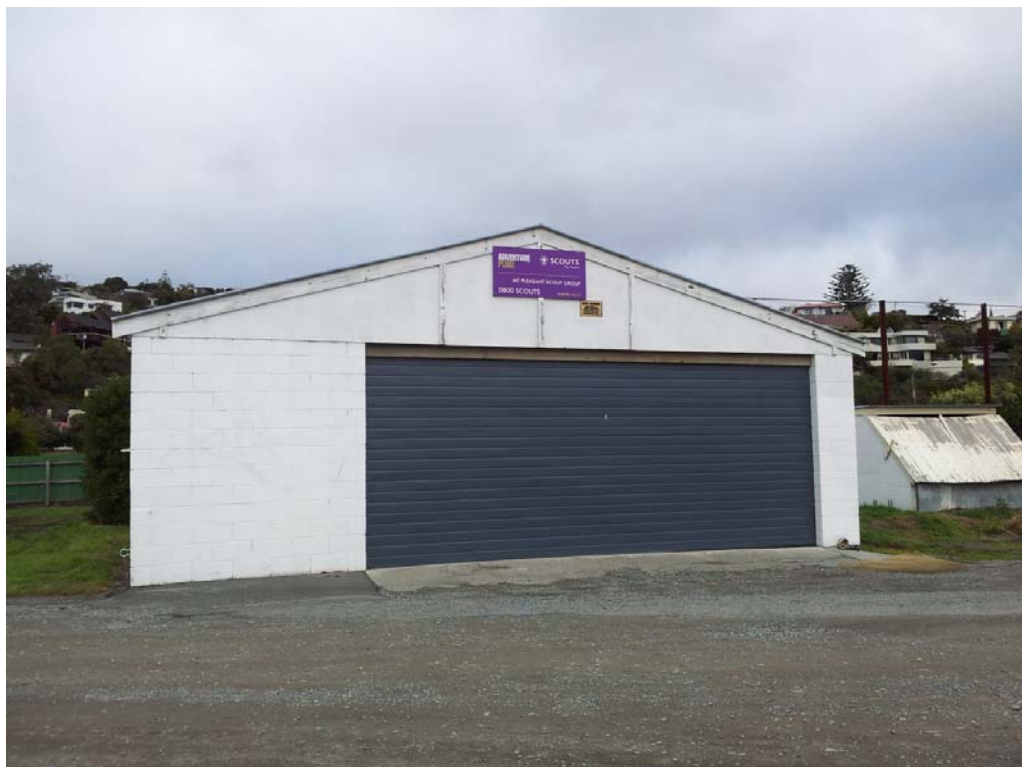
Significant evidence of liquefaction was observed during the external site walkover. Piles of sand ejecta and undulating grass land were noted on the bowls lawn. Ground bulges were also evident on nearby petanque courts where silt or sand ejecta domes had been trapped beneath the asphalt. Some ejecta was also observed adjacent to the buildings. No visual evidence of lateral spreading or settlement was noted at the site; however, due to the scale of liquefaction on the site, it is likely that some settlement of the structure would have occurred.

■ **Figure 8 Overview of the double garage (PRK_1409_BLDG_008) referred to as “rescue boat shed” in the council files drawing**

However, it is expected that a degree of settlement is likely to have occurred as a result of the severe liquefaction on site. It is, however, not clear whether the settlement was within the tolerable level for the structure. Therefore, it could not be said whether the current foundations would be adequate if an event similar in magnitude to the 22 February 2011 earthquake were to occur without a more detailed assessment of the settlement and examination of any structural damage that occurred as a consequence.
