Christchurch City Council
PRK_1409_BLDG_009 EQ2
Scott Park Ferrymead – Storage Shed
2 Main Road

QUALITATIVE ASSESSMENT REPORT
FINAL

- Rev B
- 24 September 2013

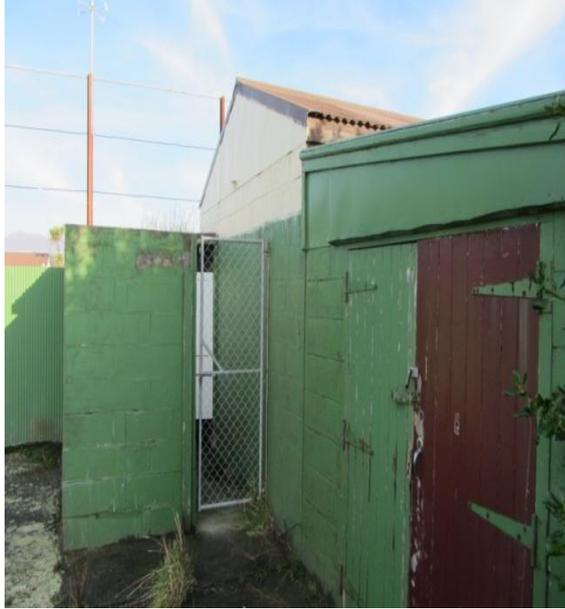
Photo 1: South Elevation

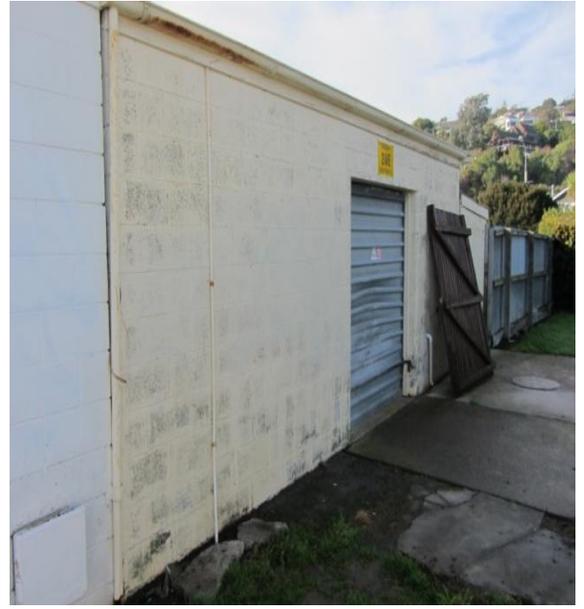
Photo 2: West Elevation

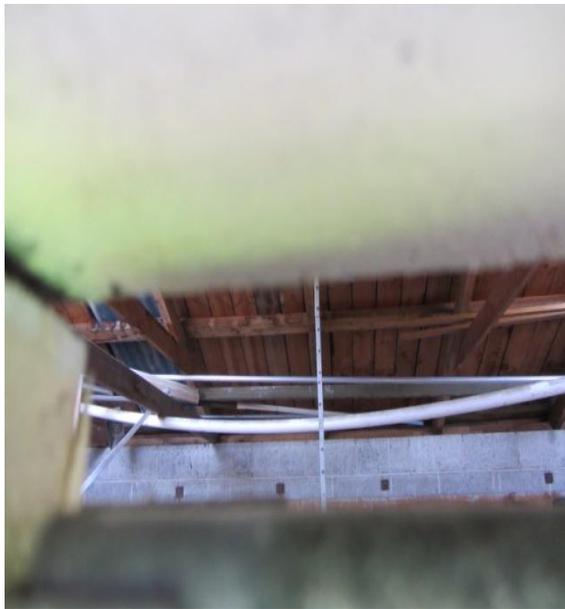
Photo 3: Internal view of shed

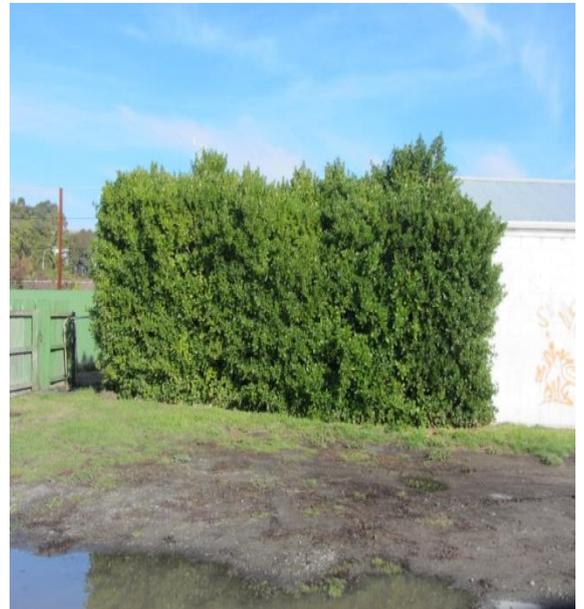
Photo 4: East Elevation (building is behind the hedges)

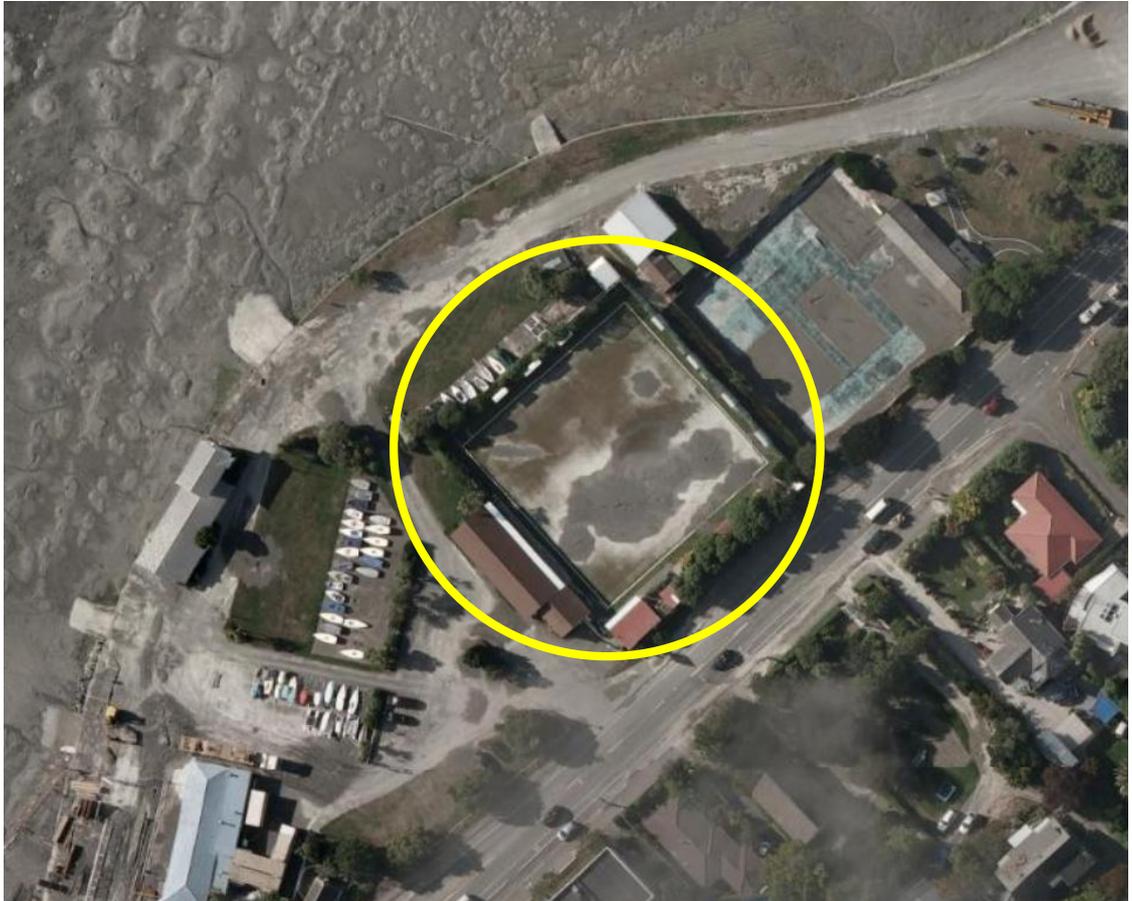
- **Figure 5 – Aerial photography from 24 Feb 2011 (<http://viewers.geospatial.govt.nz/>)**

Severe liquefaction on site and in the surrounding areas could be seen from the aerial photograph. Although there appears to be no significant evidence of lateral spreading, due to scale of liquefaction on site it is expected that some lateral spreading towards the estuary is likely to have occurred.

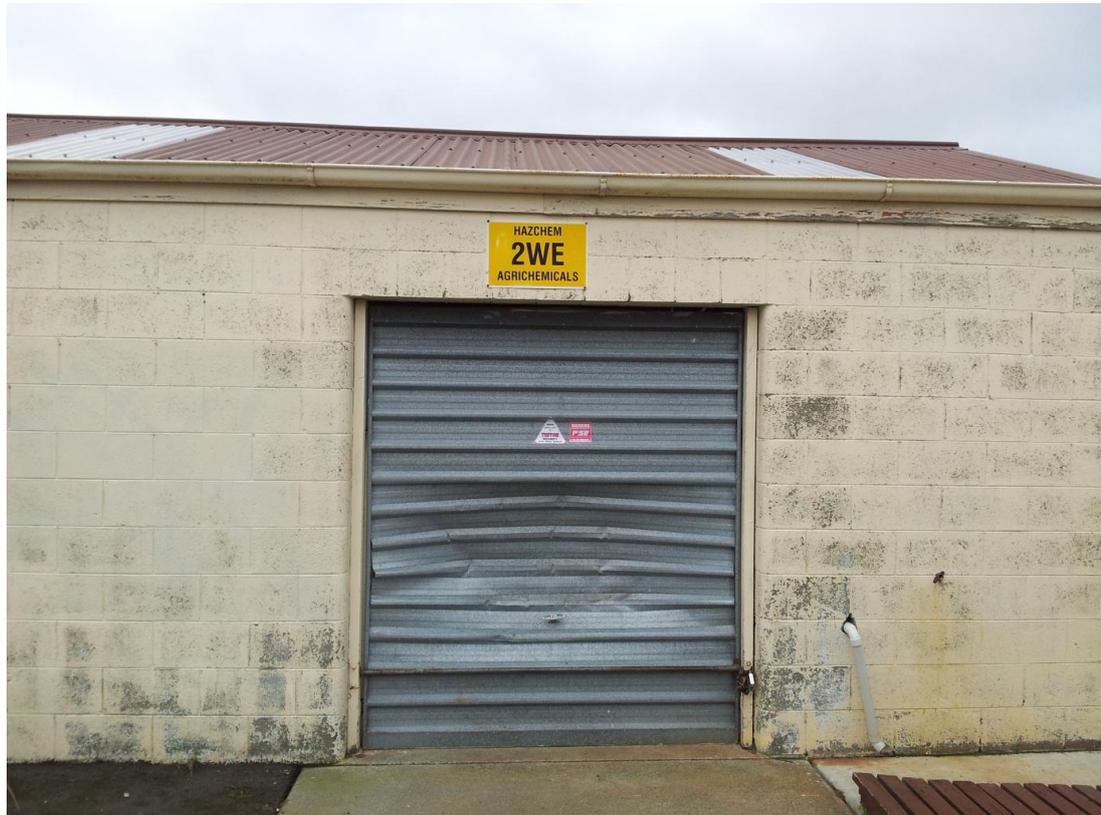
There was no significant structural damage noted on any of the buildings. The gap between the double garage and shed appeared slightly wider at the base of the building and narrowed with height; however, this is not believed to be as a result of earthquake damage.

■ **Figure 9 Overview of the shed (PRK_1409_BLDG_009)**
