Christchurch City Council  
PRK\_1409\_BLDG\_007 EQ2  
Scott Park Ferrymead - Storage Shed  
2 Main Road

QUALITATIVE ASSESSMENT REPORT

FINAL

- Rev B
- 23 May 2013

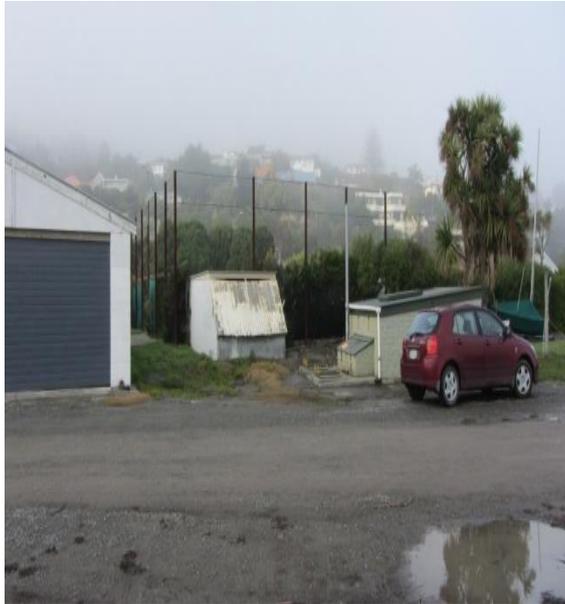
Photo 1: Overall view of the storage shed

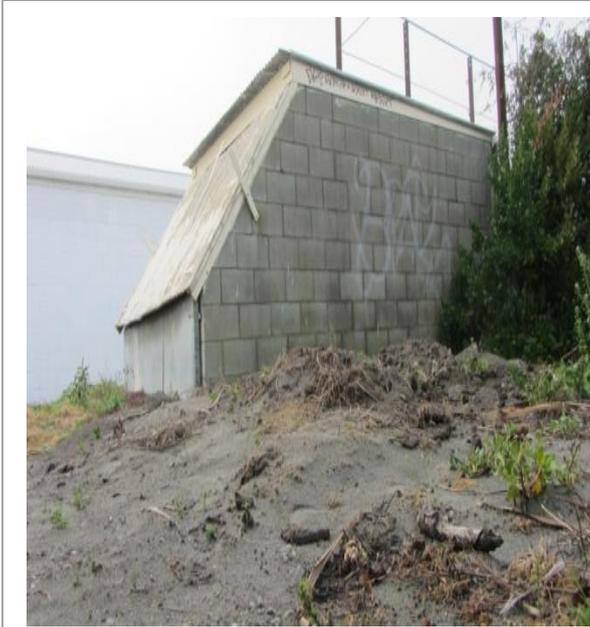
- 1) No external damage was observed during our site inspection.
- 2) Evidence of possible settlement was noted at this site, from the level of liquefaction that occurred. A level survey is not required at this stage of assessment due to the size of the structure.

Photo 5: View showing evidence of liquefaction near the shed

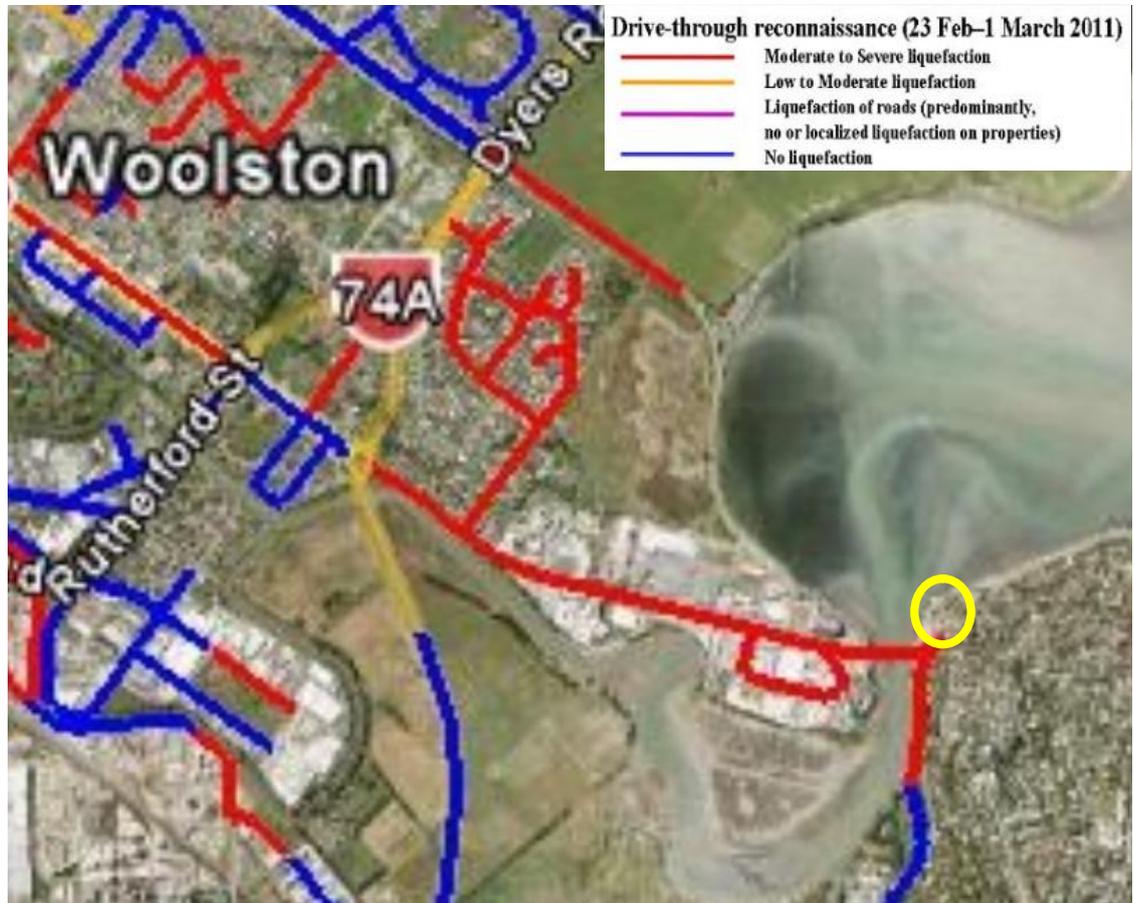
■ Figure 4 – Liquefaction map (Cubrinovski & Taylor, 2011). Site marked in yellow.

Following the 22 February 2011 event drive through reconnaissance was undertaken from 23 February until 1 March by M Cubrinovski and M Taylor of Canterbury University. The site is located near the edge of the drive through reconnaissance. However, moderate to severe liquefaction was noted in the area immediately west of the site.

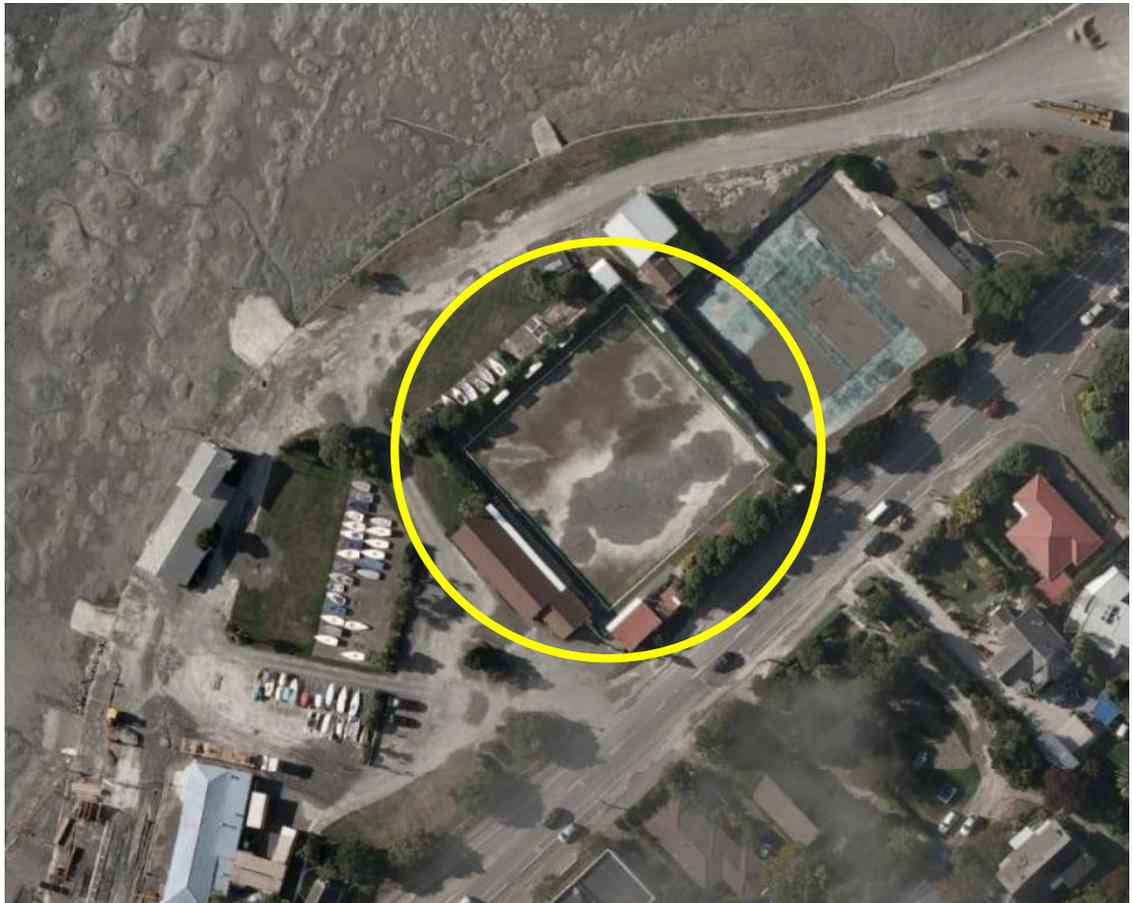
- **Figure 5 – Aerial photography from 24 Feb 2011 (<http://viewers.geospatial.govt.nz/>)**

Severe liquefaction on site and in the surrounding areas could be seen from the aerial photograph. Although there appears to be no significant evidence of lateral spreading, due to scale of liquefaction on site it is expected that some lateral spreading towards the estuary is likely to have occurred.

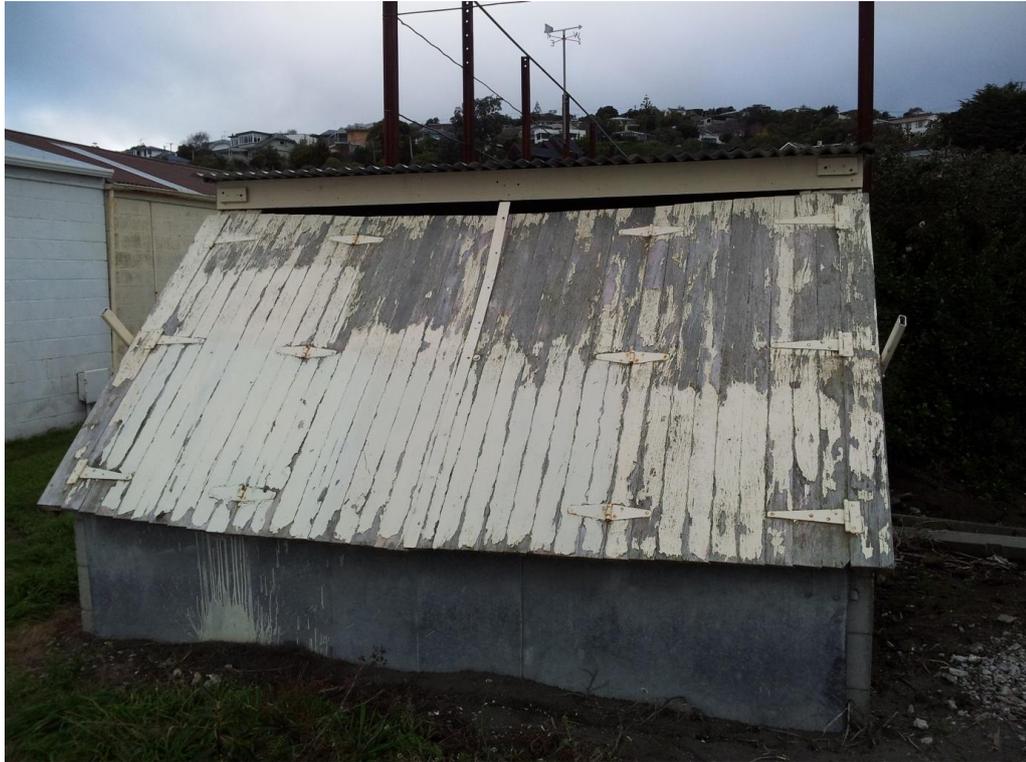
There was no significant structural damage noted on any of the buildings. The gap between the double garage and shed appeared slightly wider at the base of the building and narrowed with height; however, this is not believed to be as a result of earthquake damage.

■ **Figure 7 Overview of the storage shed (PRK\_1409\_BLDG\_007)**
