Sheldon Park Toilet  
Qualitative Engineering Evaluation

**Reference:** 229174  
**Prepared for:**  
Christchurch City Council

Functional Location ID: PRK 0370 BLDG 002

**Date:** 4 July 2013

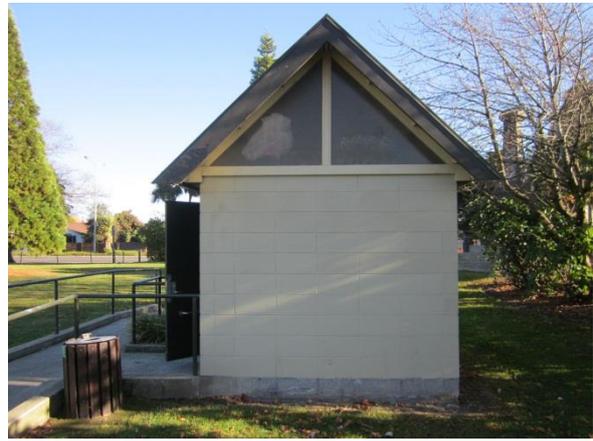
Building eastern elevation.

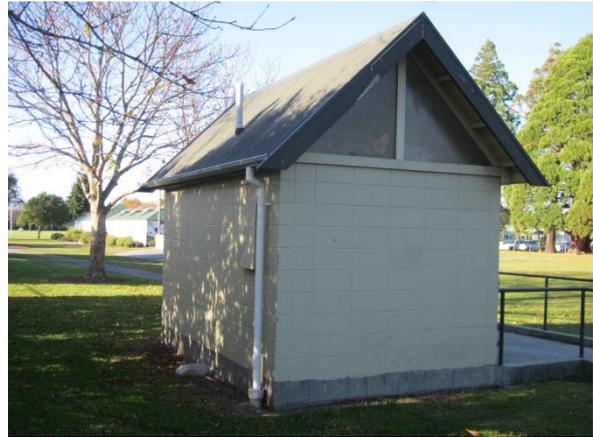
Building western elevation.

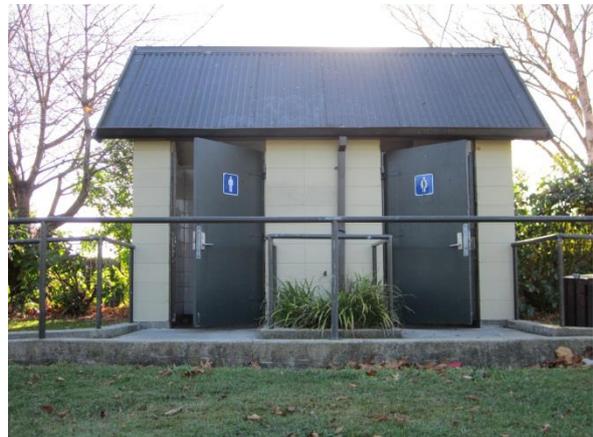
Building southern elevation.

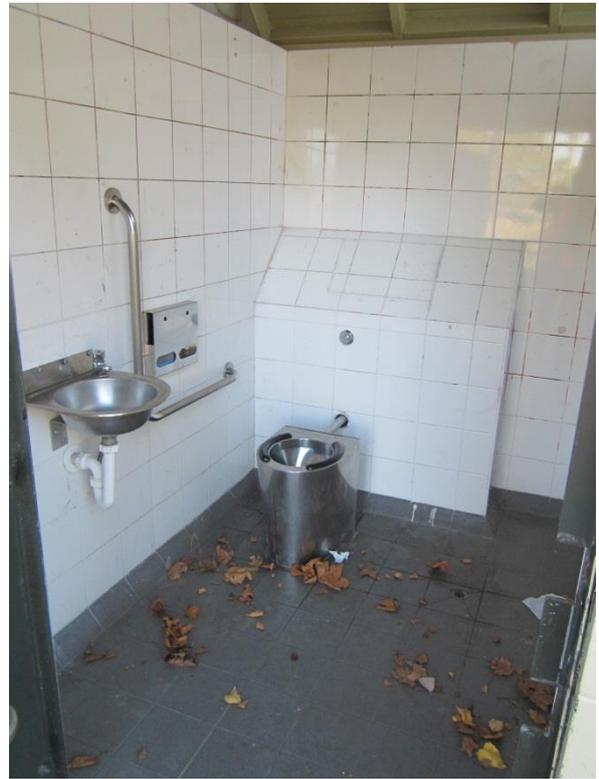
Internal view of toilets.

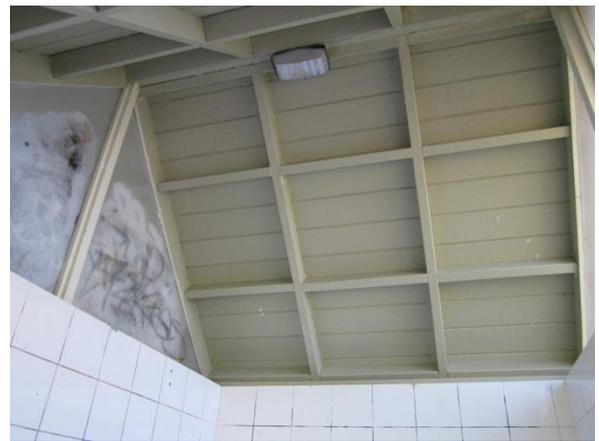
Internal view of toilet showing roof truss.
