# **Somerfield Community Centre BU 1129-001**

**Detailed Engineering Evaluation  
Quantitative Assessment Report**

Date: November 2013  
Reference: 6-QUCCC.30  
Status: Final

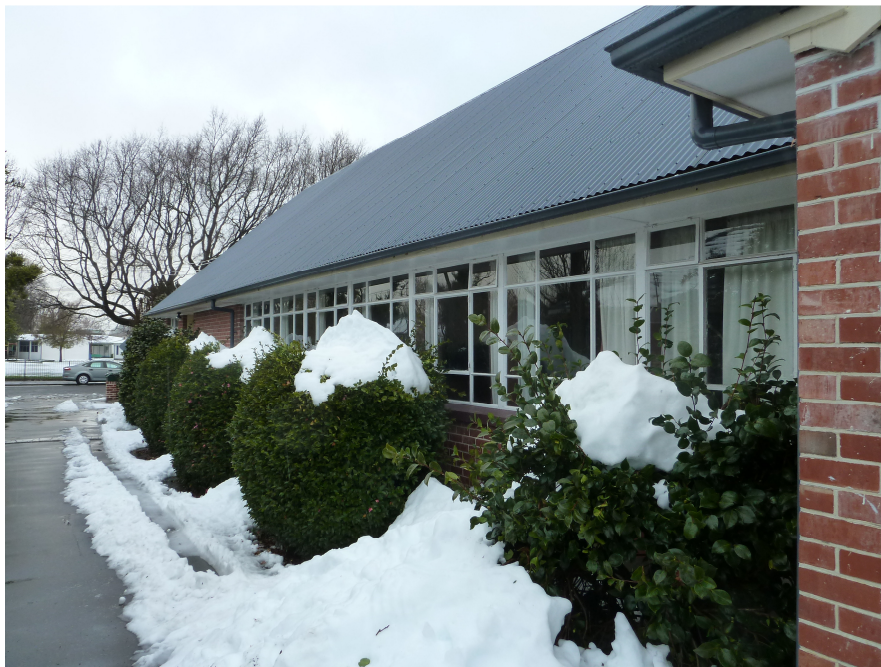
**Photo 2 – General view of the building**

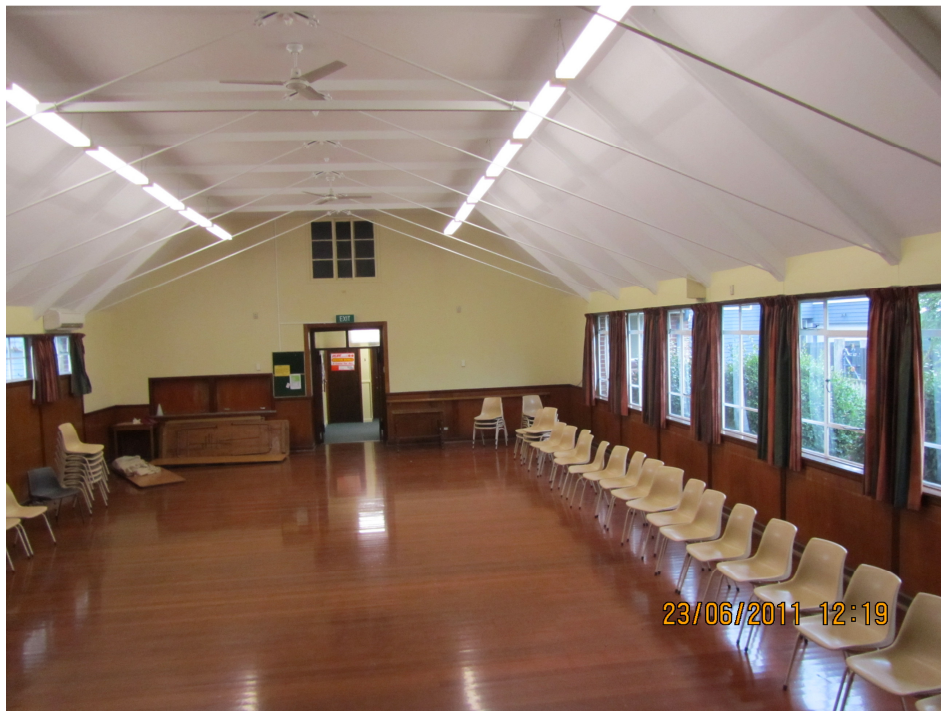
| <b>Structural Element/System</b> | <b>Failure Mode, or description of limiting criteria based on displacement capacity of critical element.</b> | <b>% NBS based on calculated capacity</b> |
|---|---|---|
| Inadequate roof bracing in the Hall | The roof over the Hall does not appear to be adequately braced or have a diaphragm present to distribute seismic lateral loads, particularly for loads in the transverse direction. Loads will be resisted by the east and west walls in out of plane bending (weak direction) rather than transferred to the adjacent north and south in plane shear walls. | <33% (This has been superseded by the temporary bracing discussed below) |

**Photo 3 – Interior of Hall showing ceiling line and steel rafter ties**

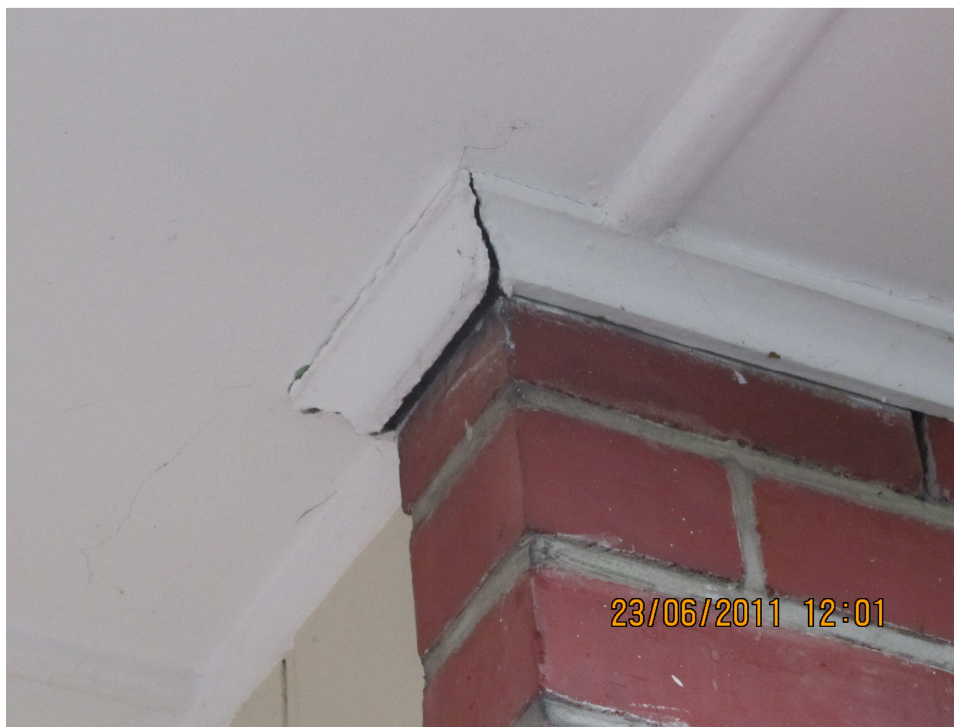
- Diagonal and horizontal cracking of some of the masonry veneer piers originating at the base of the windows.
- Vertical through brick cracking and horizontal dislocation of brickwork adjacent to the timber lintel over the entrance porch.
- Horizontal masonry veneer cracking and dislocation of the architrave adjacent to the top of some windows.

**Photo 4 – Typical masonry veneer damage**
