South Brighton Motor Camp – Workshop Detailed Engineering Evaluation BU 1359-005 EQ2 Qualitative Report

Prepared for Christchurch City Council

By Beca Carter Hollings & Ferner Ltd (Beca)

14 June 2013

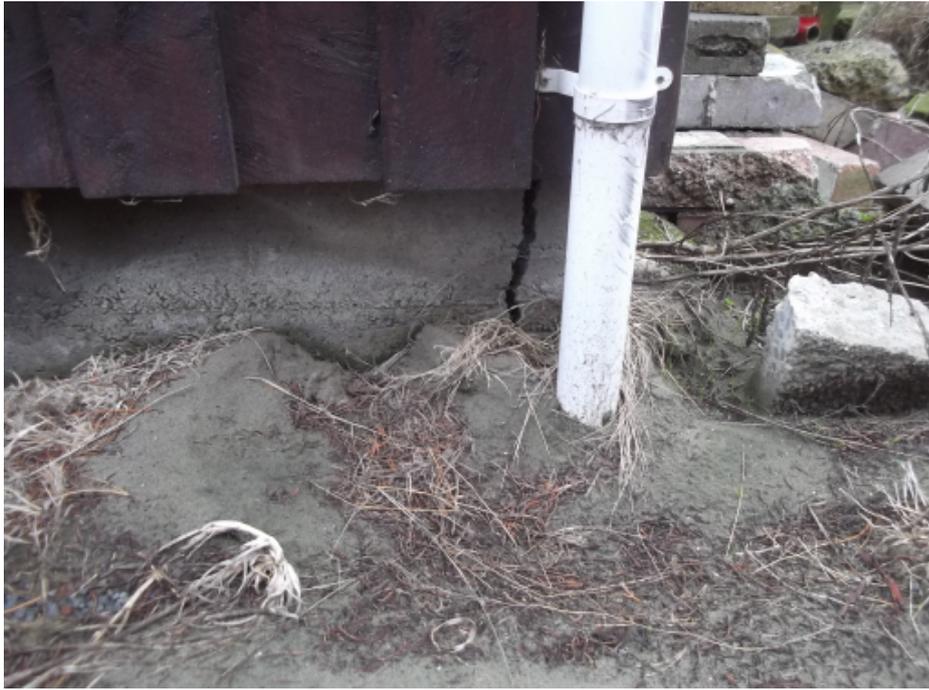
Photo 5: Cracking to foundation

Damage description: Cracking to foundation at the southwest corner of the building with cracking with approximately 10mm.

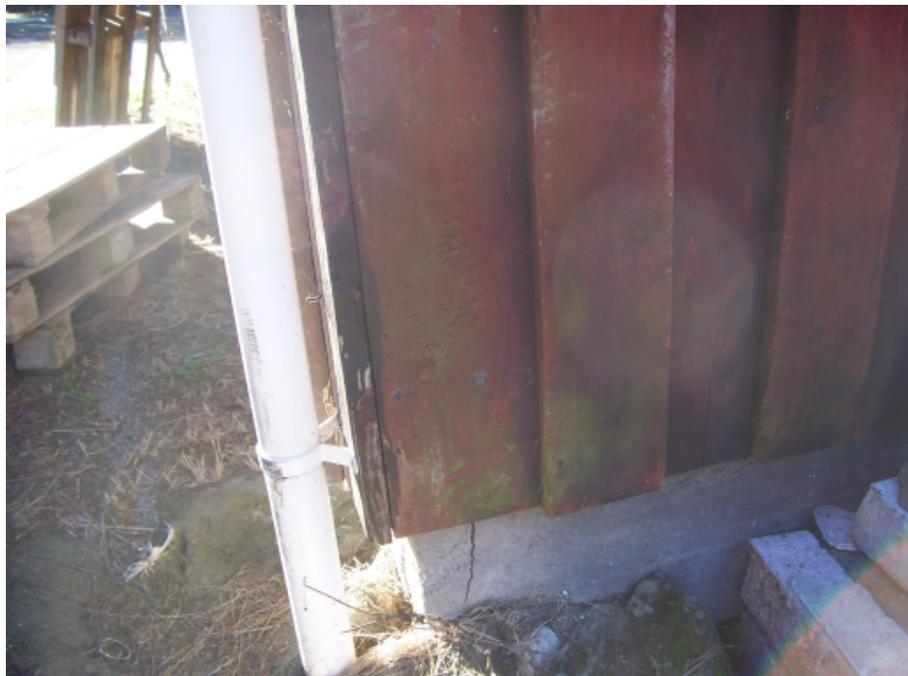
Photo 6: Cracking to foundation

Damage description: Cracking to foundation at the southwest corner of the building with cracking with approximately 5mm.

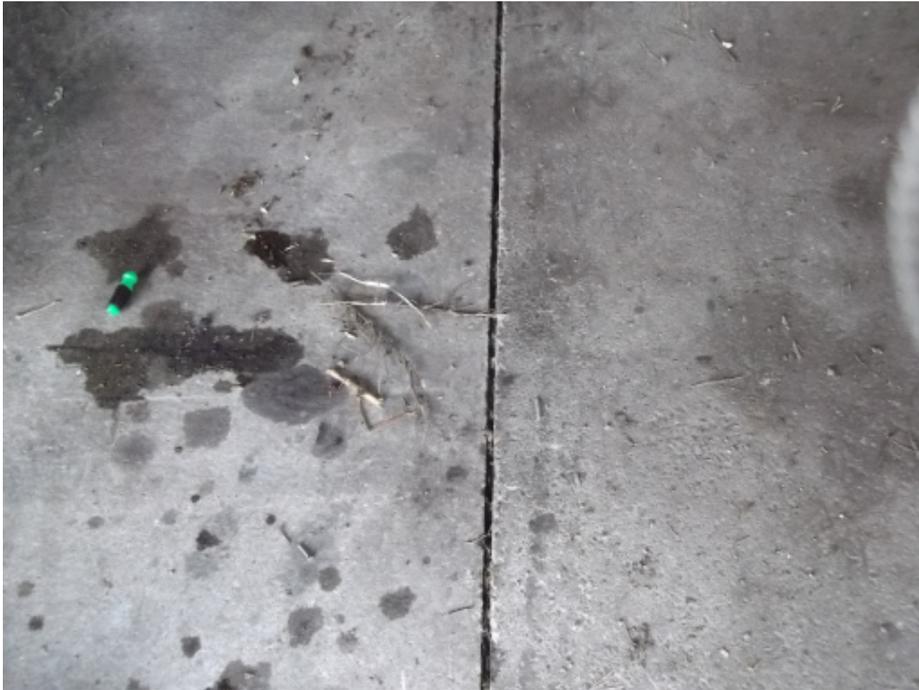
Photo 7: Widened construction joint

Damage description: The construction joint of the concrete slab has been widened potentially due to settlement caused by liquefaction.

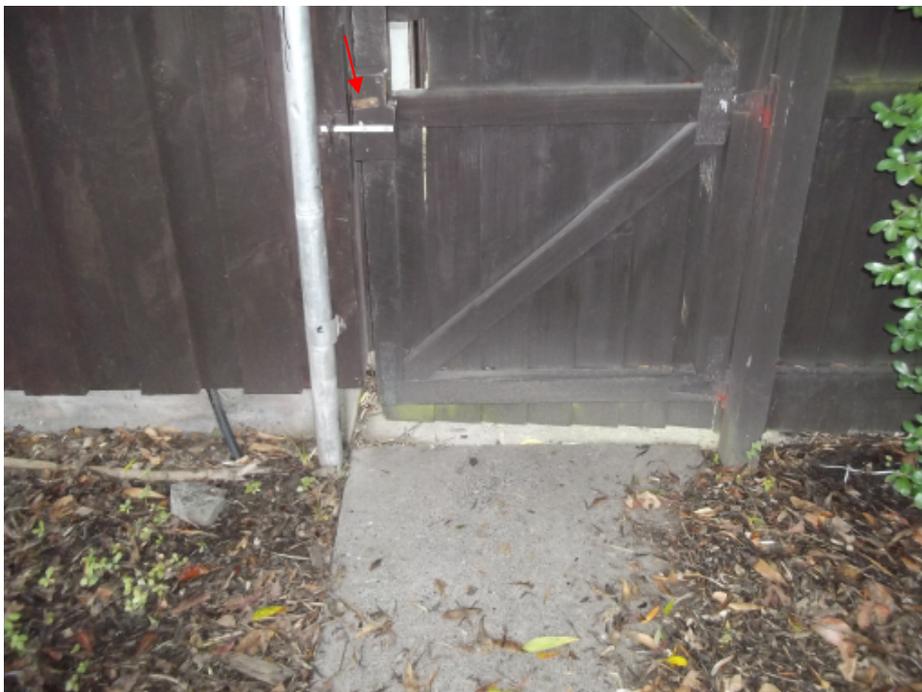
Photo 8: Ground movement indication

Damage description: the shifting door lock at the northern end of the building indicates the ground settlement/movement.
