South New Brighton Park – South Toilets
PRK 1944 BLDG 003 EQ2
Detailed Engineering Evaluation
Qualitative Report
Version FINAL

74 Beatty Street, New Brighton

Christchurch City Council

Date
7th December 2012

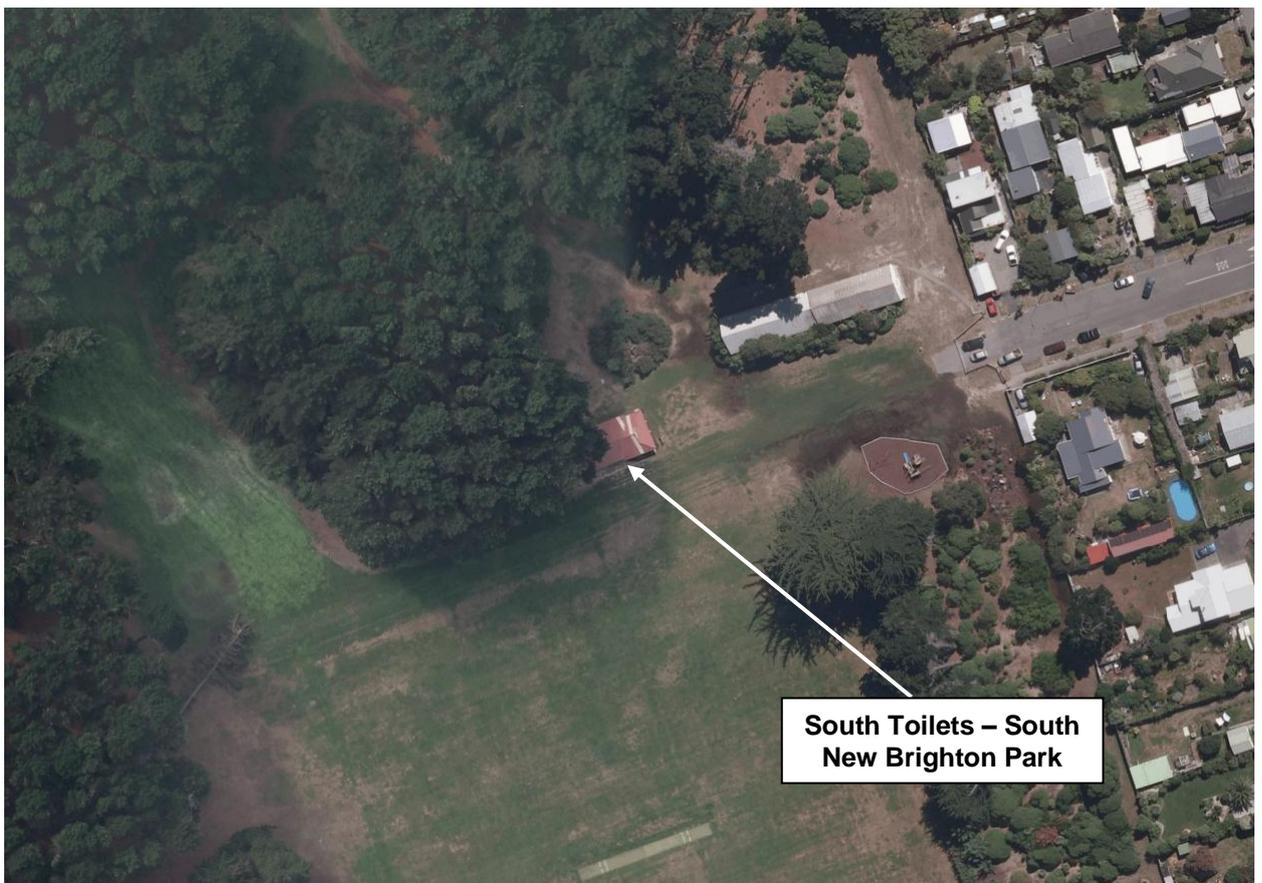
Figure 3 Post February 2011 Earthquake Aerial Photography³

Aerial photography taken following the 22 February 2011 earthquake shows signs of minor liquefaction outside the building footprint, as shown in Figure 3.

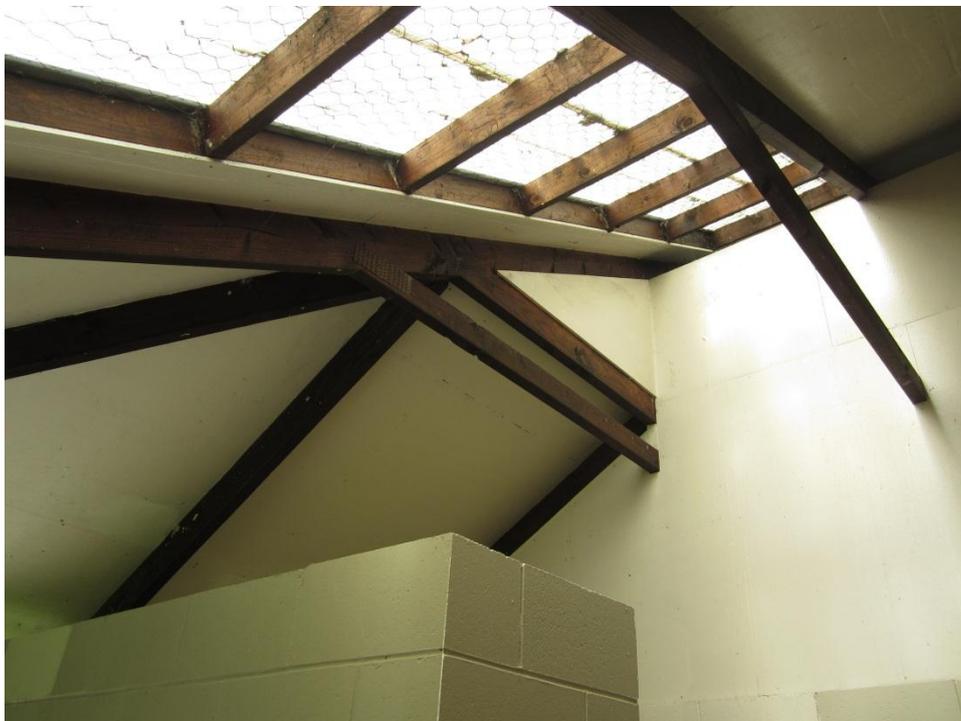
The 190 mm partially filled concrete masonry partition walls are unrestrained along the top edge. The vaulted trusses are likely to provide only limited out-of-plane restraint to the concrete masonry wall set back from the line of steel posts along the south-eastern side of the building. These unrestrained masonry walls are susceptible to collapse from out-of-plane seismic actions.

The unrestrained concrete masonry panels are not expected to have an adverse effect on overall structural performance; however, they do have implications for possible threat to life if they collapse.

Photograph 4 Unrestrained top edge of internal concrete masonry partition walls

No future action from Christchurch City Council is required to comply with the building code, however given the low %NBS score achieved, GHD recommend a detailed quantitative assessment.

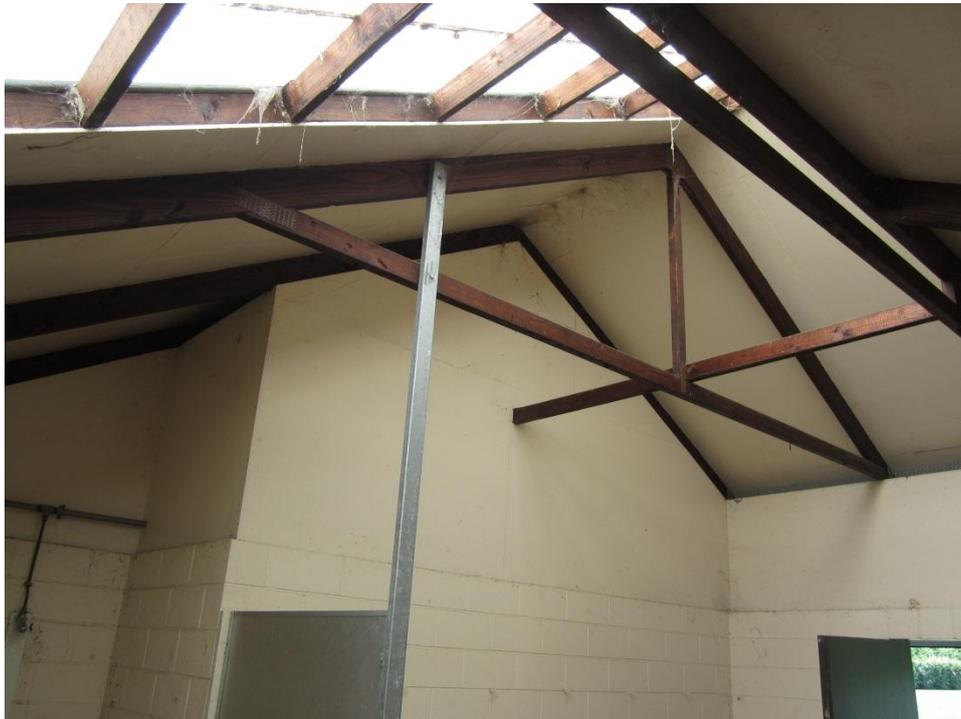
Photograph 8 Vaulted truss

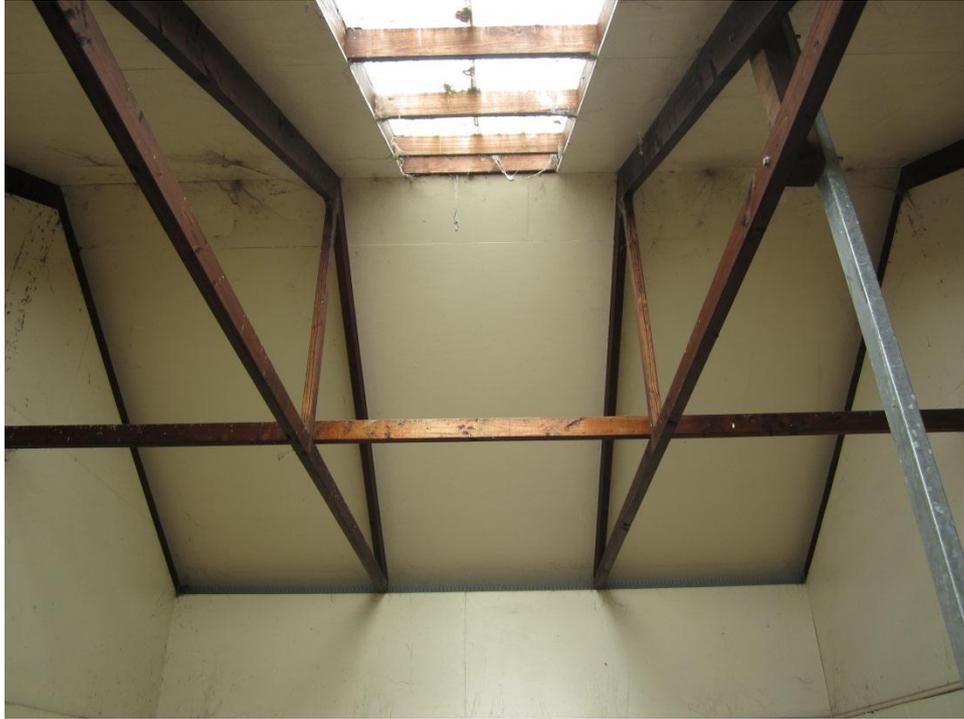
The duo-pitch roof consists of sheet metal on timber purlins supported by vaulted timber trusses. The underside of the timber purlins are lined with hardboard. Photograph 9 shows the layout of the roof structure. The roof has a dutch gable hip to the north-eastern and south-western ends of the building. Concrete masonry walls support the timber roof framing.

Photograph 9 Hardboard lining to underside of roof purlins

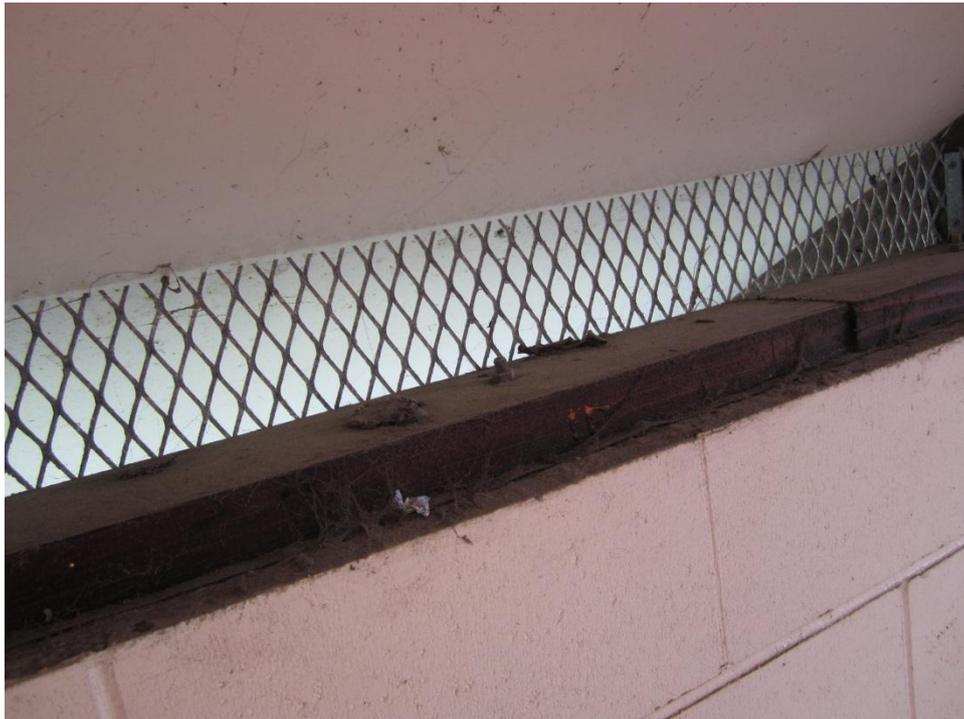
Photograph 10 Timber top plate connected to concrete masonry wall
