Spencer Park Dwelling
Qualitative Engineering Evaluation

Reference: 228890

Prepared for:
Christchurch City
Council

Date: 3 July 2013

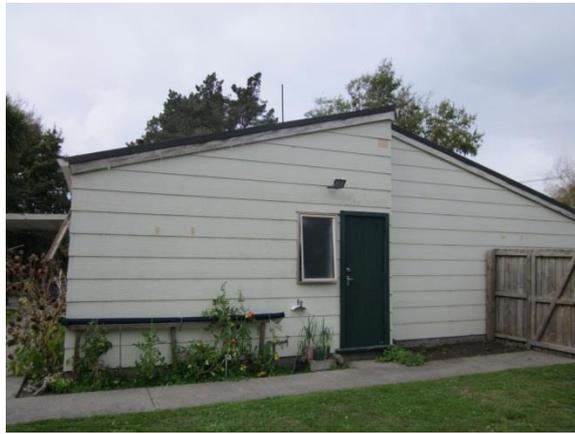
The damage to the concrete paths surrounding the building is likely due partially to the shaking experienced by the path as well as some minor differential settlement of the material beneath the paths.

Cracking in the concrete paths.
