Spencer Park Main Reserve  
Workshop  
Qualitative Engineering Evaluation

Functional Location ID: PRK 0157 BLDG 024

Address: 100 Heyders Road

**Date:** 8 April 2014

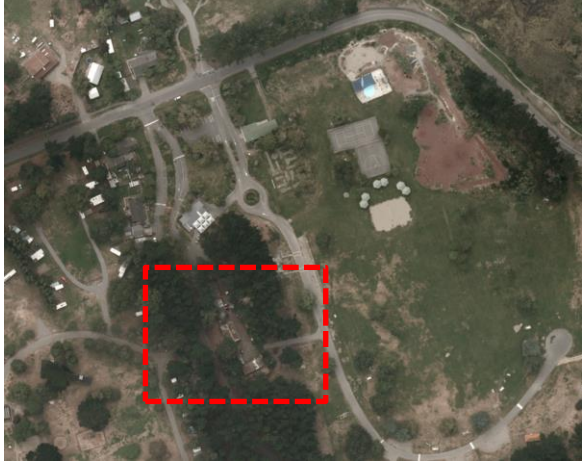
<p>Aerial photograph of the Spencer Park Main Reserve Workshop.</p>

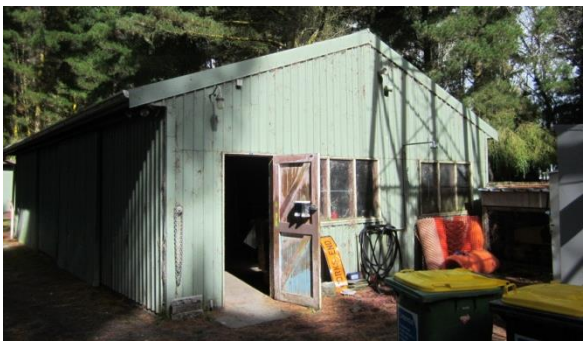
<p>Eastern elevation of the Spencer Park Main Reserve Workshop.</p>	 
<p>Southern elevation of the Spencer Park Main Reserve Workshop.</p>	 
<p>Internal view of the Spencer Park Main Reserve Workshop.</p>	 
<p>Internal view of the Spencer Park Main Reserve Workshop.</p>
