Spencer Park Shop and Dwelling
Qualitative Engineering Evaluation

Reference: 228898

Functional Location ID: PRK 0157 BLDG 004

Date: 3 July 2013

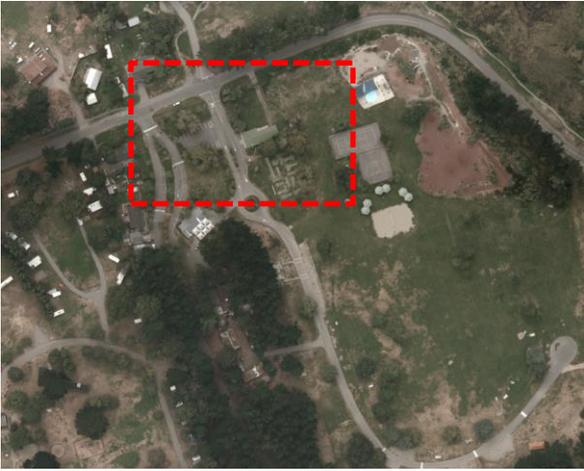
<p>Location of the Shop and Dwelling.</p>

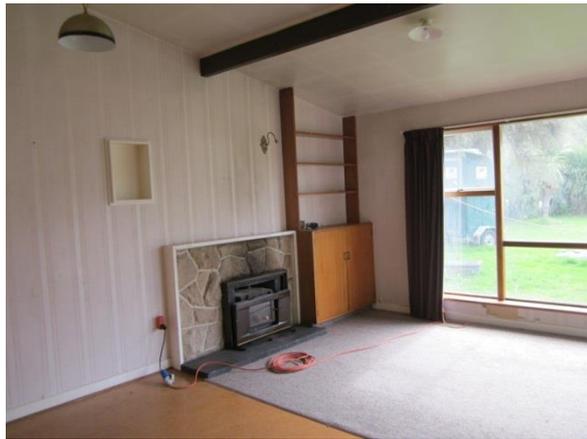
Building internal view.

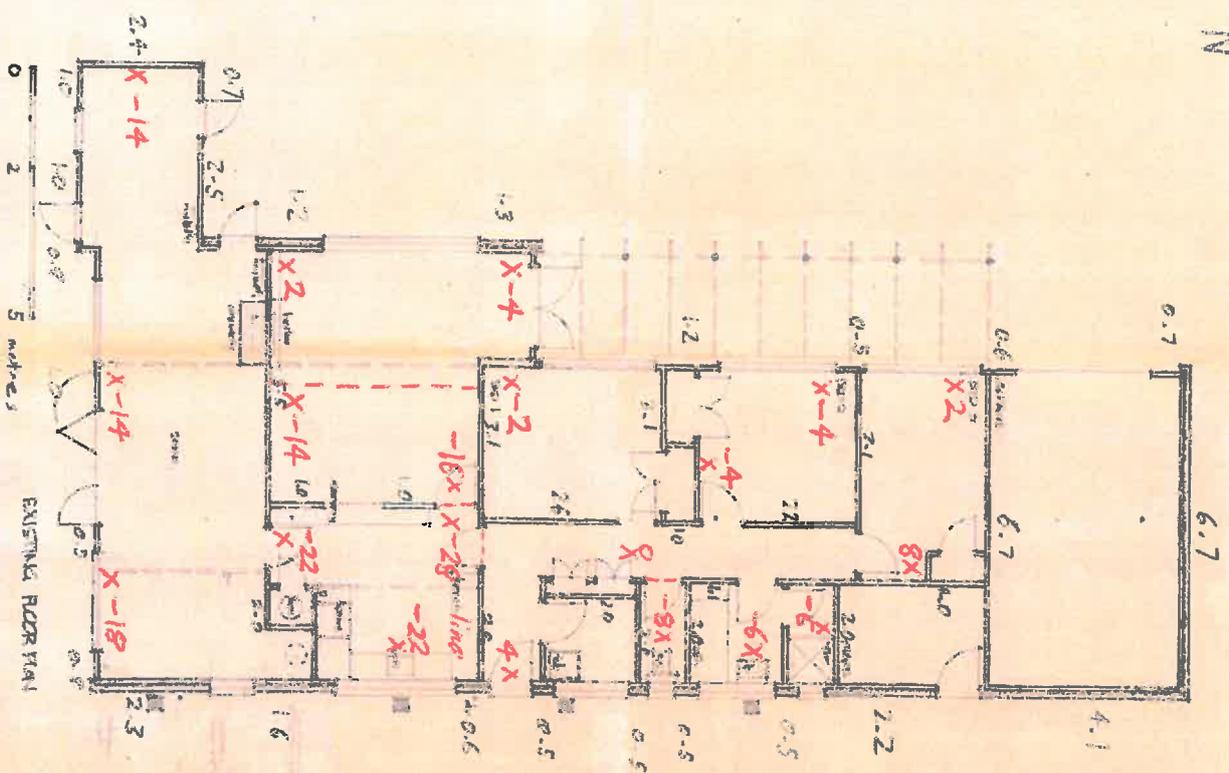
EXISTING FLOOR PLAN

The floor levels for the Spencer Park Shop and Dwelling were found to be inside the recommended tolerances with slopes of up to 0.3% and a variation of 36mm over the floor plan.
