Spencer Park Surf Club
Quantitative Engineering Evaluation

Reference: 228701
Prepared for:
Christchurch City Council

Functional Location ID: PRK 2971 BLDG 001

Date: 19 June 2013

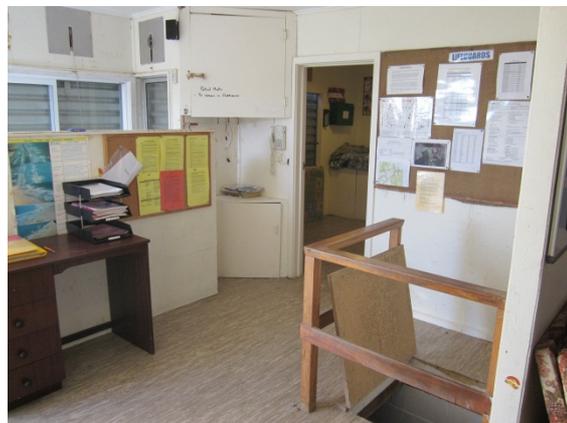
Interior view of the first aid room on the upper floor.

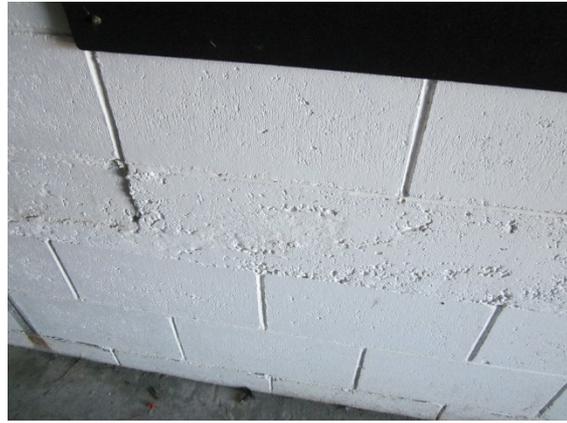
Interface showing the 1994 extension (left) and the original concrete masonry wall (right) in the inflatable rescue boat shed.

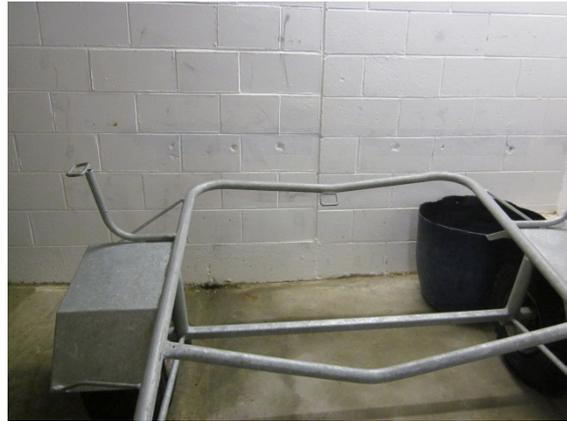
- The balcony in the North East does not drain properly, rather water accumulates by the balcony door, this is supported by the levels survey;
- Concrete spalling on the top of the Northern concrete masonry wall interior; and
- Impact damage to the face shell at about mid height on the Northern concrete masonry wall interior.

Non seismic related damage - concrete spalling on the top of the Northern concrete masonry wall interior.

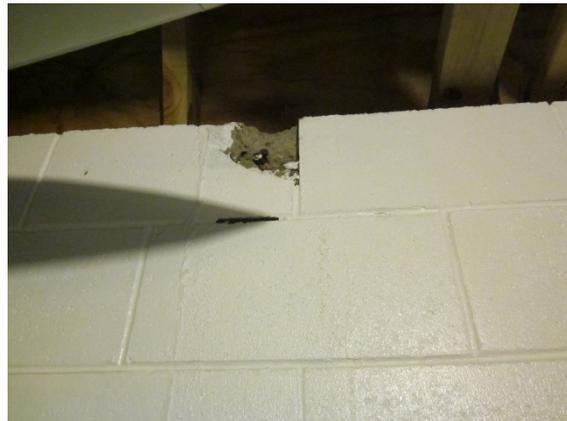
Non-seismic related damage - impact damage to the face shell at about mid height on the Northern concrete masonry wall interior.
