Spencer Park Toilets
Qualitative Engineering Evaluation

Reference: 228899

Prepared for:
Christchurch City
Council

Address: Spencer Park, 100 Heyders Road

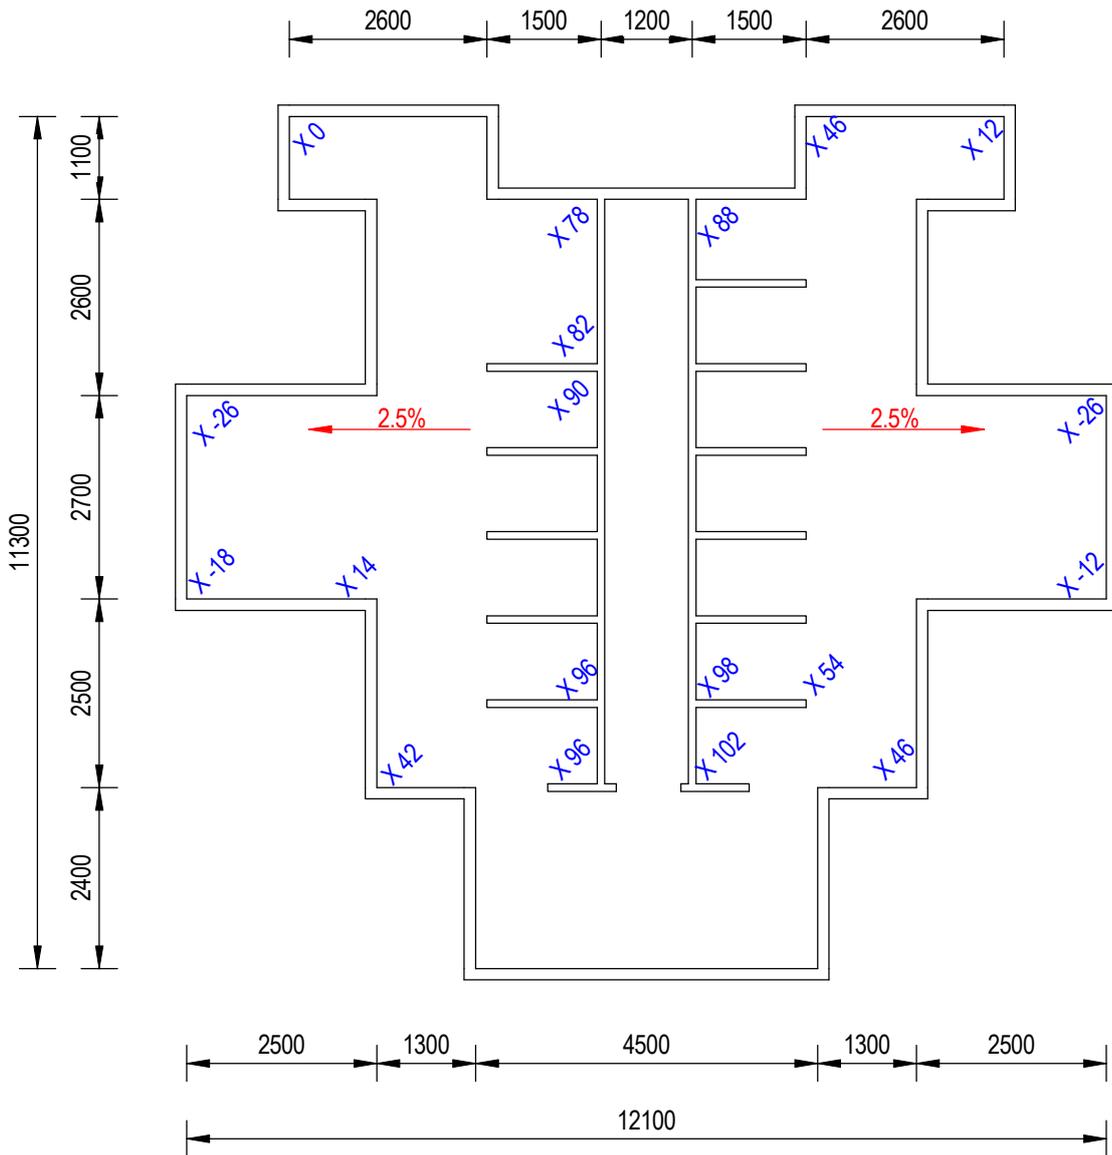
PRELIMINARY NOT FOR CONSTRUCTION	
PROJECT No. 228899	
SCALE 1:100	SIZE A4
DRAWING No. SK-01	REV

The floor levels for the Spencer Park Toilets were found to be within acceptable levels with the slopes prescribed in the plans similar to those measured.

3% FALL CALLED FOR IN PLANS
2.5% FALL TYPICAL
