## CHRISTCHURCH CITY COUNCIL

PRK\_1099\_BLDG\_007 EQ2

Spreydon Domain – Pavilion & Toilets

### QUALITATIVE ASSESSMENT REPORT FINAL

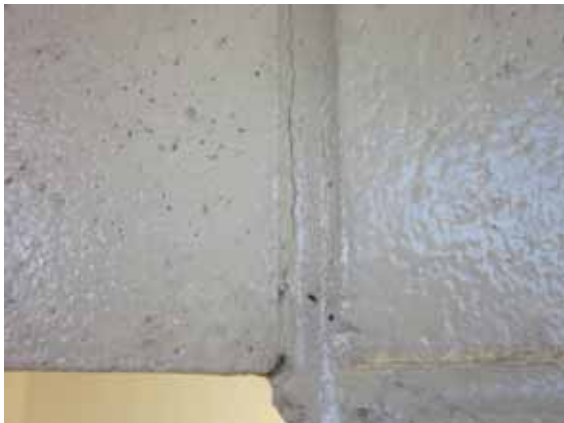
- 1) Vertical hairline cracking was observed in the mortar at either end of the lintel over window and door openings in the south and west walls of the building. (see Photo 3)

Photo 3: Typical vertical cracking in the mortar at each end of the lintels of door and window openings

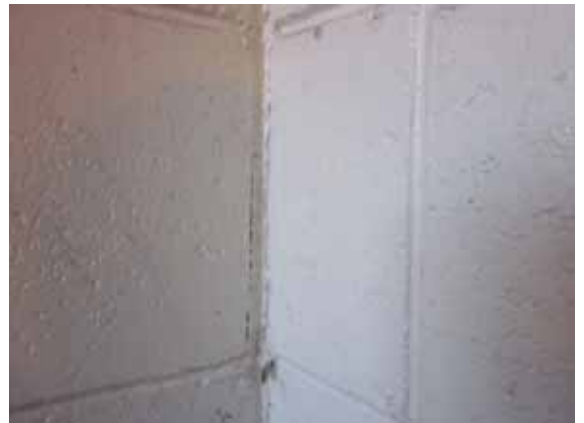
- 2) Hairline separation was noted between the internal and perimeter masonry walls. (see Photo 4)
  - 3) Hairline cracking was observed in the window sill and wall beneath the window at the centre of the southern wall. (see Photo 5 and Photo 6)

Photo 4: Typical separation between internal and perimeter masonry walls

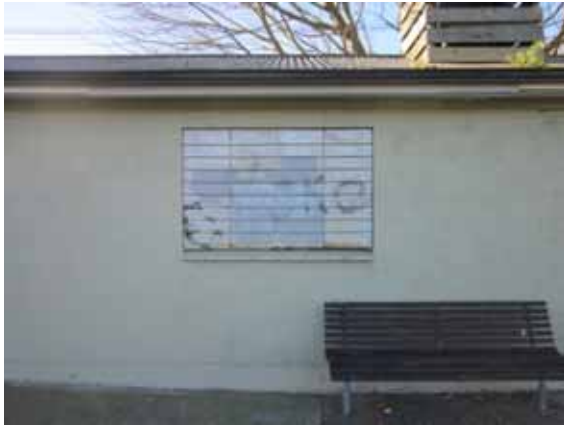
Photo 5: Elevation on the window at the centre of the southern wall

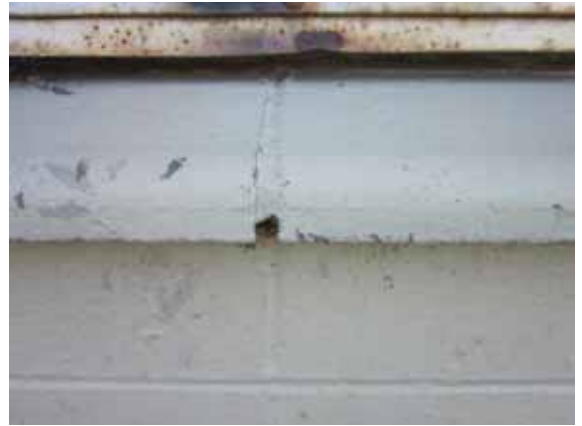
Photo 6: Cracking in the window sill and wall beneath the central window

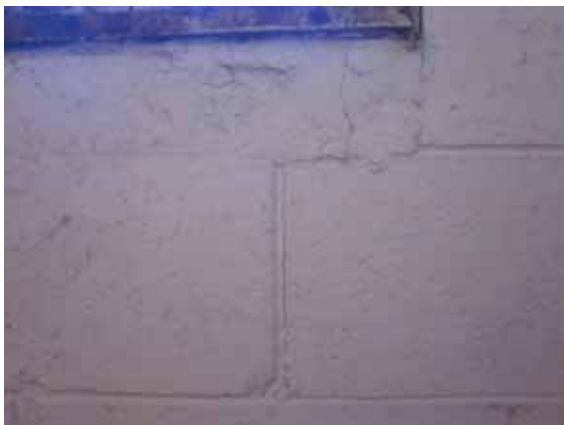
- 4) Hairline cracking was observed adjacent to the windows and doors in the eastern half of the structure. This cracking looks to be existing. (see Photo 7)

Photo 7: Typical cracking found adjacent to windows and doors in the eastern half of the building

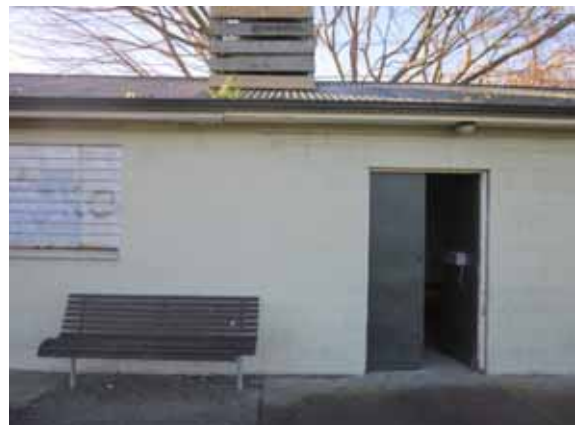
Photo 8: Elevation on the junction between the original structure and the extensions to the west

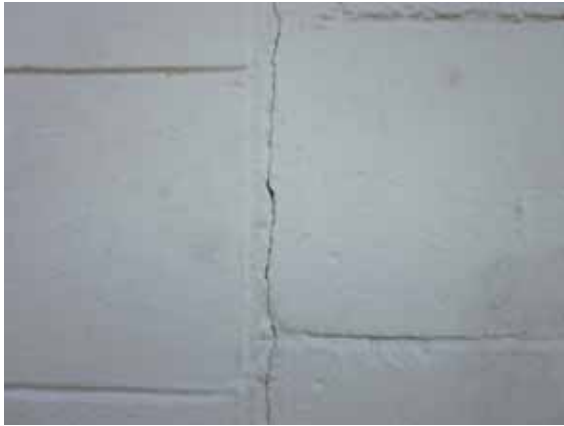
Photo 9: Detail of the junction showing separation between structures

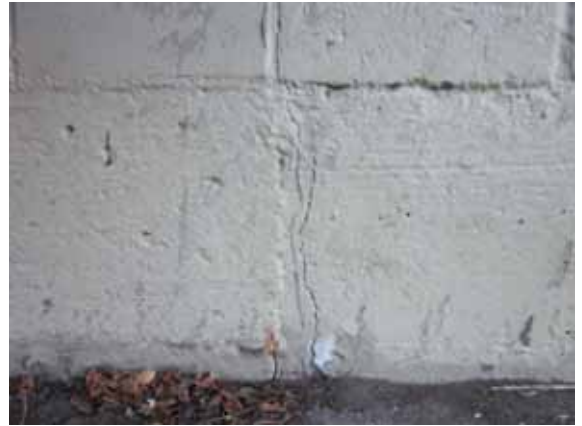
Photo 10: Detail of the footing at the junction showing separation

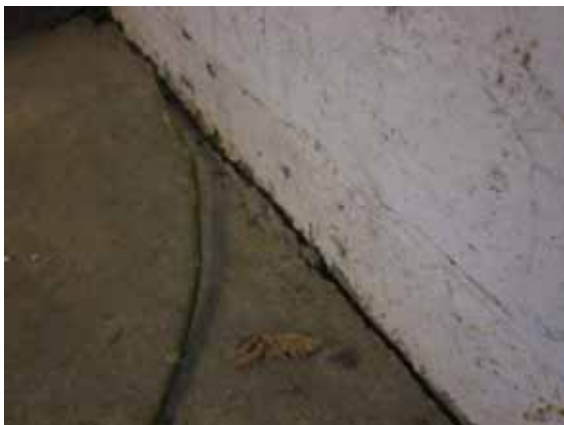
Photo 11: Separation between the internal floor slab in the shower room and the footing the masonry wall to the east

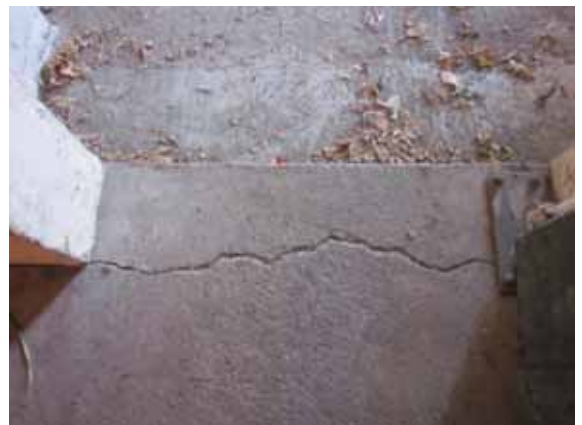
Photo 12: Cracking in the internal floor slab over the footing to the east of the shower room

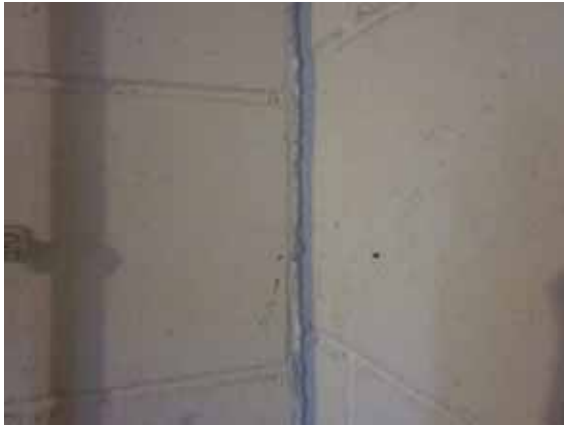
- 5) Approximately 0.8mm separation was noted on the exterior of the southern wall at the junction between the eastern structure and the extension to the west. The junction is located at the centre of the building. Separation extends the full height of the wall and in to the footing (see Photo 8, Photo 9 and Photo 10). Separation was also observed between the internal floor slab of the shower room and the footing for the wall dividing the shower room and adjacent change room at this location (see Photo 11 and Photo 12). Separation between sections of the wall had been filled with a sealant on the interior of the building and on the exterior of the northern wall (see Photo 13 and Photo 14).

Photo 13: Typical detail of sealant used on the interior of the building at the central junction between structures

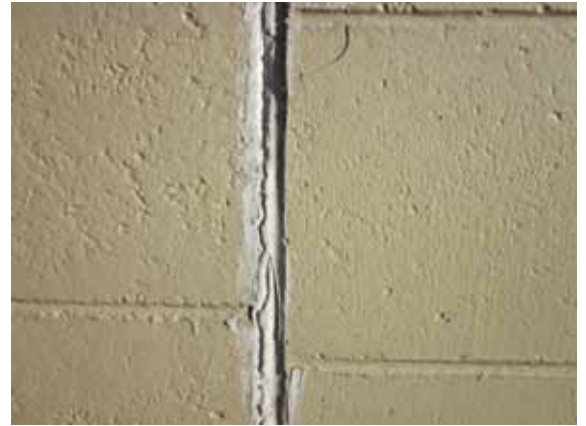
Photo 14: Detail of the sealant on the exterior of the north wall at the central junction between structures

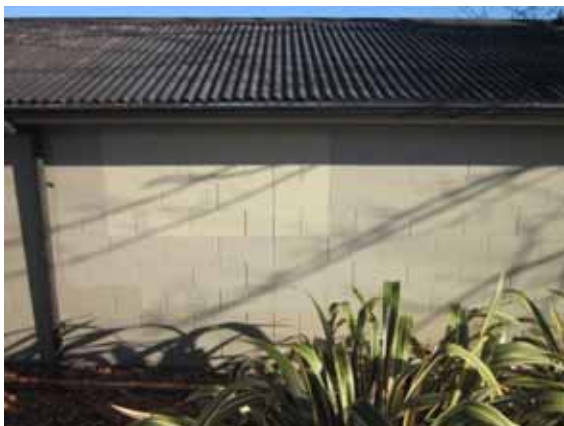
- 6) Separation was noted between the most recent extension at the west end of the building and the adjacent structure. Separation was recorded at 0.5mm in width and the top of the walls and hairline in width at the base. (see Photo 15 and Photo 16)

Photo 15: Elevation on the junction between the western most extension and the adjacent structure

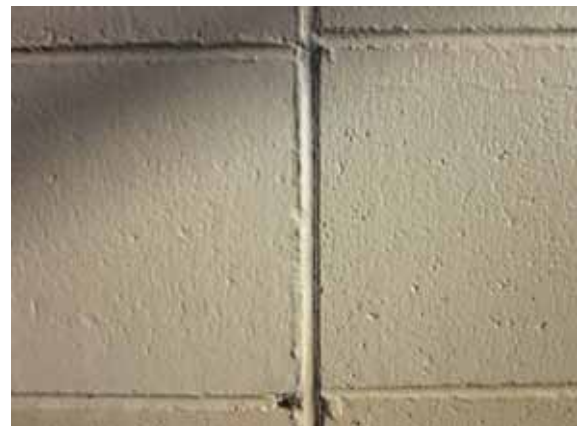
Photo 16: Detail of the separation between the westernmost extension and the adjacent structure

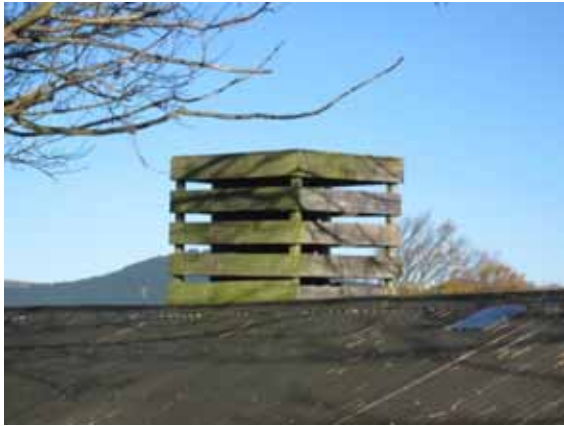
Photo 17: Timber framing for the water tank fixed to the roof of the building. Note damage to lower plank and lean in the structure

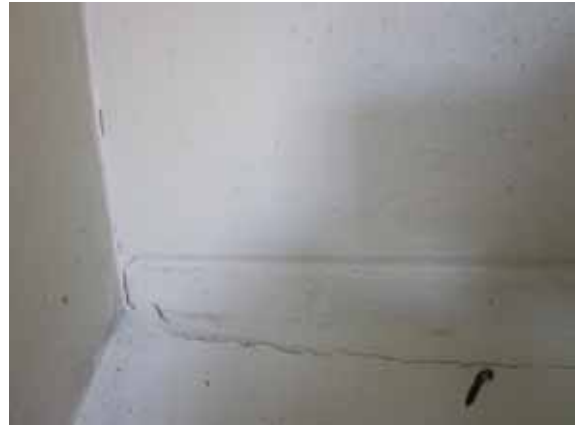
- 8) Some damage to paint and minor separation was observed where the internal timber framing meets the perimeter masonry walls. This damage is non-structural. (see Photo 18)

Photo 18: Typical damage to the paint at the junction between internal timber framing and the perimeter masonry walls

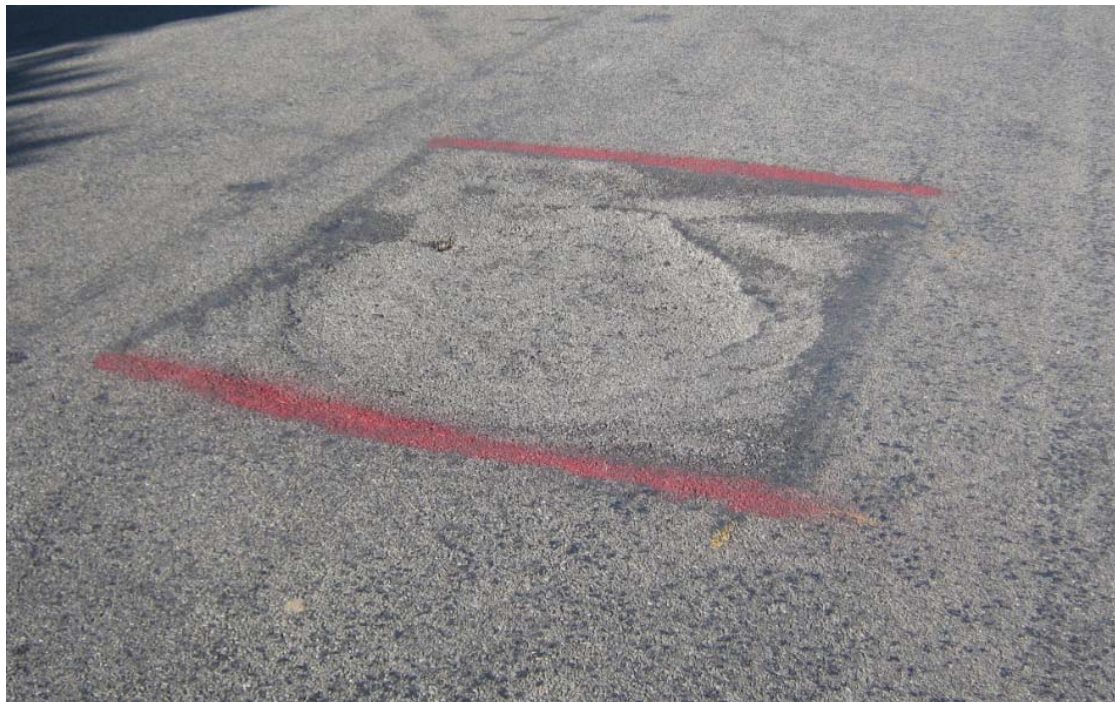
- **Figure 8** Area of depressed asphalt along Domain Terrace due to liquefaction.
