**St Johns Courts
Housing Complex
PRO 0853**

**Detailed Engineering Evaluation
Quantitative Assessment Report**

**20 St Johns Street, Woolston,
Christchurch 8062**

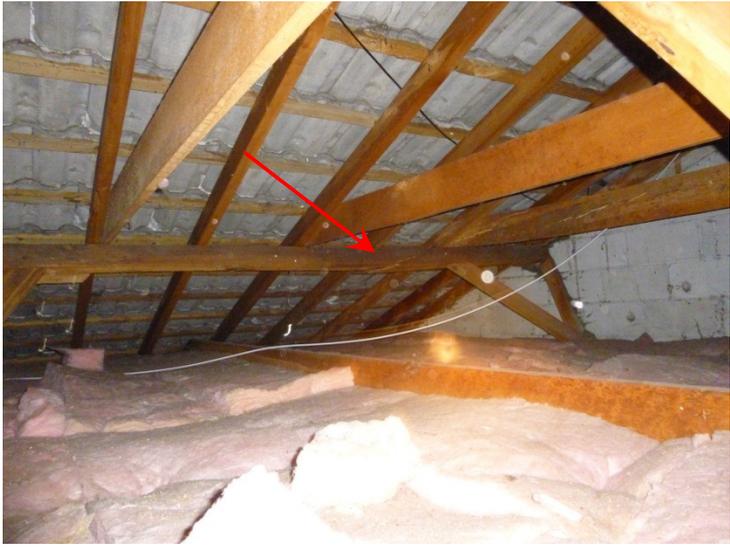
The roof structure at this site has not performed well, some structural members have broken or buckled in Unit 4 (photo 12), and some other units as well. Sagging of the rooflines is visually evident externally and requires repair.

12.	Typical roof void (Unit 4) showing broken member.

- Blocks A-C be strengthened to at least 67%NBS.
- Veneer at height (gable ends) have the veneer ties checked.
- Cosmetic repairs be undertaken as required.
- The timber roof framing requires repair in Unit 4. Other roof spaces should be fully inspected to confirm no further damage has occurred.

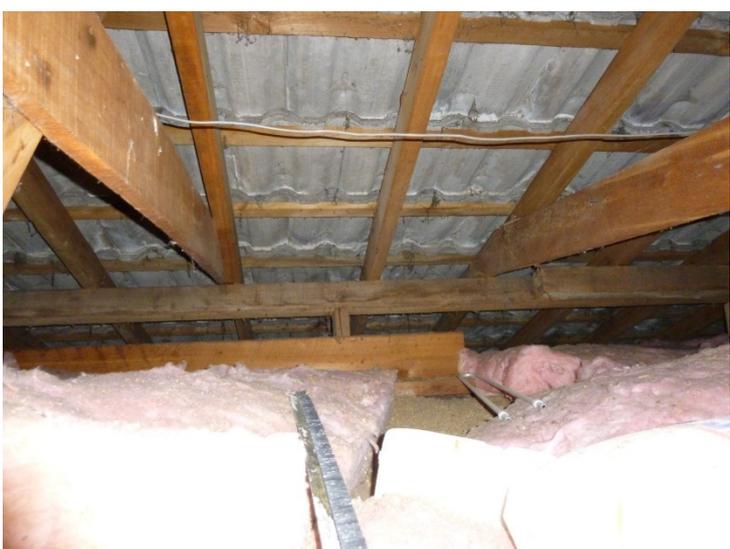
A photograph of a roof void in Unit 11. The image shows wooden rafters and joists. A horizontal wooden member is visible, which appears to be damaged or broken. There is a white vapor barrier and some debris on the floor of the void.
14.	Typical roof void (Unit 11)

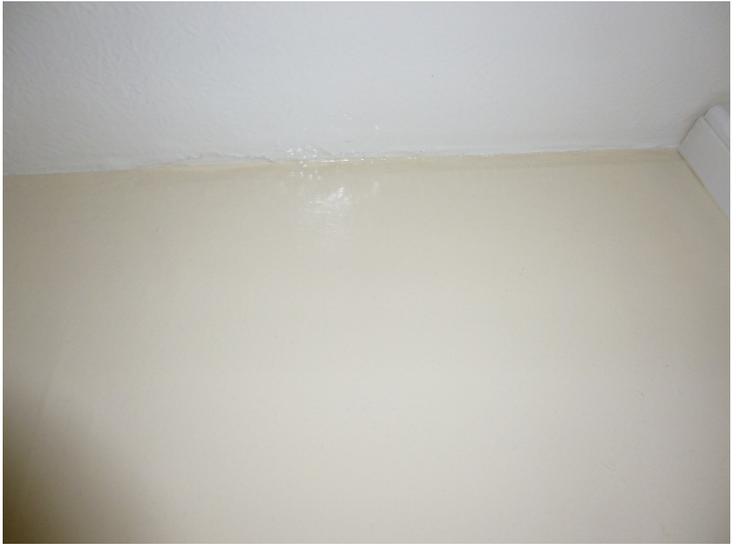
Minor plasterboard cracking was observed in most units, typically above doorways, windows and at the roofline. Cracking in the ceiling diaphragms was observed in a number of units.

23.	Typical cracking at roofline

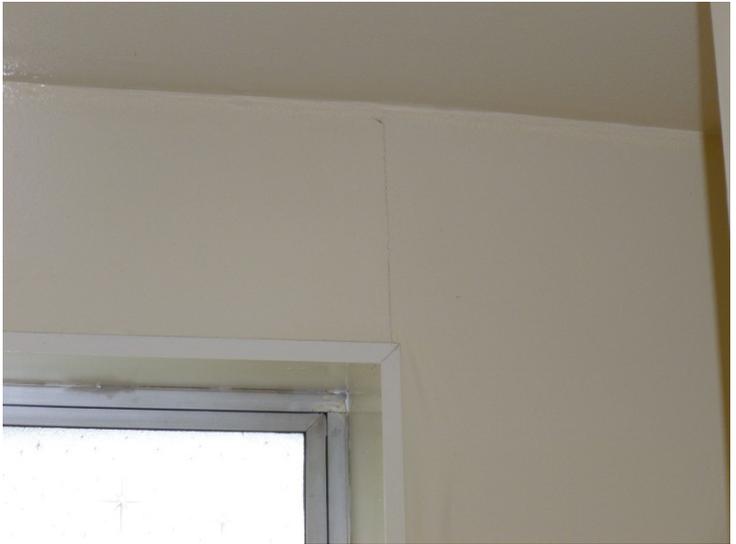
A photograph showing the top edge of a wall where it meets the ceiling. There is a visible horizontal crack running across the wall, with some discoloration and peeling paint around the crack line.
24.	Typical cracking above windows

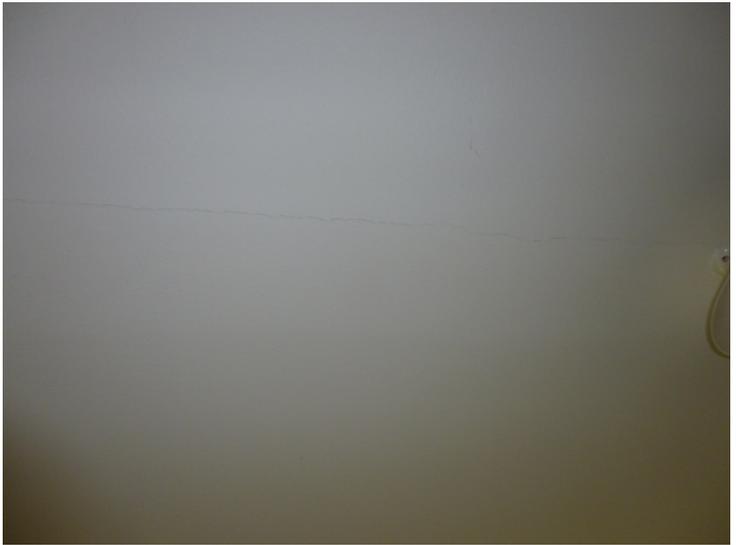
A photograph showing a window frame with a white sill. Above the window, there is a vertical crack in the wall that extends upwards towards the ceiling. The wall is painted a light beige color.
25.	Typical cracking of the ceiling diaphragm

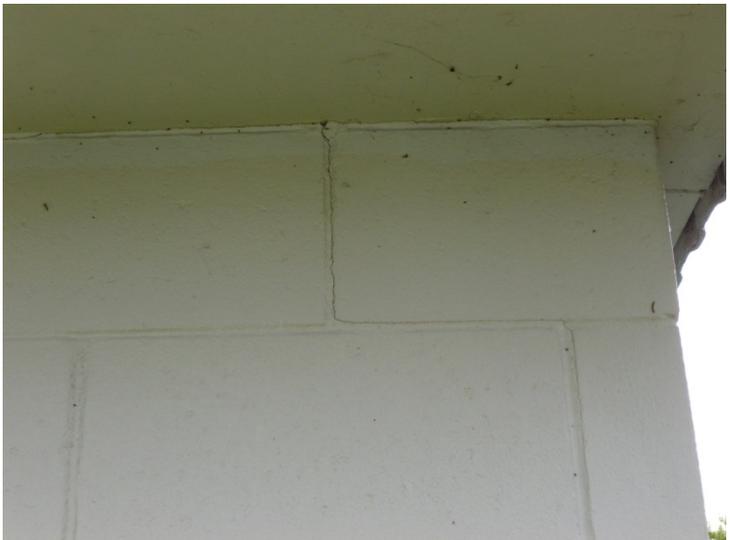
Hairline cracking of the block veneer was observed, typically under windows or at the corner of buildings. A 1mm stepped crack was observed in the veneer at the back of Unit 10. A large crack of approximately 2-3mm was observed between Units 6 and 7, and a similarly large

32.	Typical stepped cracking around corners

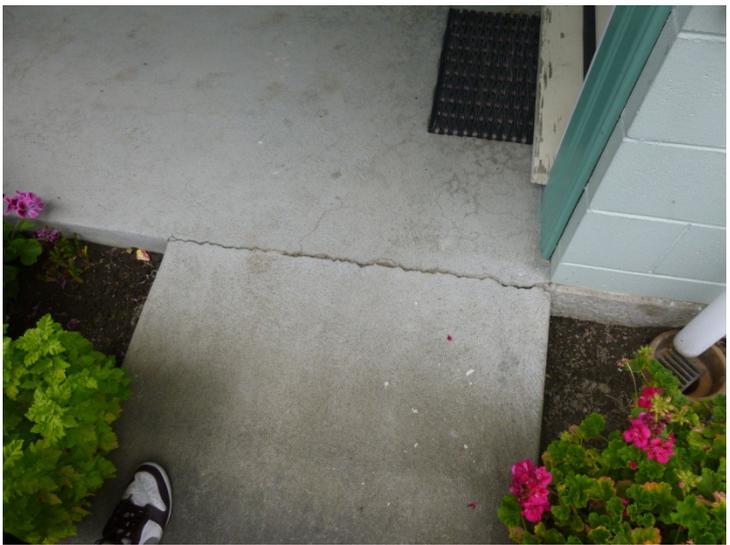
crack between Units 8 and 9, between the veneer and firewall. Cracking was observed in the entrance patios and ramps.

33.	Cracking of ramp to entrance of unit

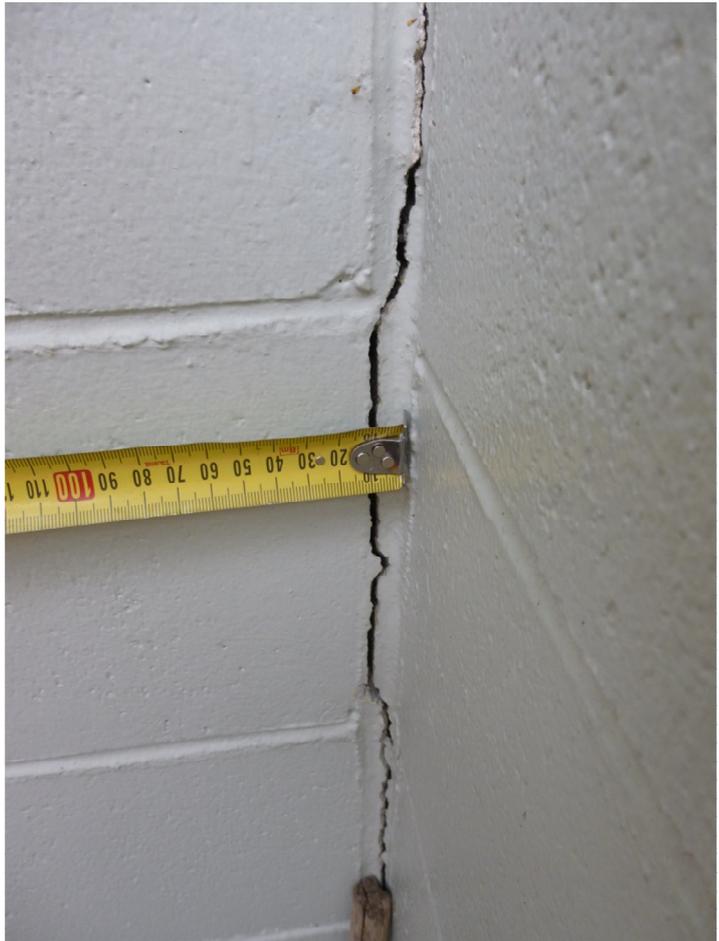
<p>34.</p>	<p>Cracking between veneer and firewall between Units 6 and 7</p>

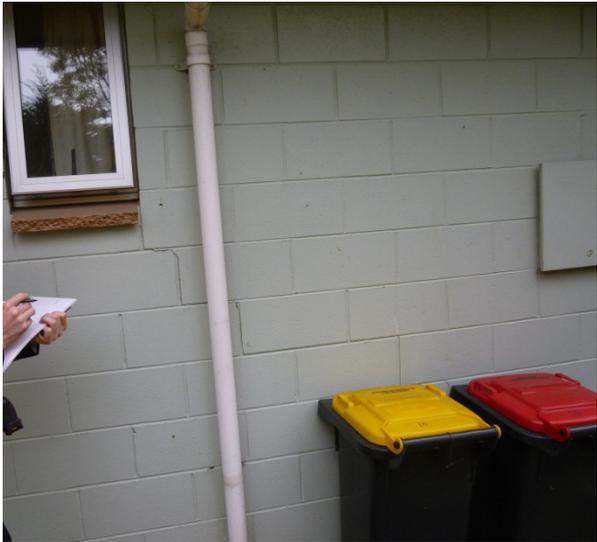
<p>35.</p>	<p>Stepped cracking on Unit 10</p>

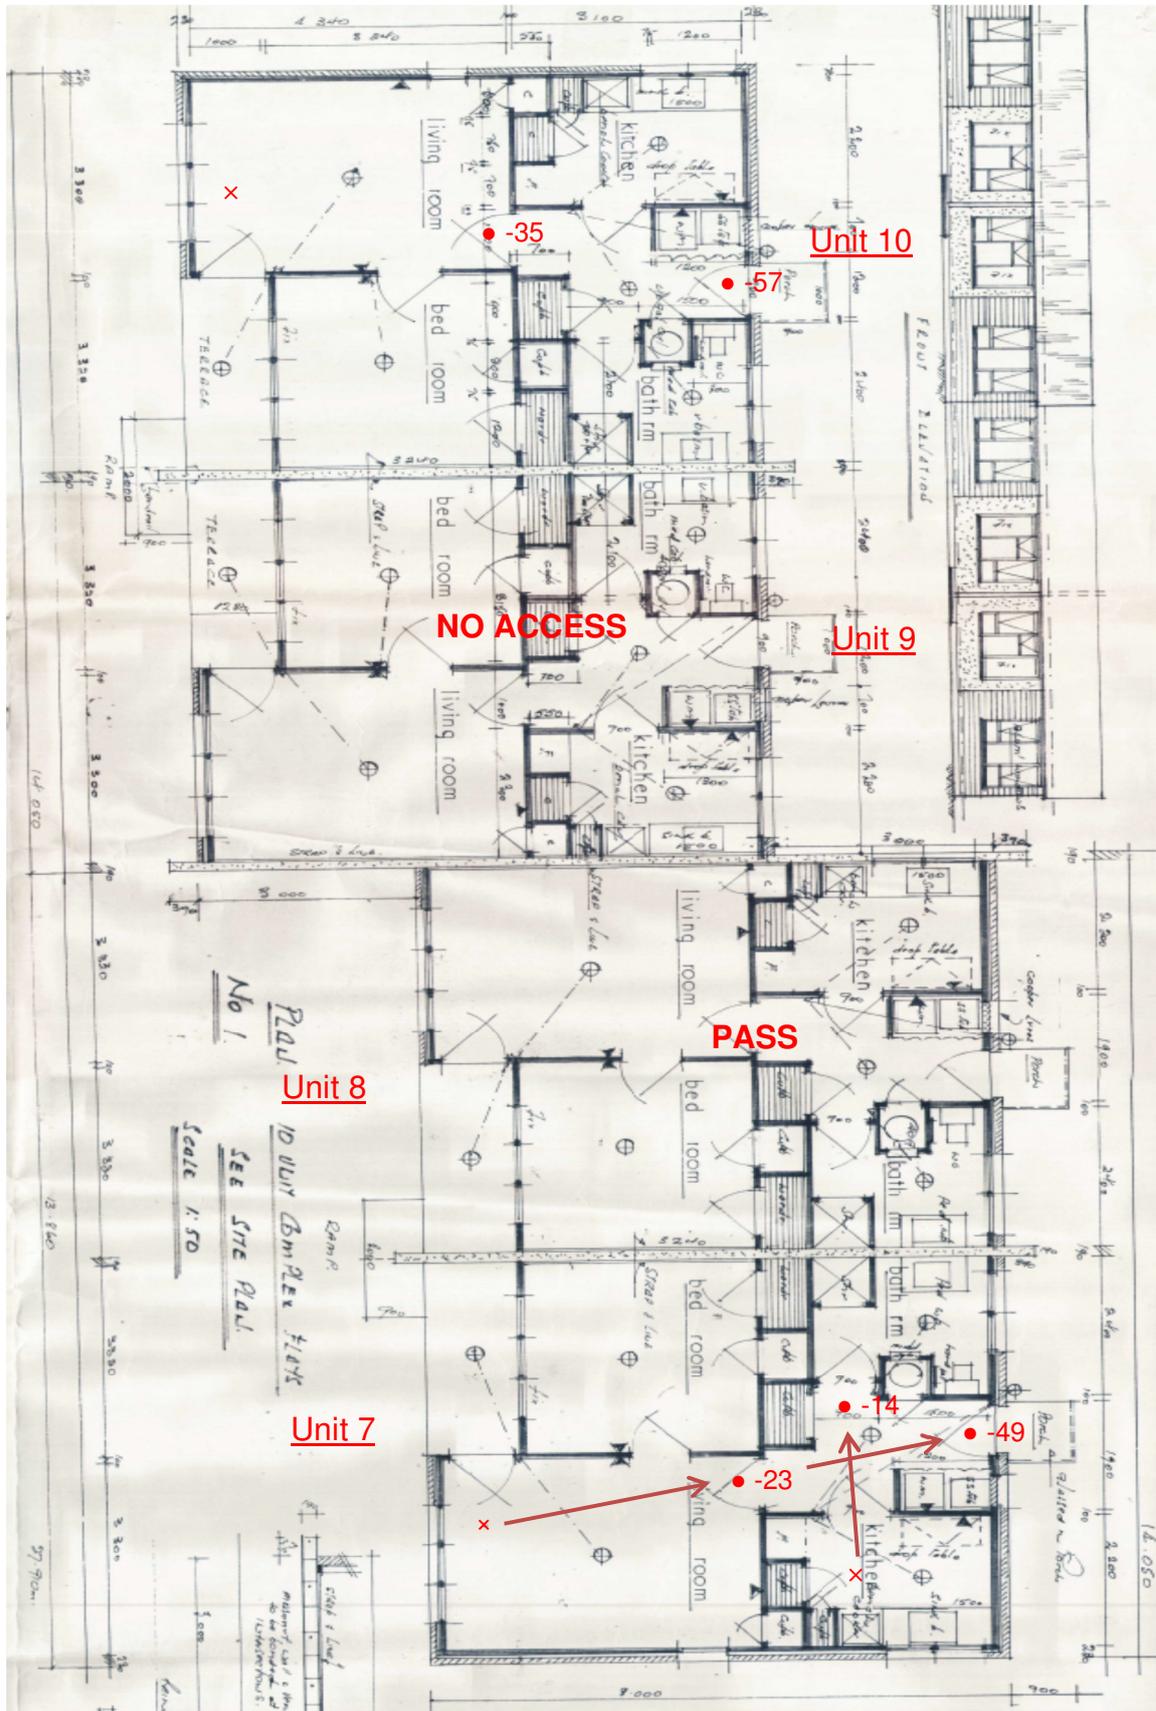
Block C (Units 7-10)

Block	Unit No.	Comment	Maximum Fall*
A	1	Pass	-
	2	Pass	-
	3	Pass	-
B	4	Pass	-
	5	Pass	-
	6	Pass	-
C	7	Fail	7mm/m
	8	Pass	-
	9	No Access	-
	10	Fail	8 mm/m
D	11	Fail	8 mm/m
	12	Fail	7 mm/m
	13	Fail	7 mm/m

Blocks A and B suffered very little residual displacement. Residual displacement was observed in Block C where the maximum slope was observed in Unit 10. These slopes were observed to be toward the nearby creek. Residual displacement was observed in Block D where the maximum slope is 8 mm/m, in Unit 11. Despite the proximity of Block D to the creek, the residual displacements slope away from the creek.

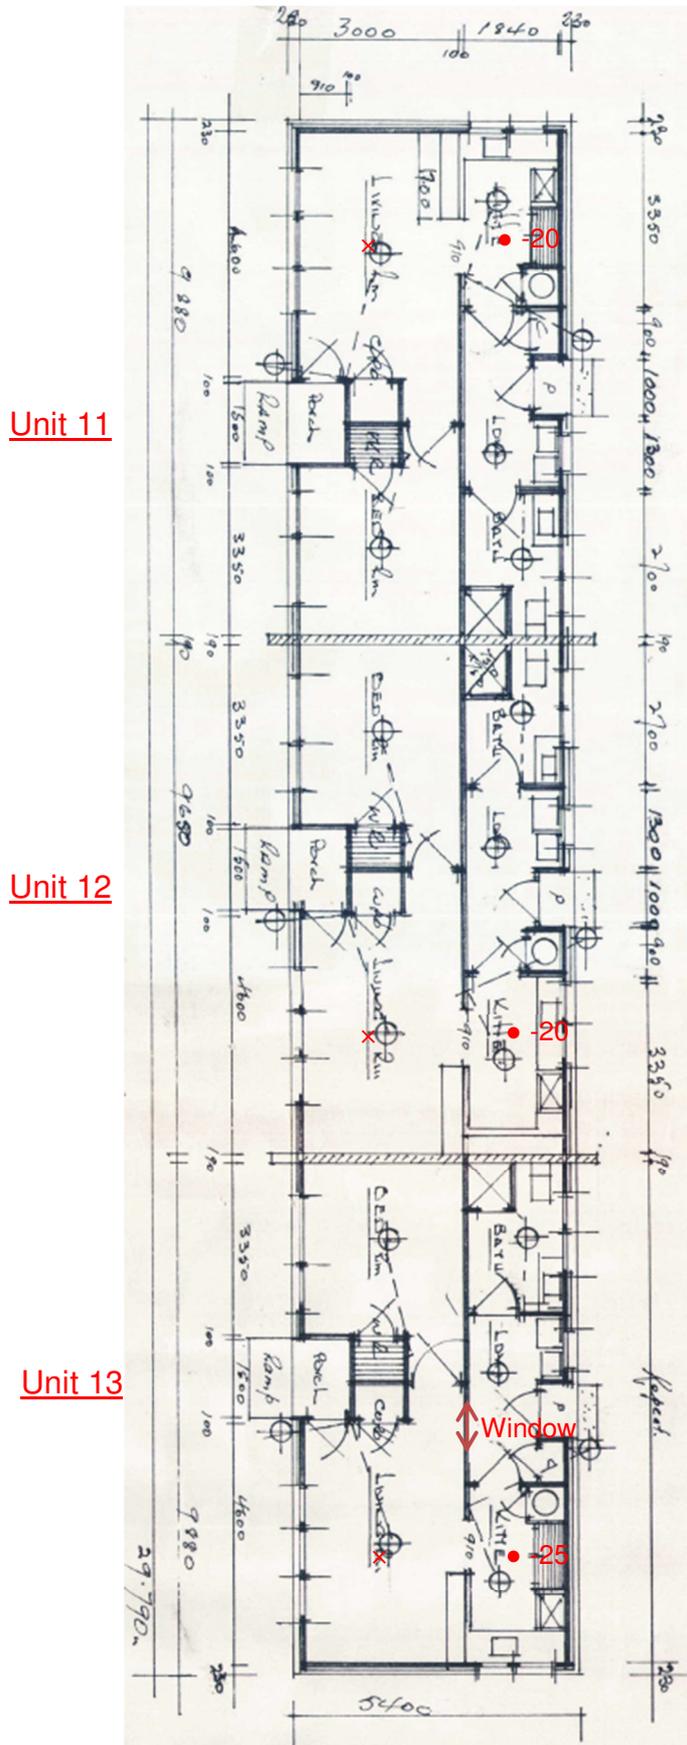
Block D (Units 11-13)

An old stream runs along the south side of block D. It appears that this block has generally rotated down, potentially due to movement within the infill material of the stream. This suggests that further geotechnical investigation may be warranted for future development of the site.
