Styx Mill Reserve Equipment Shed
PRK 0340-BLDG-004 EQ2
Detailed Engineering Evaluation
Qualitative Report
Version FINAL

130 Hussey Road, Harewood

Christchurch City Council

Date
31/10/12

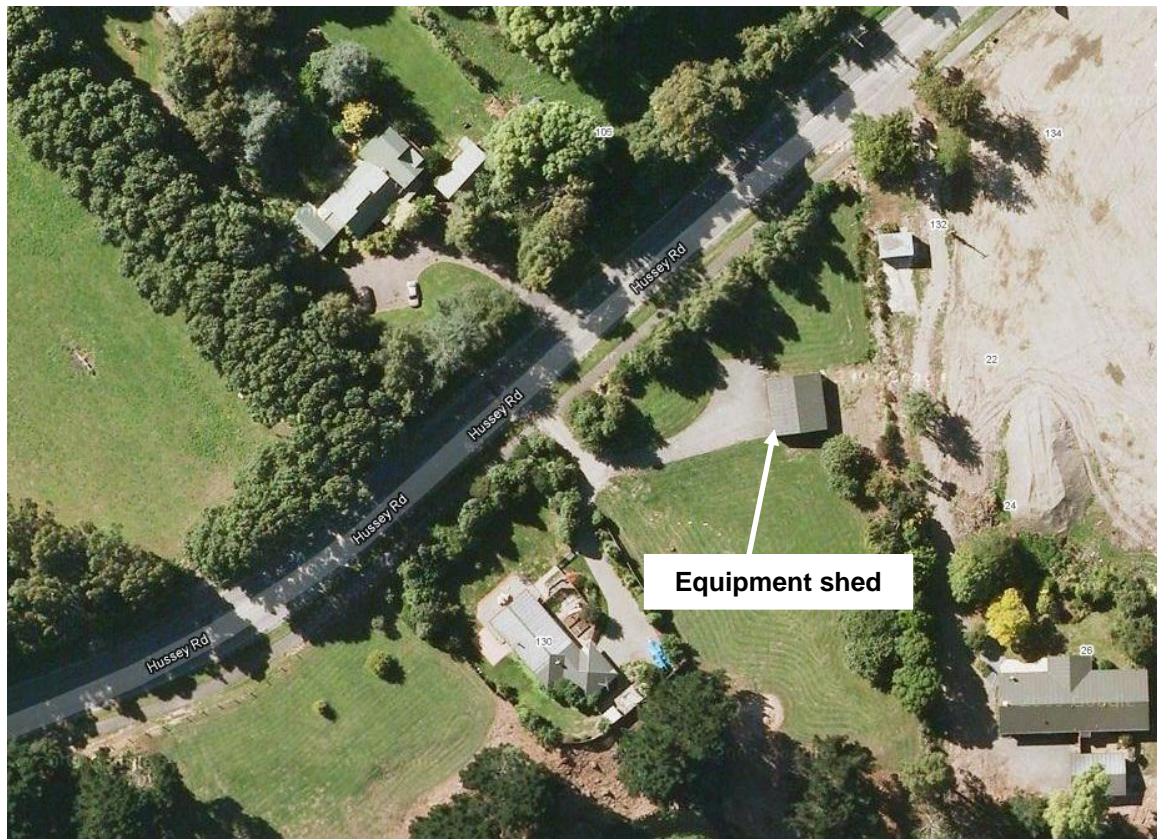
Figure 3 Post February 2011 Earthquake Aerial Photography ²

Aerial photography taken following the 22 February 2011 earthquake doesn't show the clear signs of liquefaction, as shown in Figure 3.

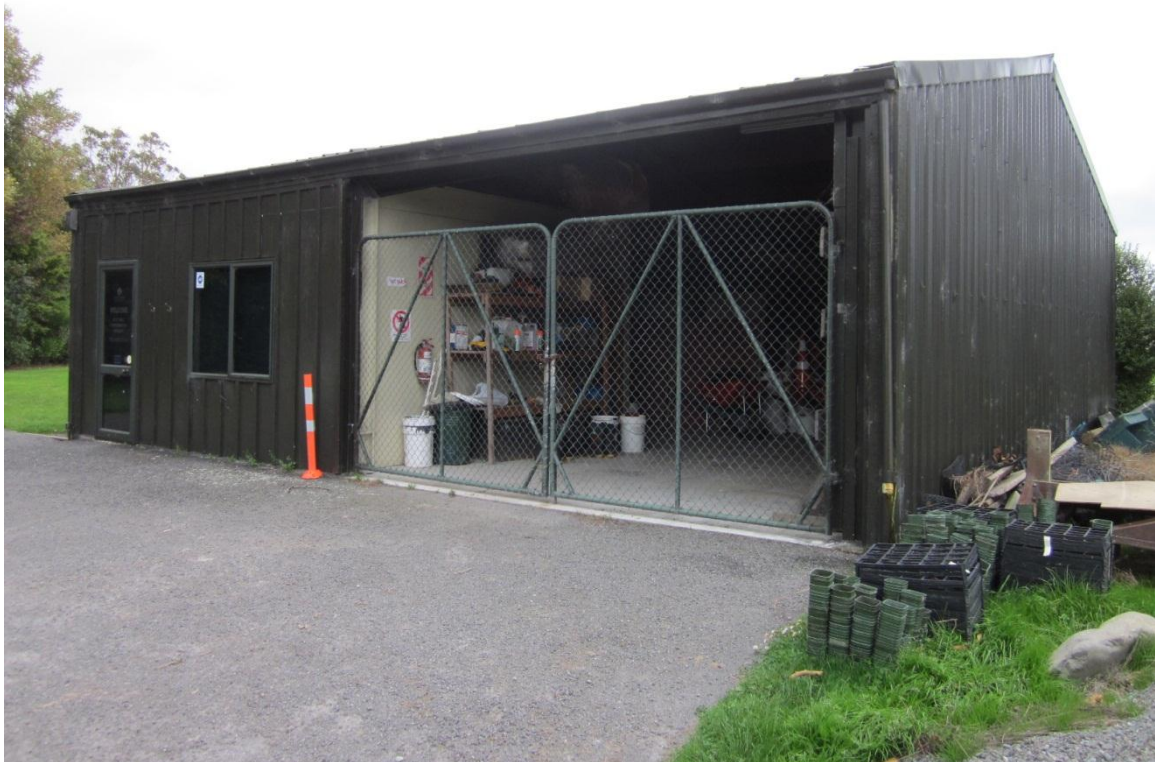
Photo 2 Equipment Shed (Northeast elevation).

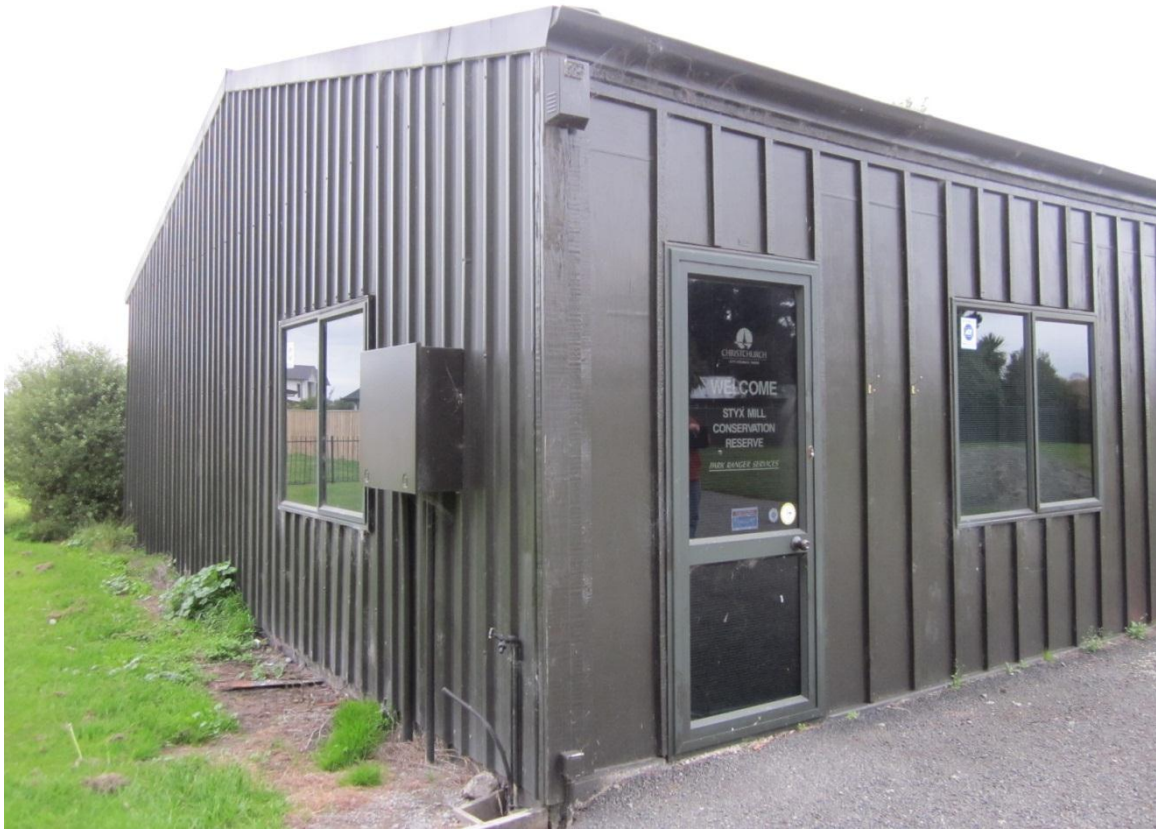
Photo 3 Equipment Shed (Northwest elevation).

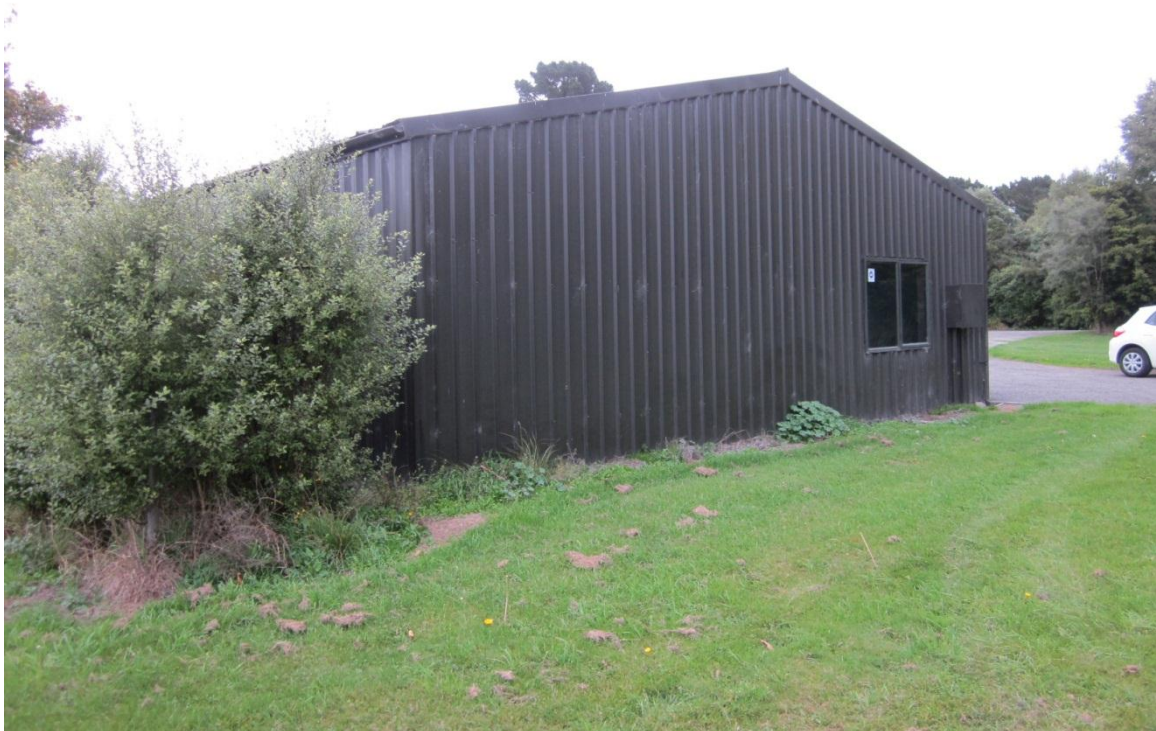
Photo 4 Equipment Shed (Southeast elevation).

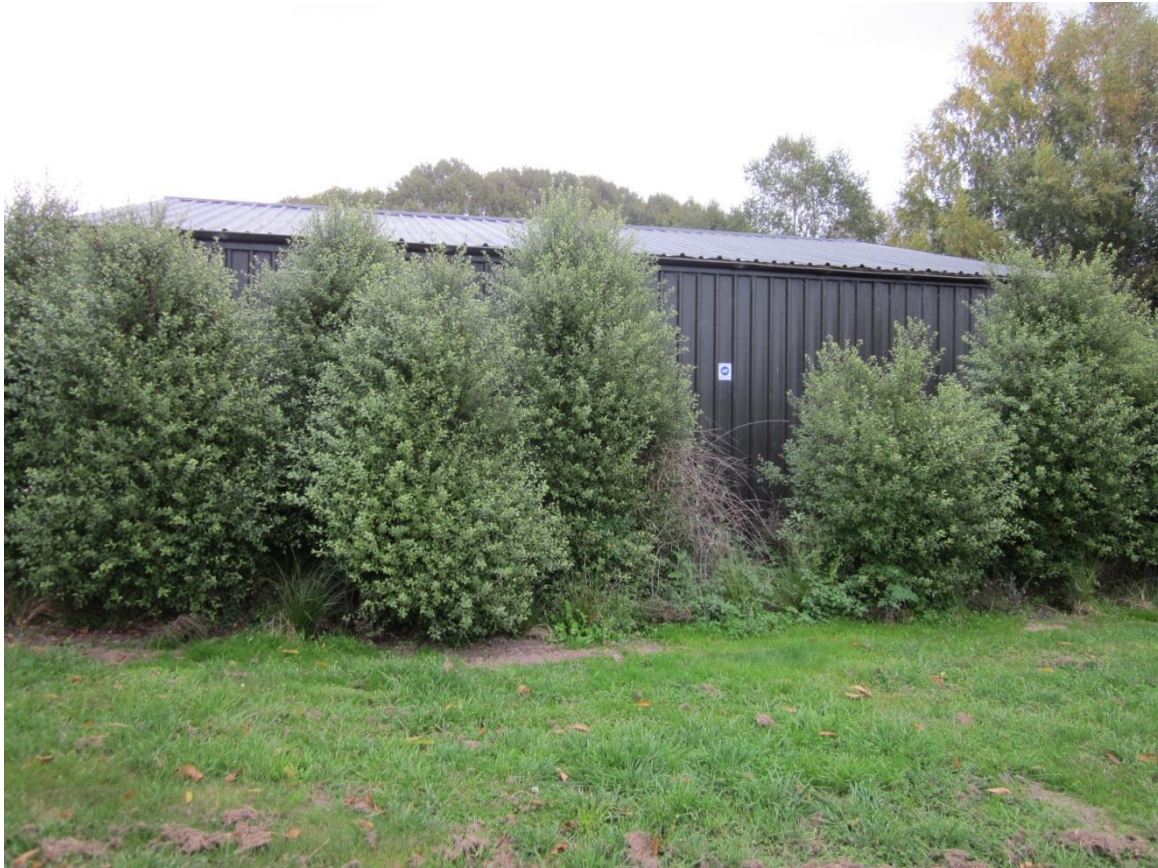
Photo 5 Equipment Shed (South elevation).

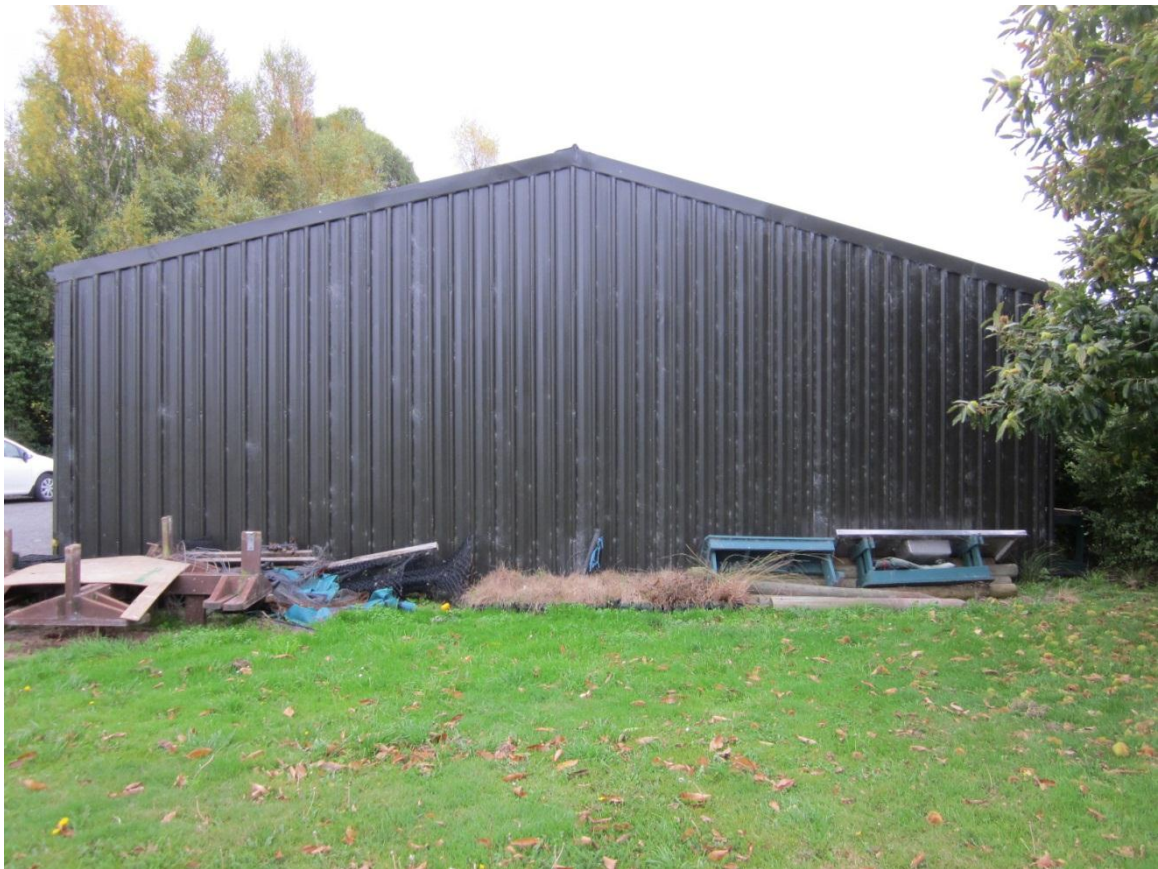
Photo 6 Equipment Shed (West elevation).

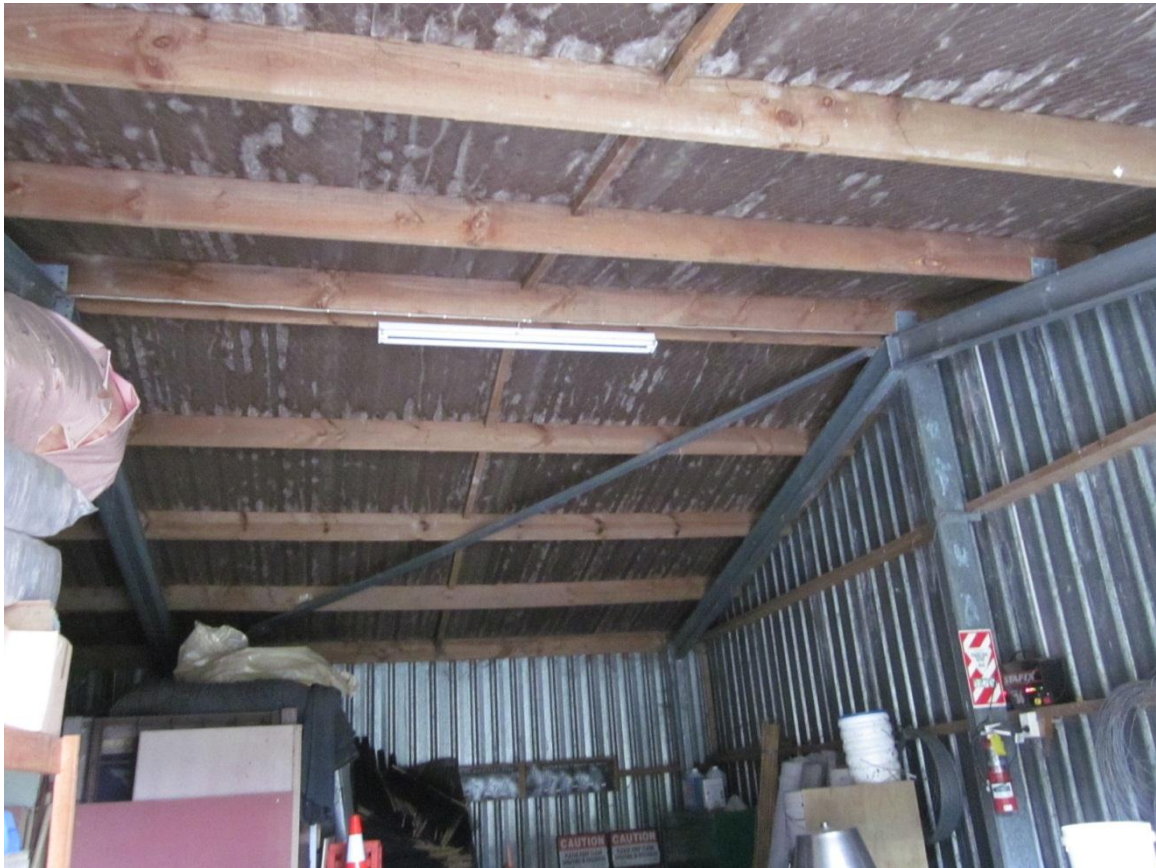
Photo 7 View of the roof structure.

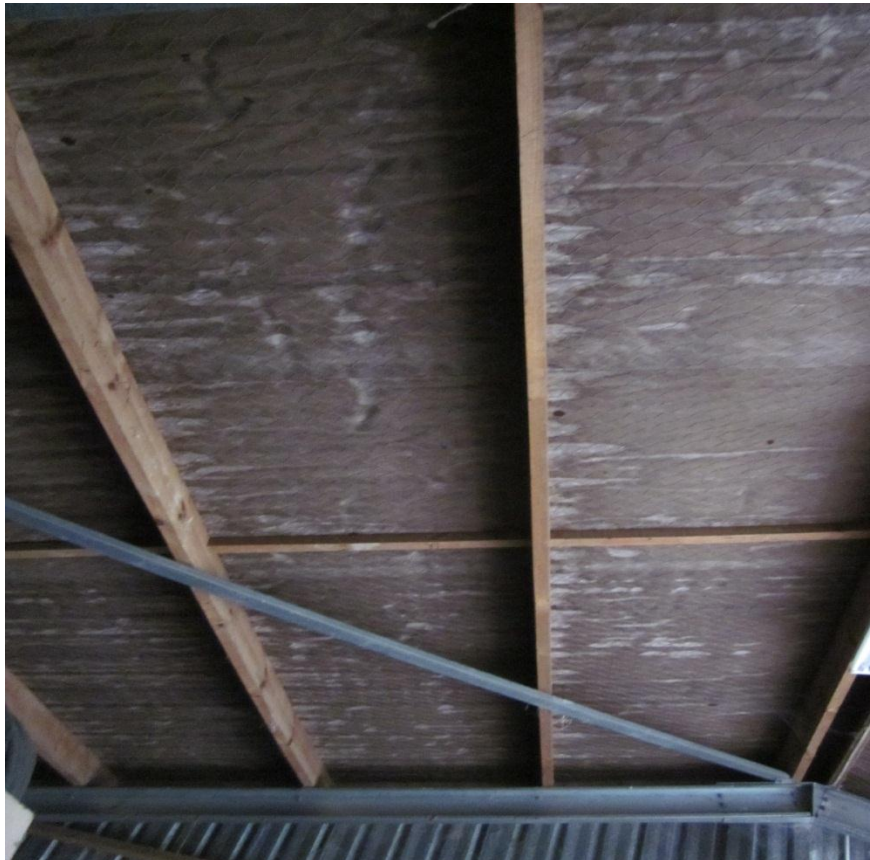
No Critical Structural Weakness was observed on the roof structure. The roof is braced by the two diagonal steel angles located in the northeast and southwest roof quadrants. These work in conjunction with the timber purlins which act as struts between the portal frames.

Photo 8 View of the diagonal roof bracing.

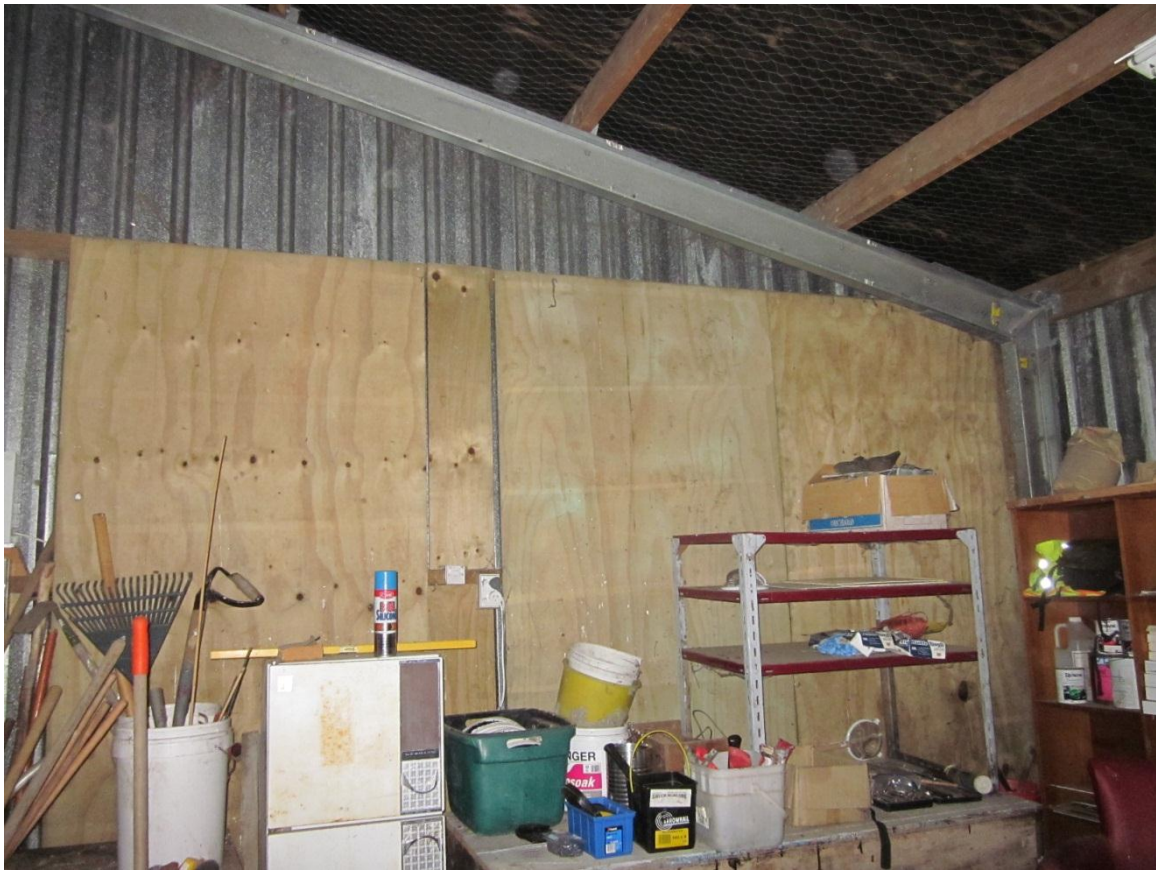
Photo 9 View of corrugated metal walls.

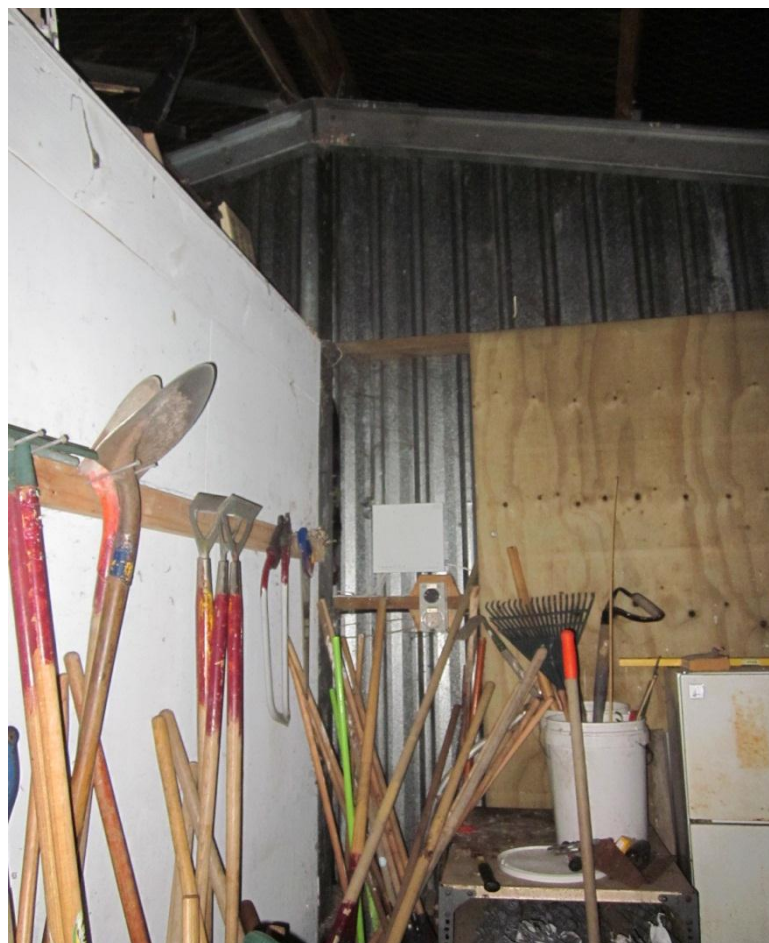
A timber framed office has been constructed within the Equipment Shed. The timber walls of the office are not load bearing.

Photo 10 View of partition between Equipment Room and Ranger's Office.
