Shed - 002
Styx River Reserve #2
PRK 2546 BLDG 003-EQ2
Detailed Engineering Evaluation
Qualitative Report
FINAL Version

Styx River Reserve, 303 Radcliffe Road,
Belfast, Christchurch

Detailed Engineering Evaluation
Qualitative Report
FINAL Version

Christchurch City Council

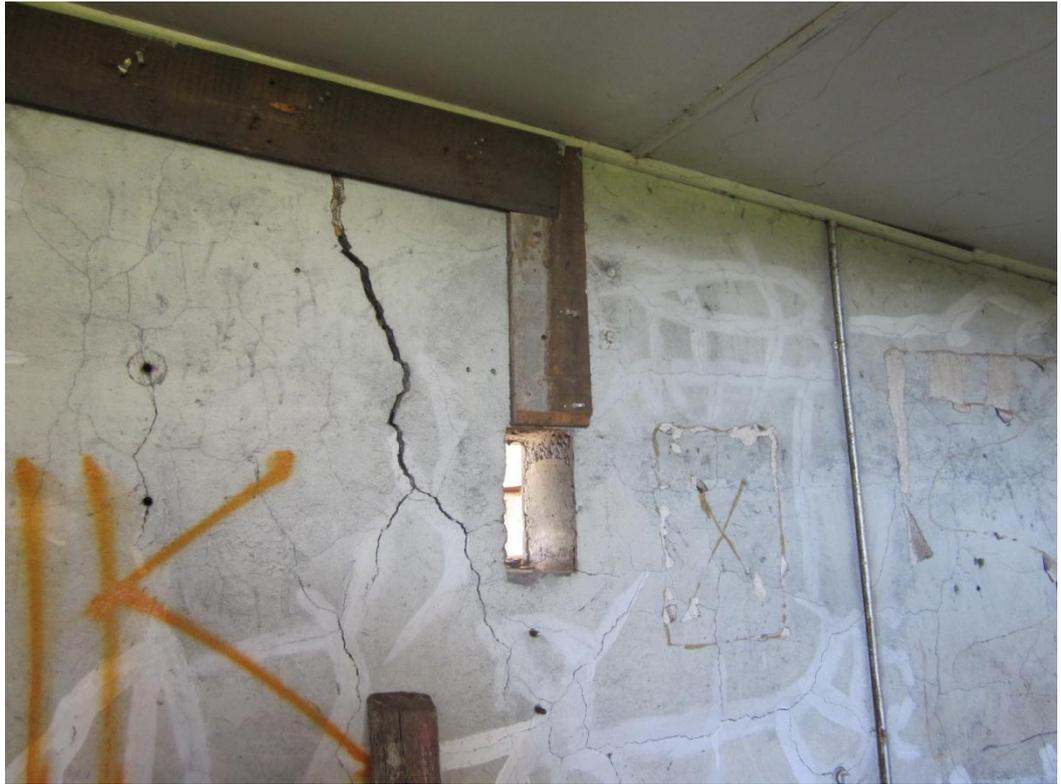
Photograph 13: Damaged masonry wall at western entry area.

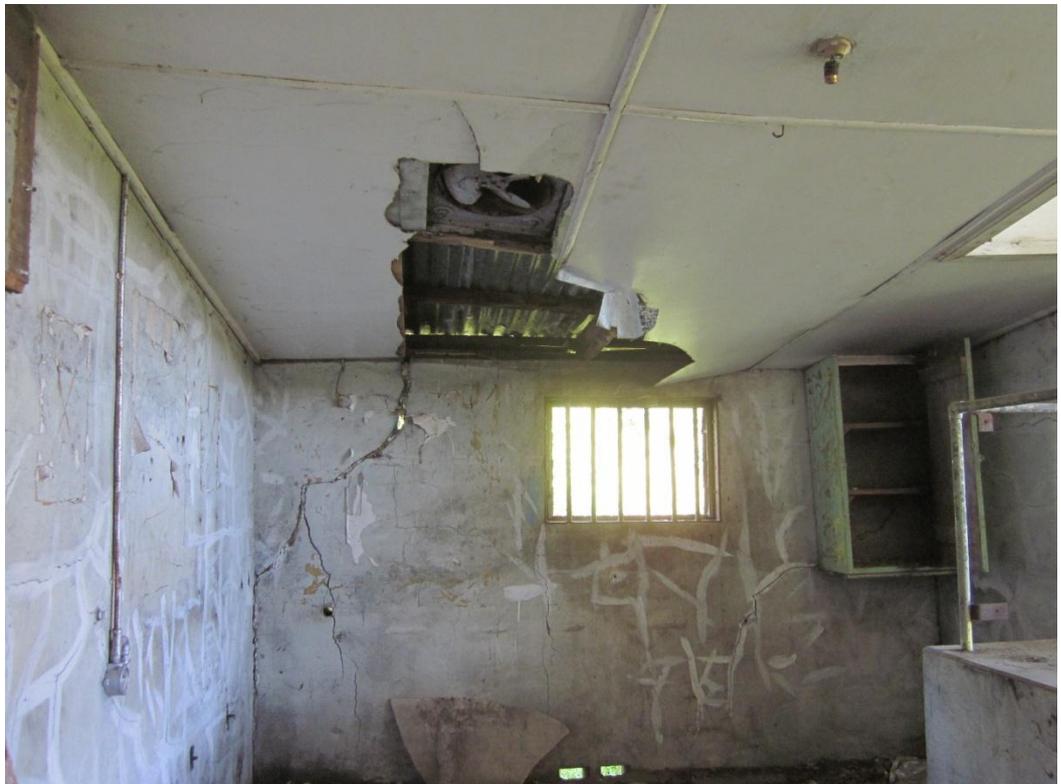
Photograph 10: Damaged walls, ceiling and roof at western entry area.
