Barn - 004
Styx River Reserve #2
PRK 2546 BLDG 004
Detailed Engineering Evaluation
Qualitative Report
FINAL Version

Styx River Reserve, 303 Radcliffe Road,
Belfast, Christchurch

Christchurch City Council

Date
22/5/13

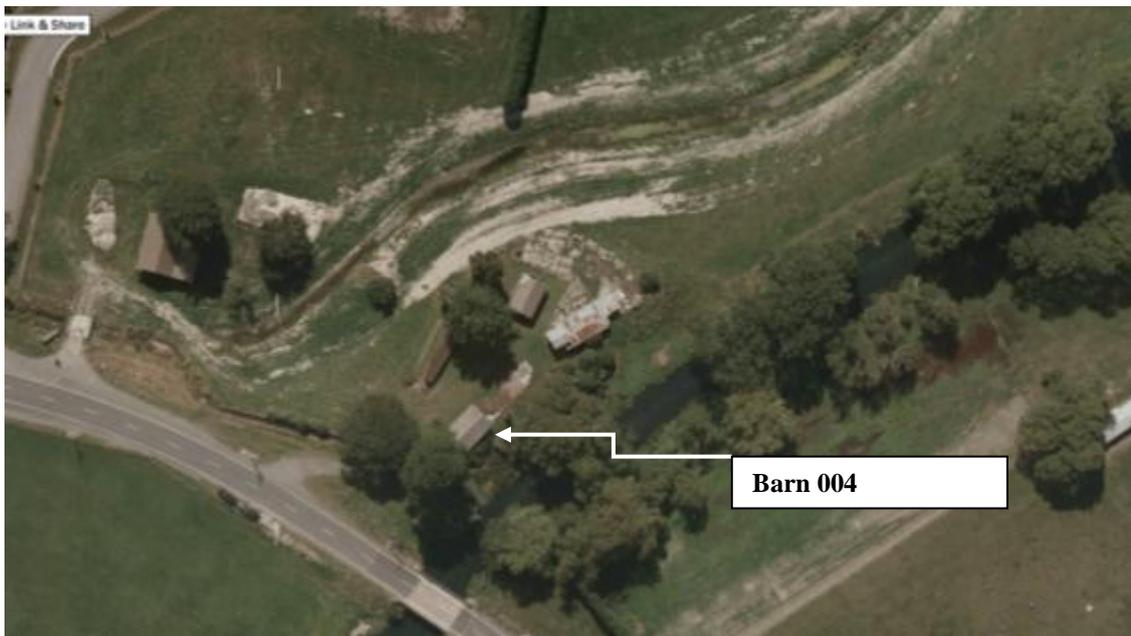
Figure 3 Post February 2011 Earthquake Aerial Photography²

Aerial photography taken following the 22 February 2011 earthquake shows a large amount of material on site (and properties adjacent) that maybe liquefaction as shown in Figure 3, although this material could also be evident on the surface due to a dry summer. However, lateral spreading is visible to the south along the Styx River. Material in the base of the drainage channel appears to be sand ejected from liquefaction.

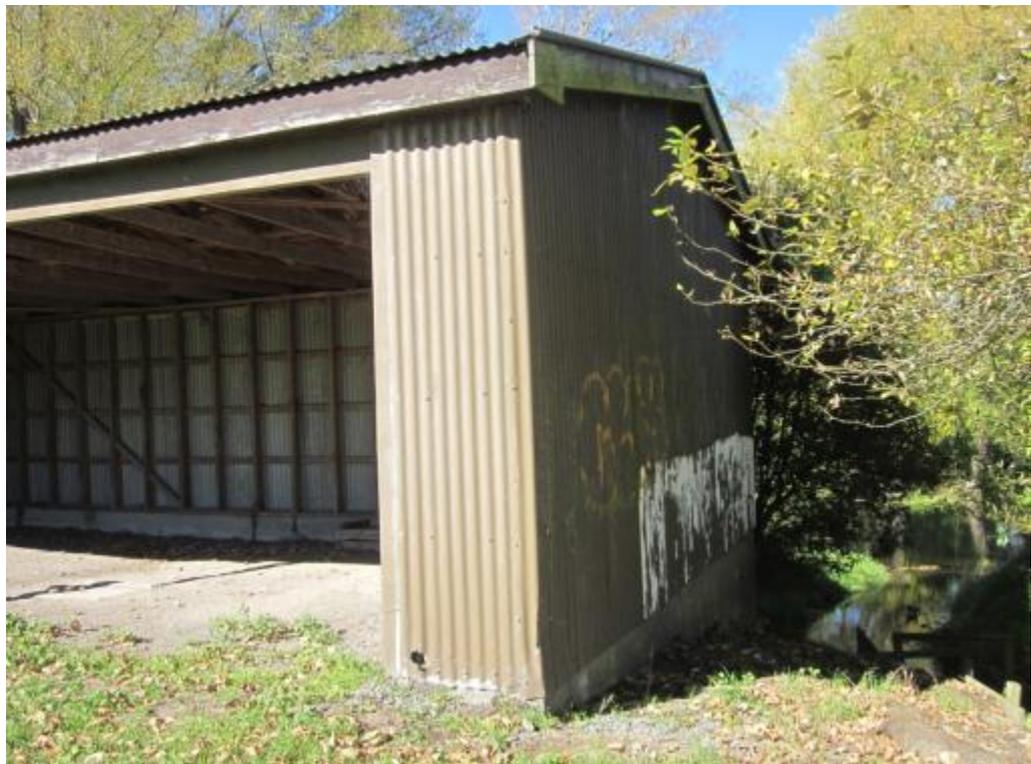
Photograph 2: Southwest corner elevation. Note proximity to the creek at the corner of the building.

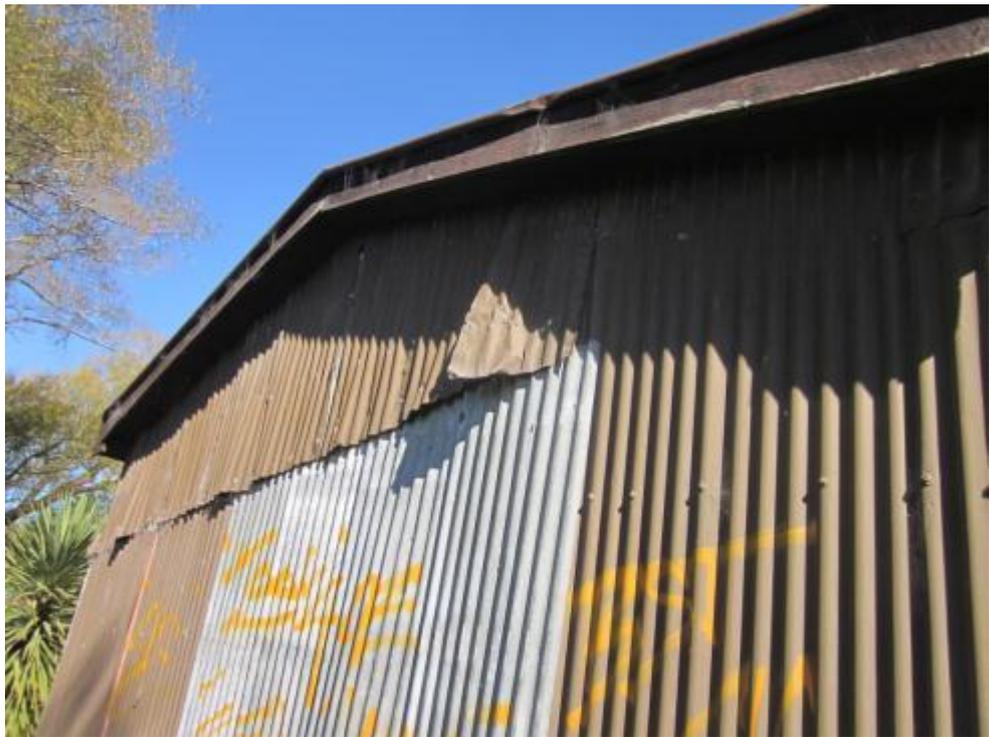
Some damage was observed on-site, but it is believed that the damage is due to poor workmanship and not caused by seismic action. Key damage observed includes partial separation of the external corrugated steel cladding from the timber framing along the north transverse wall.

Apart from some of the wall cladding separating from the framing, no residual displacements were observed. Some of the edges of the corrugated steel cladding panels on the northern exterior wall had separated from the timber wall framing. This is likely due to poor craftsmanship in the post-construction works to fill the opening in this wall, and not due to seismic damage. In addition, there was one hole in the exterior cladding roughly 100mm in diameter noted near the bottom of the wall on the western wall next to the barn entry. The rest of the exterior wall cladding on the northern and other exterior walls appeared to be in reasonable condition and still well-attached to the framing.

Photograph 9: Exterior wall cladding at northern wall.

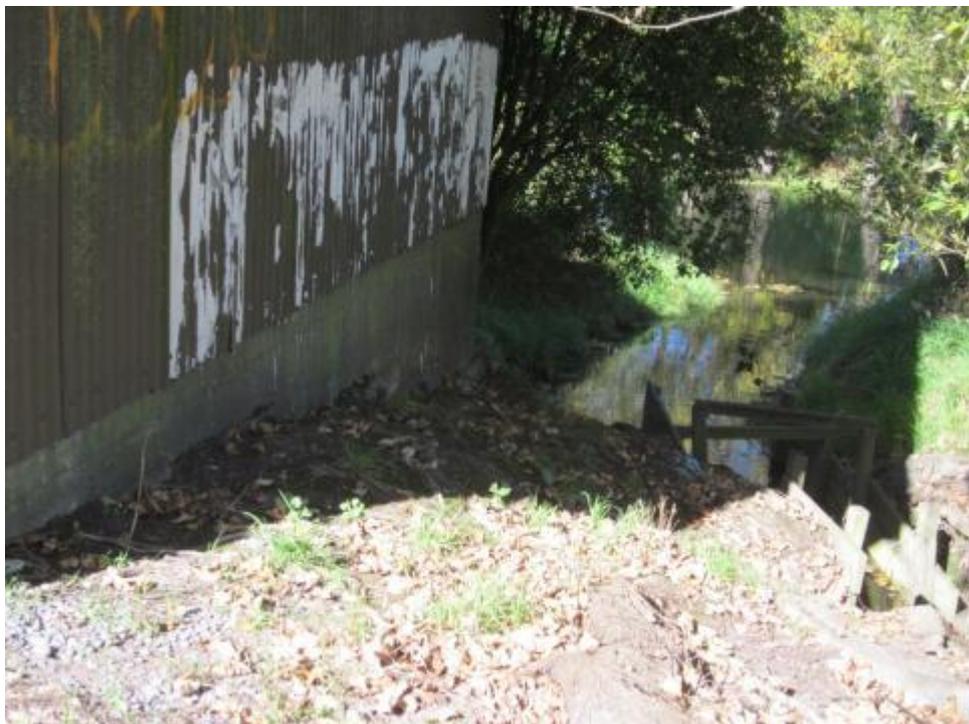
No liquefaction was observed at the site. However, the geotechnical investigation has identified a high liquefaction potential for the site, as well as the potential for lateral spreading. The southeast corner of the shed is situated on the bank of a creek which feeds the nearby Styx River, and the east side of the building runs roughly parallel to the creek and is especially susceptible to lateral spreading along the river's edge. Lateral spreading along the river could possibly undermine the building's foundations and lead to a premature collapse of the structure. Accordingly, the site characteristics have been noted as "significant" in the IEP assessment.

Photograph 10: Proximity of river at southeast corner. Note proximity to the creek.

Further investigation is recommended to better determine subsoil conditions. An intrusive investigation comprising one piezocone CPT test to 20m bgl is recommended to allow a more comprehensive liquefaction assessment to be undertaken.
