Styx River Conservation Reserve  
– Walnut Tree Lookout  
Qualitative Engineering Evaluation

Functional Location ID: PRK 2625 BLDG 001

Address: 53 Willowview Drive, Redwood

**Date:** 14 October 2013

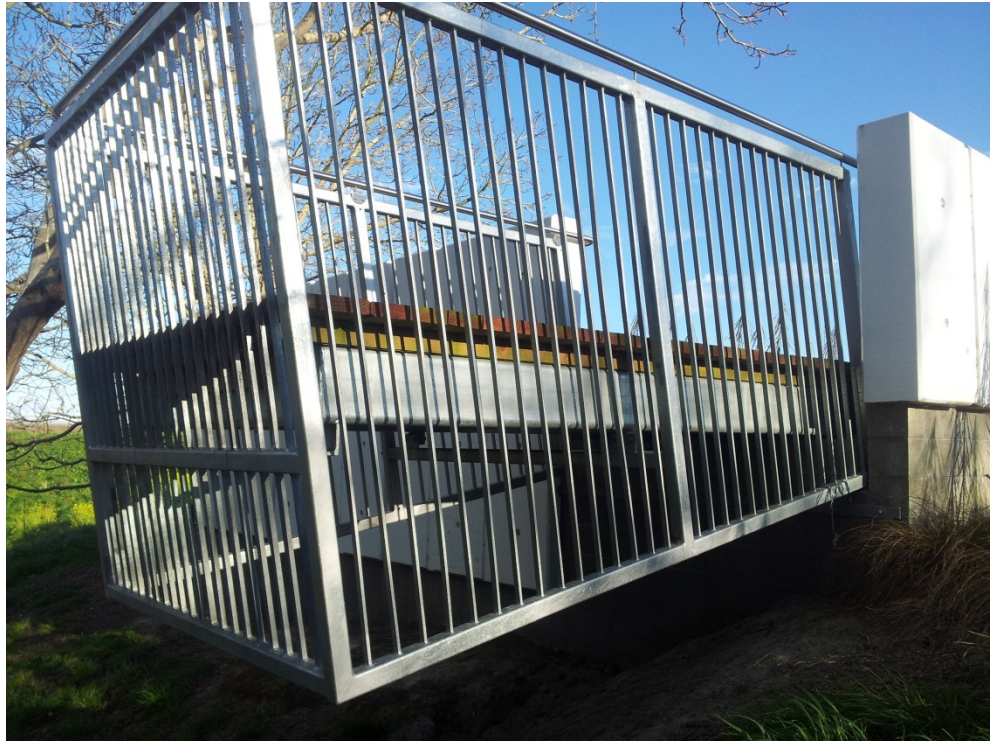
Structure  
northern  
elevation.

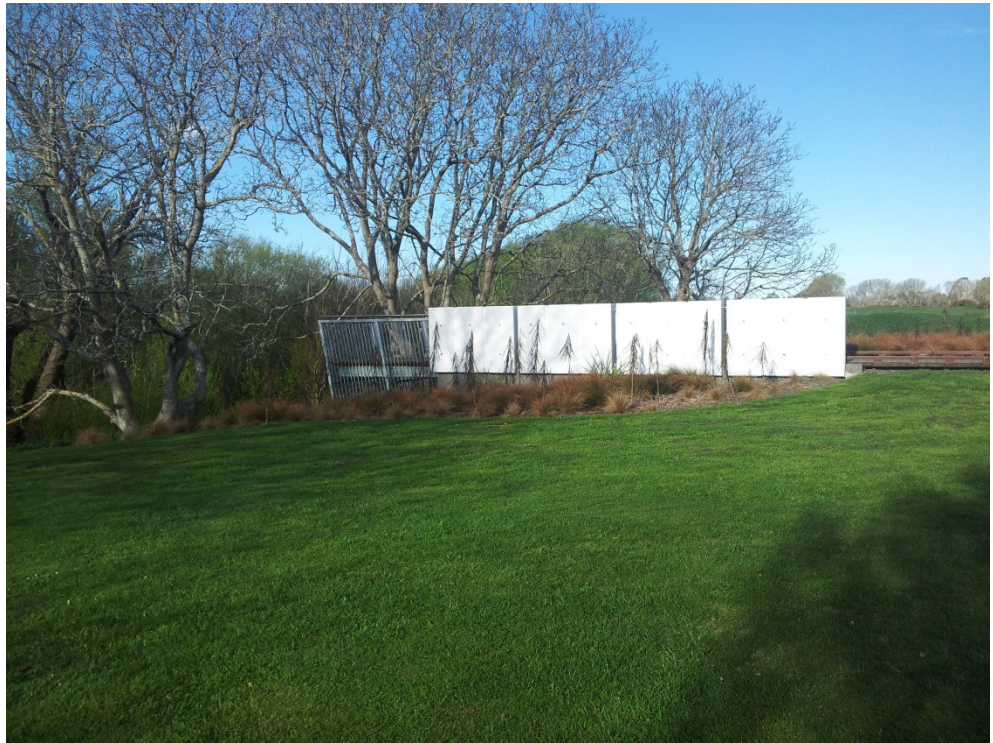
Structure  
western  
elevation.

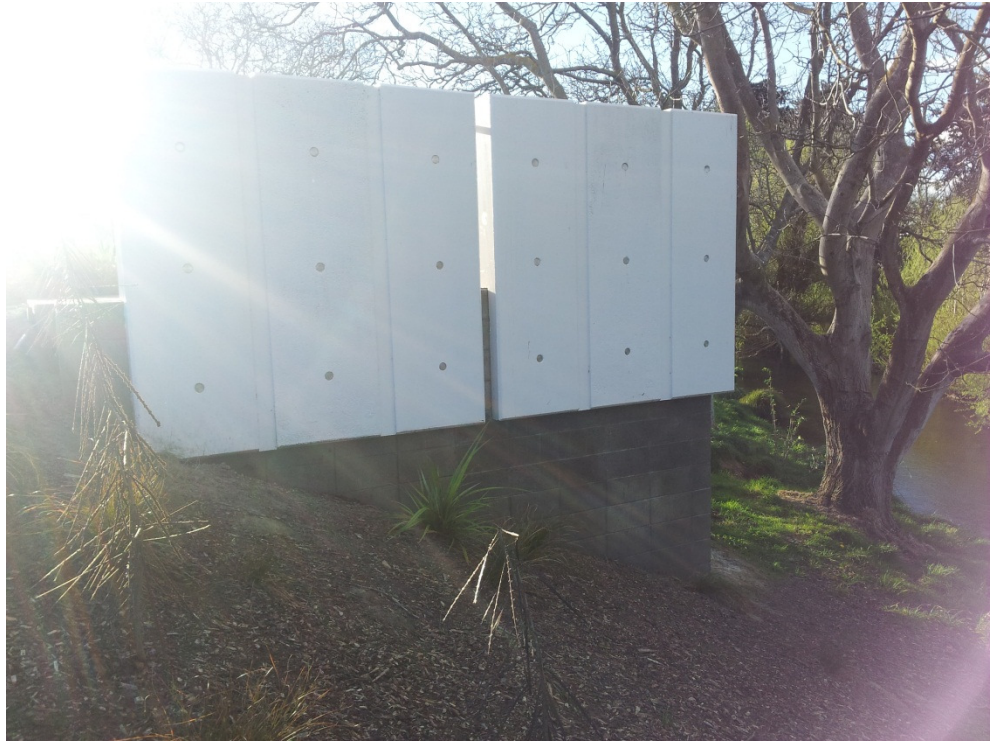
Structure  
eastern  
elevation.

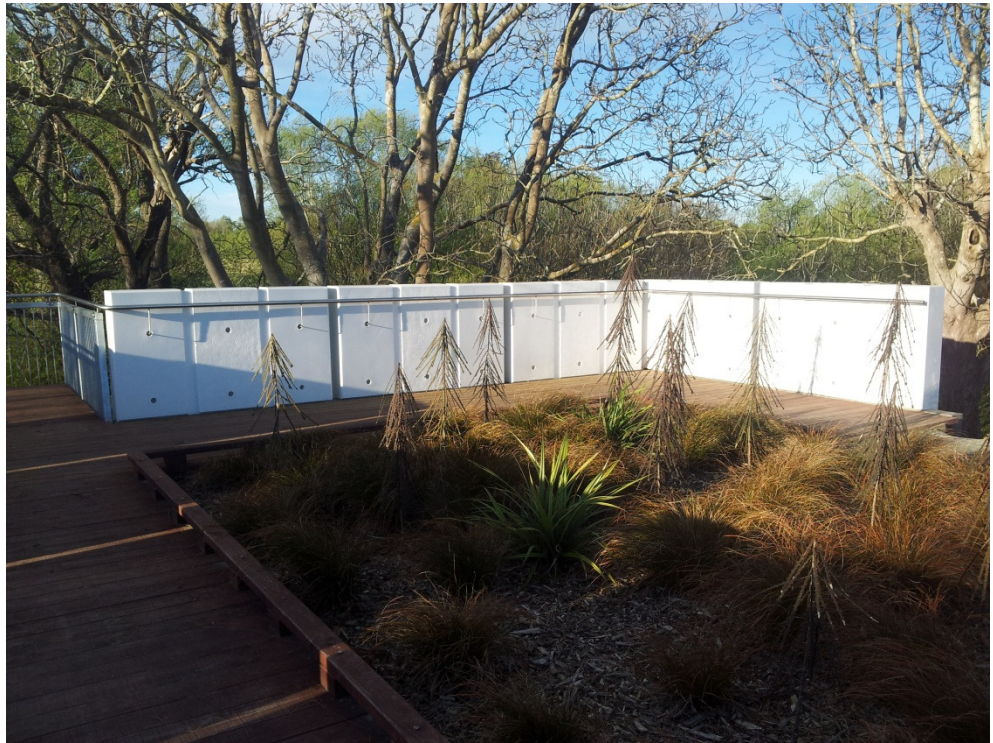
Structure  
Southern  
elevation.

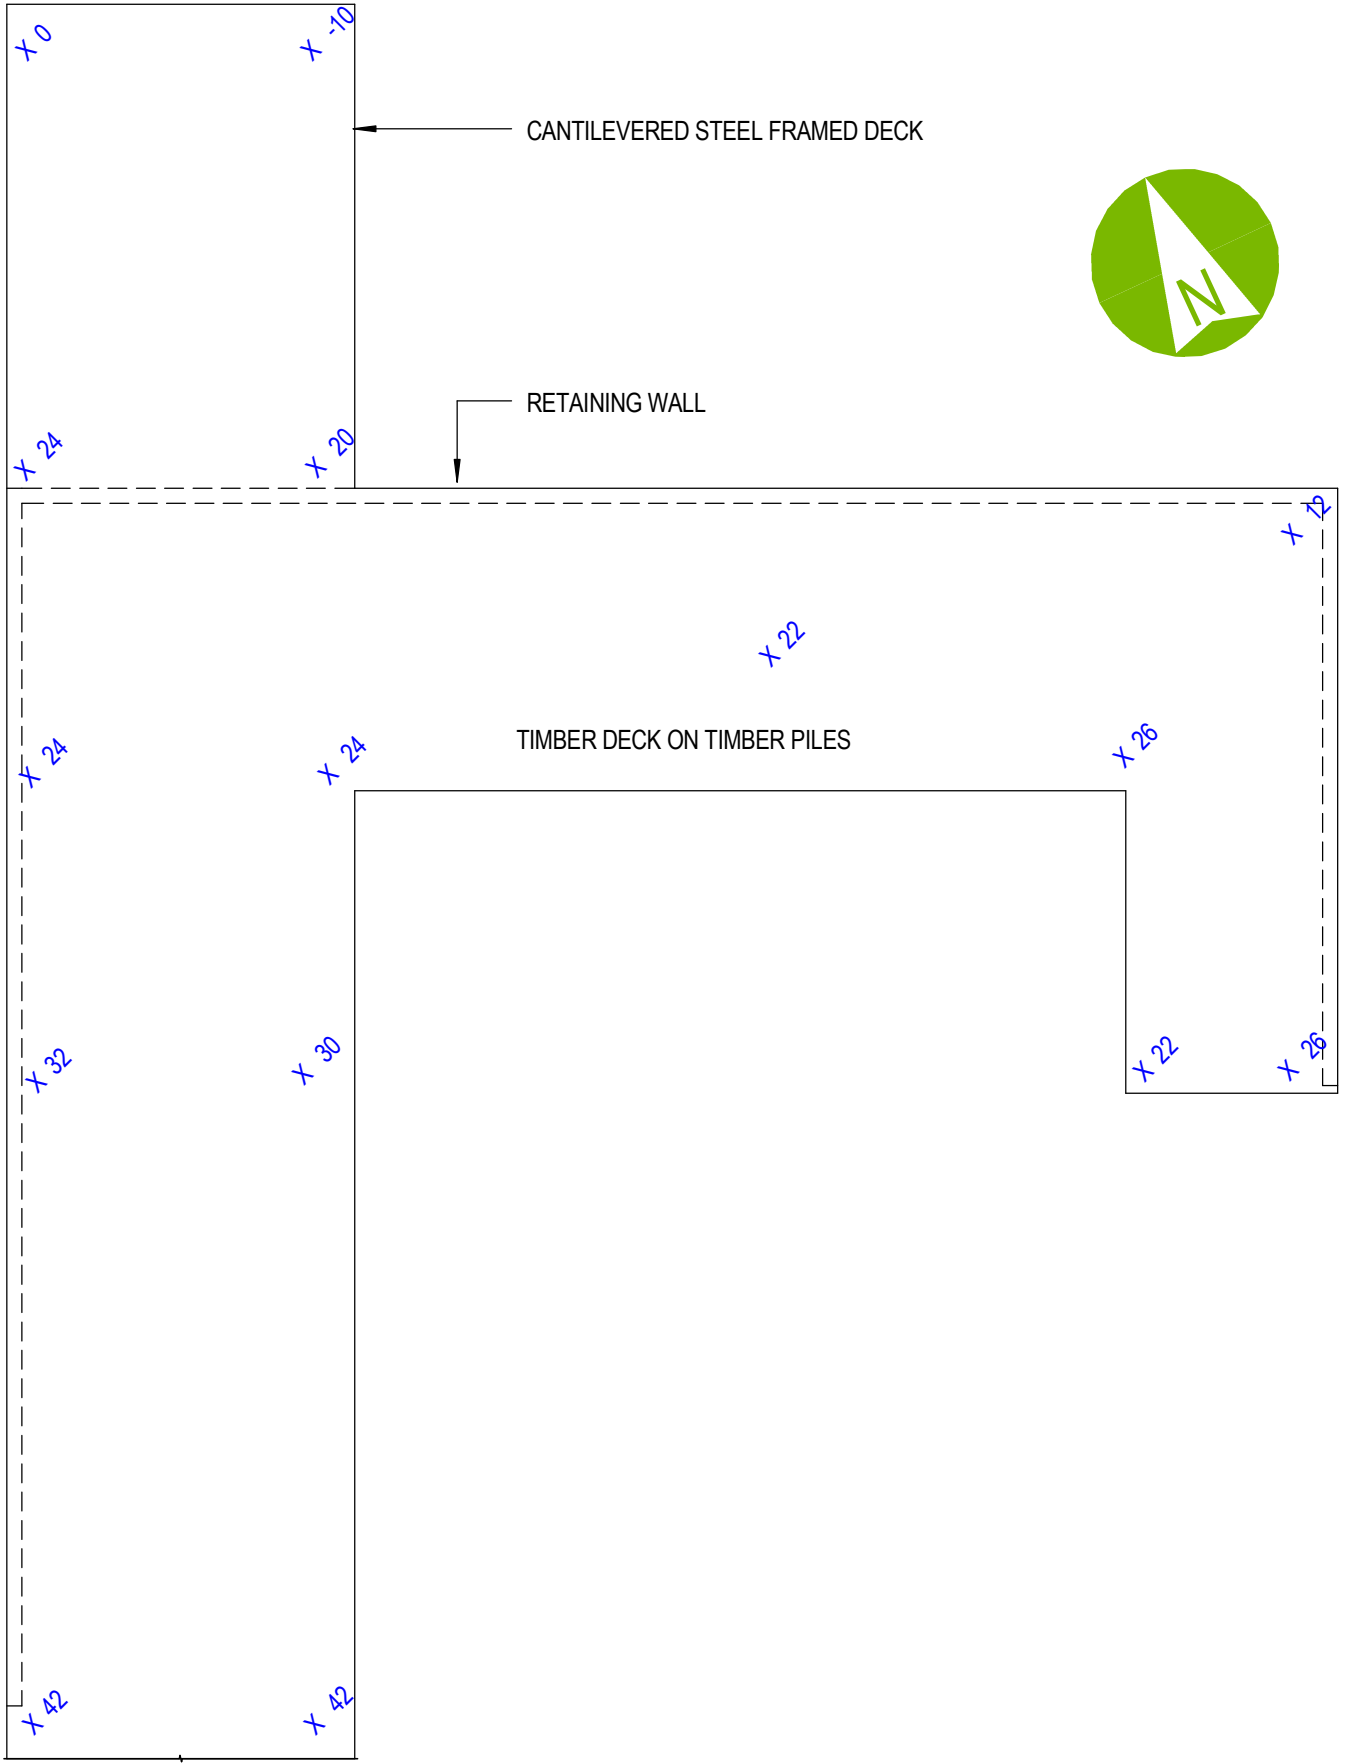
# PLAN - LEVELS

The floor levels for the Styx River Conservation Reserve – Walnut Tree Lookout were found to be within the recommended tolerances with slopes less than 0.5%.
