Templeton Courts Housing Complex PRO 1672

**Detailed Engineering Evaluation
Quantitative Assessment Report**

Templeton Courts Housing Complex

Date: February 2014
Reference: 6-QC404.00
Status: Final

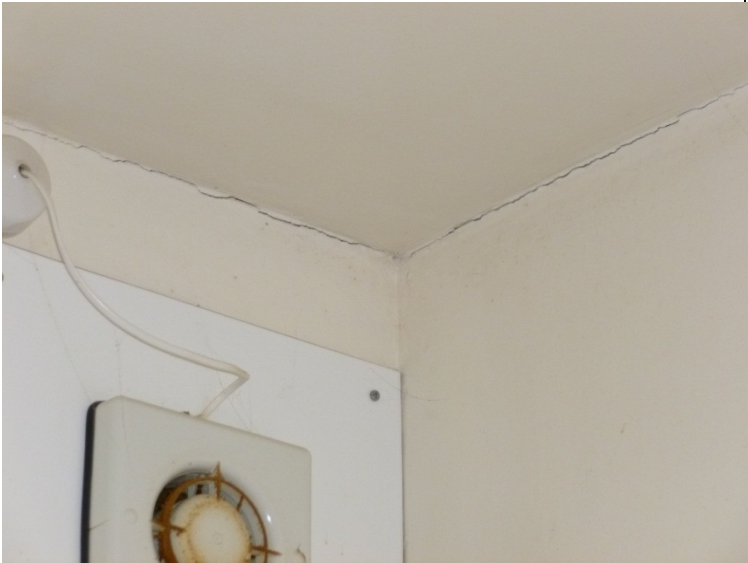
General plasterboard cracking was observed in all units typically along the roofline and above window and door frames (photos 4-6). A crack was observed in the roof lining in Unit 3 (photo 7). This damage was deemed low and does not affect the lateral resistance structure.

4.	Typical plasterboard cracking at ceiling line

- Cosmetic repairs are undertaken as required.

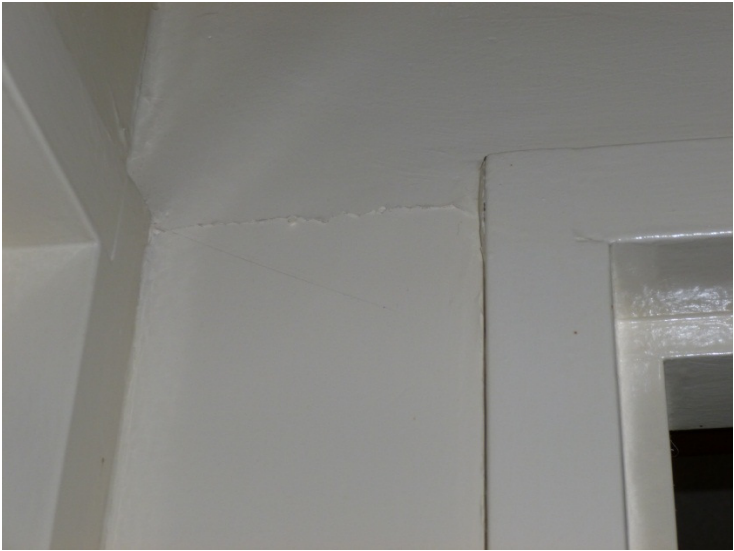
5.	Typical plasterboard cracking around doorways

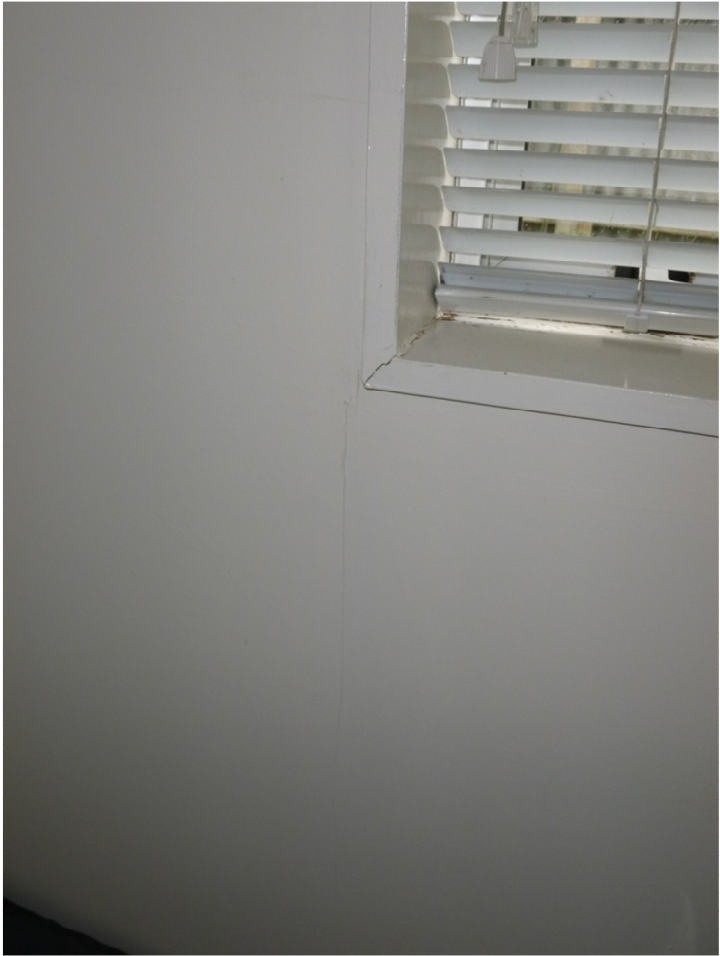
6.	Typical plasterboard cracking around window frames

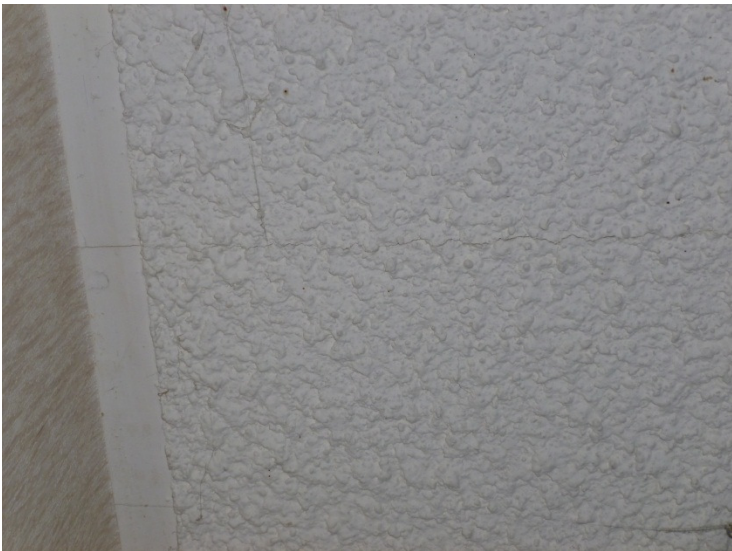
7.	Roof crack in Unit 3

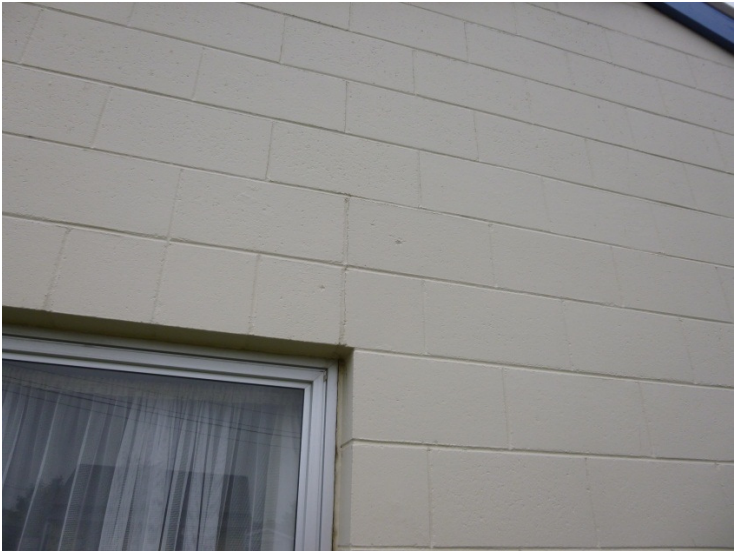
Some stepped cracking was observed in the concrete block veneers in all units (photo 8). Cracks were observed between the concrete block firewall and the block veneer.

8.	Typical stepped cracking on concrete block veneer

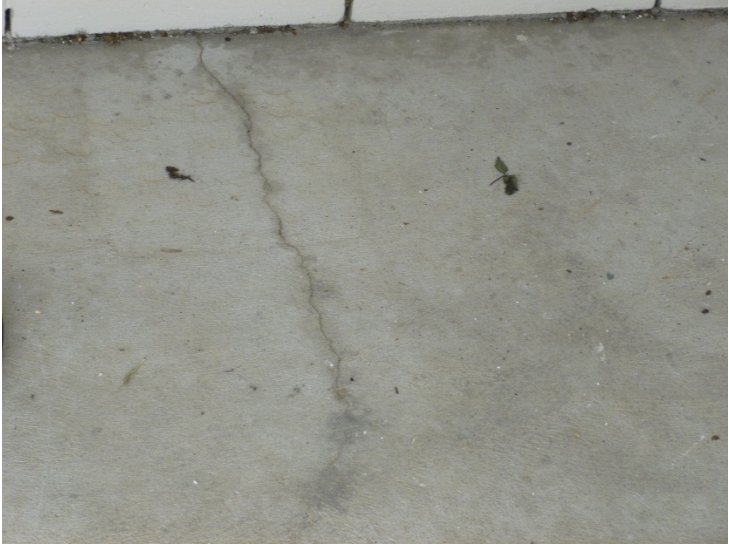
No cracking was observed in the concrete pad foundation. Some cracks were observed on the concrete patios (photo 9).

9.	Typical cracks in concrete patio

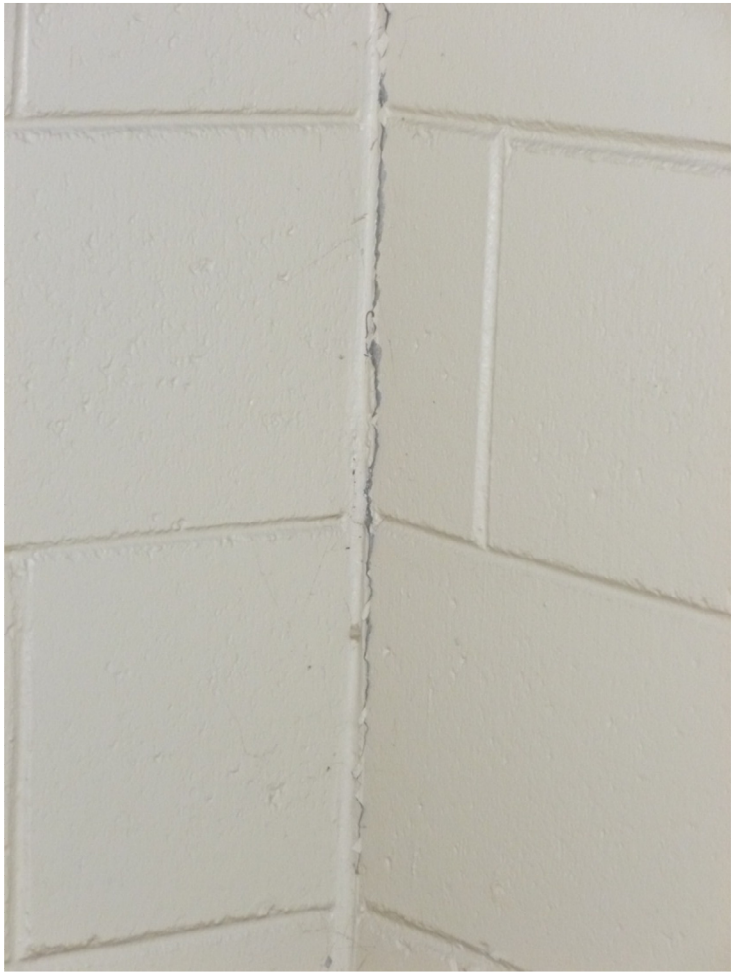
10.	Typical cracks between the concrete block walls
