**Christchurch City Council**  
PRK\_1673\_BLDG\_001 EQ2  
Templeton Domain Toilet  
Kirk Road, Templeton

QUALITATIVE ASSESSMENT REPORT

FINAL

- Rev B
- 21 November 2012

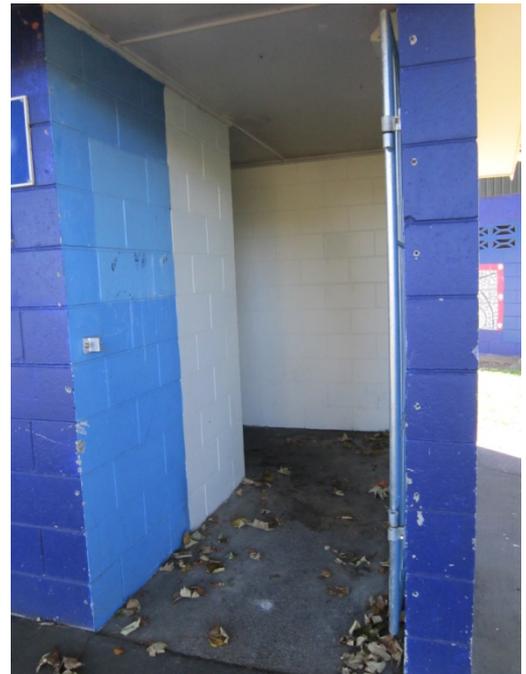
Photo 4: View of the mens toilet entrance block walls at either side of the opening

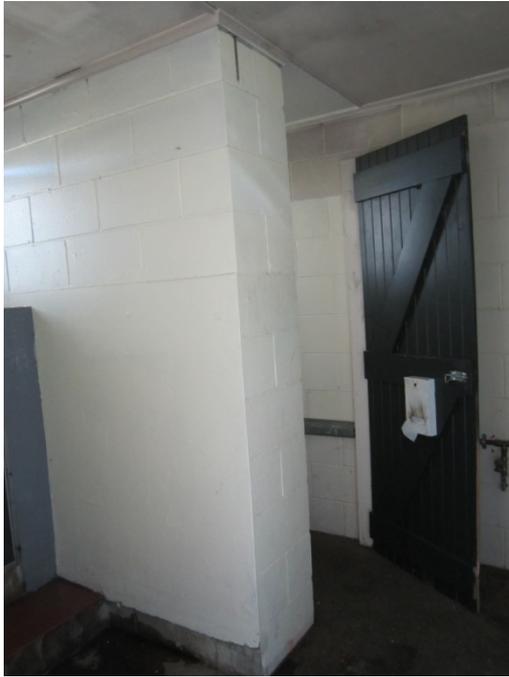
Photo 5: View of the block walls within the mens toilet area.

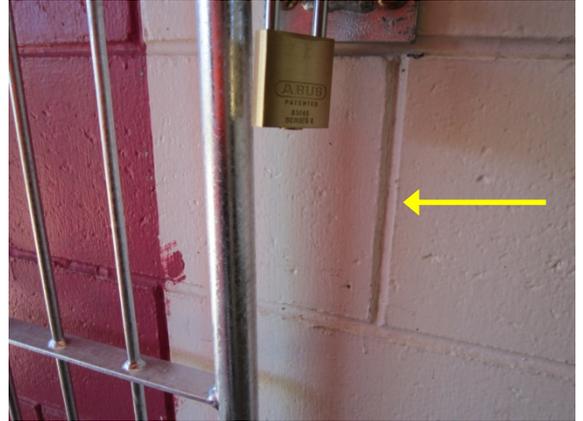
- 1) Cracking less than 0.5mm in the concrete block bed joints. Note that the damage may not have been caused by the earthquake, however is of a type consistent with earthquake damage and there was no other evidence which would lead us to believe that the damage existed prior to the earthquakes.

Photo 6: Minor bed joint cracking.

<b>Recommendations</b>		Level of repair/strengthening required: minor structural	Describe: Cracking repairs to blockwork
Building Consent required: no		Interim occupancy recommendations: full occupancy	Describe: Like for like repair
			Describe: No restrictions required
Along	Assessed %NBS before: 94%	%NBS from IEP below	If IEP not used, please detail SKM conceptual calculations
	Assessed %NBS after: 94%		assessment methodology: _____
Across	Assessed %NBS before: 94%	%NBS from IEP below	
	Assessed %NBS after: 94%

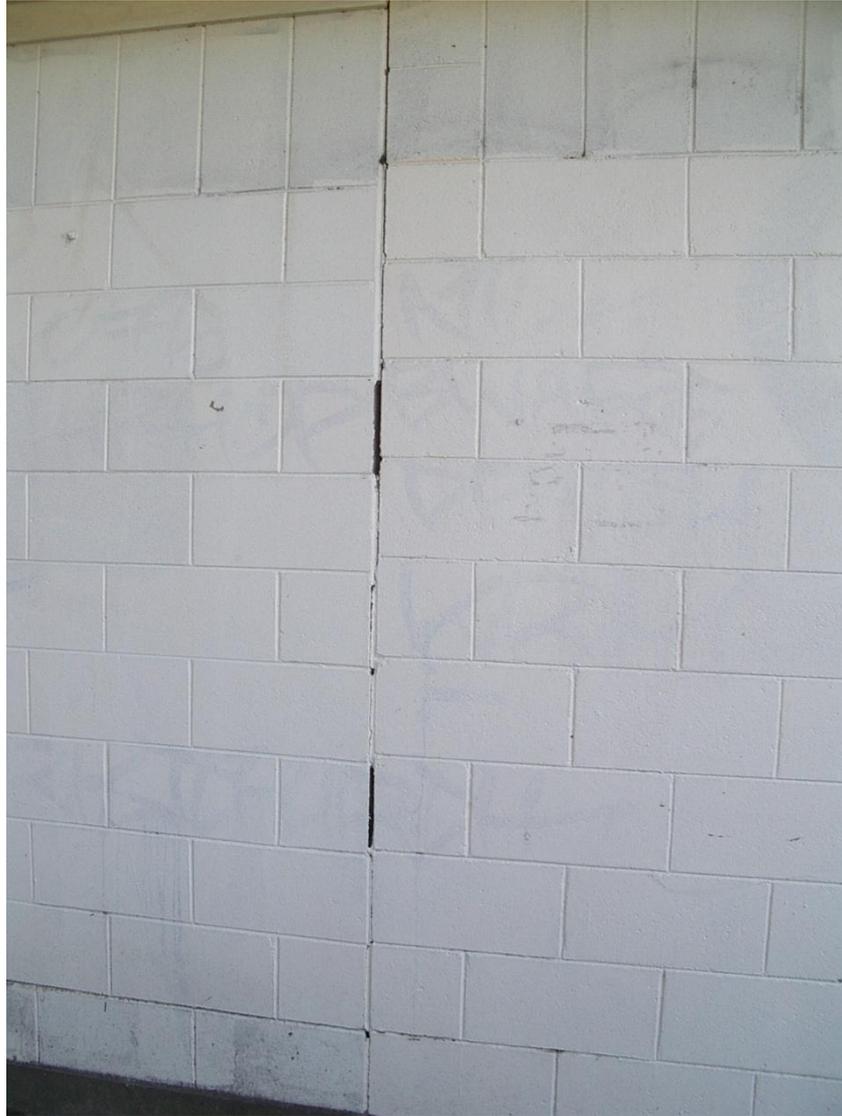
Very minor separation of an extension building from the main block of the changing shed (approx 2mm) was observed; otherwise no damage was noted from the external site inspection. Additionally, there was no evidence of any land damage around the site.

- **Figure 5 Observed separation of changing shed from main block**
