Thompson Park - Toilets  
Qualitative Engineering Evaluation

**Reference:** 228662  
**Prepared for:**  
Christchurch City Council

Functional Location ID: PRK 1316 BLDG 012

**Revision:** 2  
**Date:** 5 July 2013

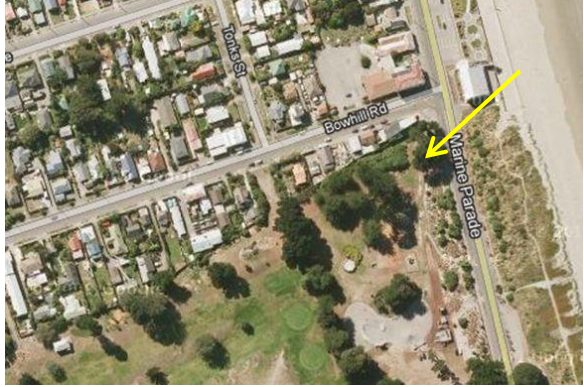
<p>Aerial photograph of Thompson Park – Toilets.</p>

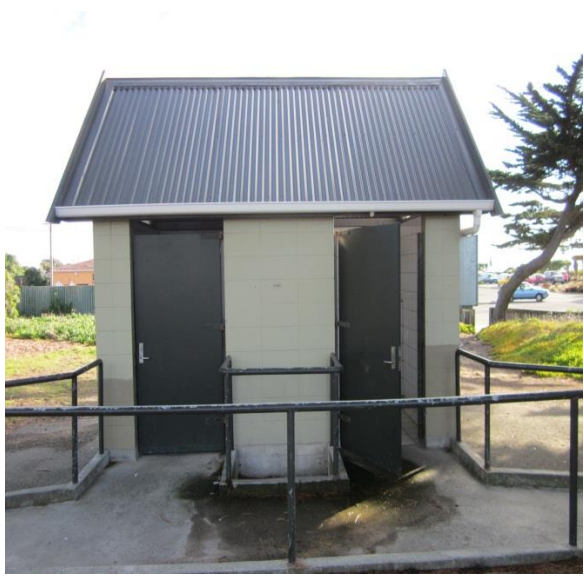
<p>South view of the Thompson Park Toilets.</p>

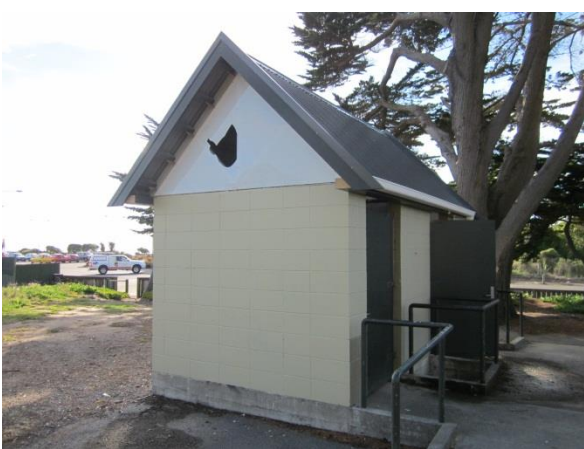
<p>Western view of the Thompson Park Toilets.</p>

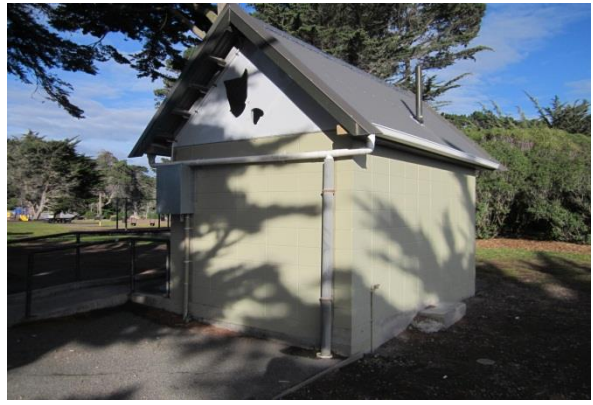
Eastern view of the Thompson Park Toilets.

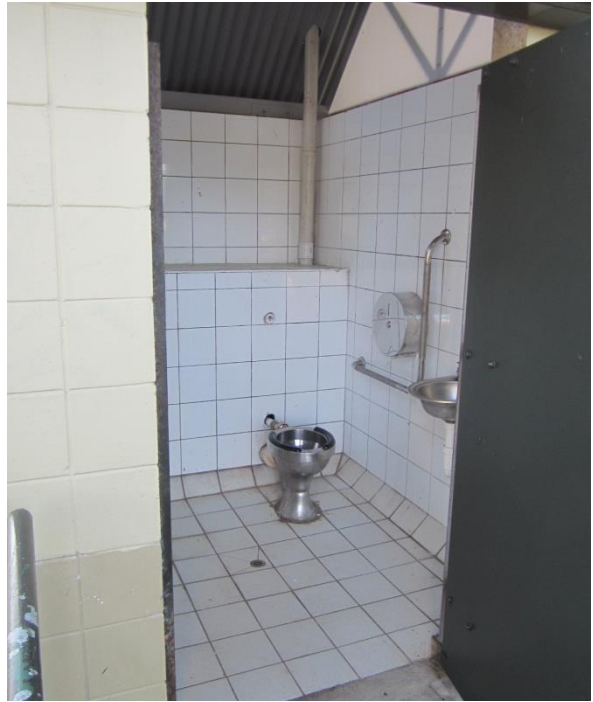
There was no observed damage to the Thompson Park - Toilets as a result of seismic actions. Buildings of this nature have a high bracing capacity. No damage was found on the tiled wall linings.

Internal view of the Thompson Park Toilets.

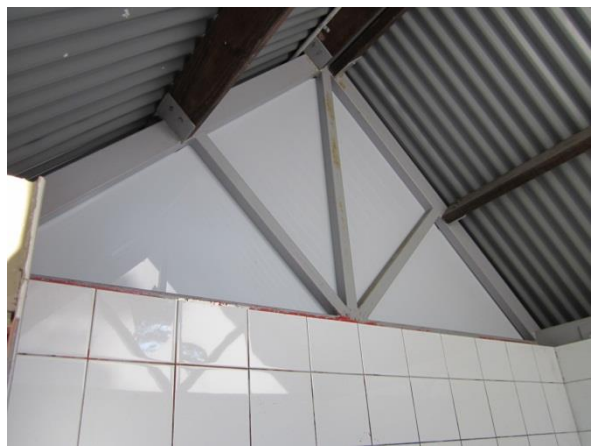
Truss detail.
